Kiel High School

Swimming Pool Audit

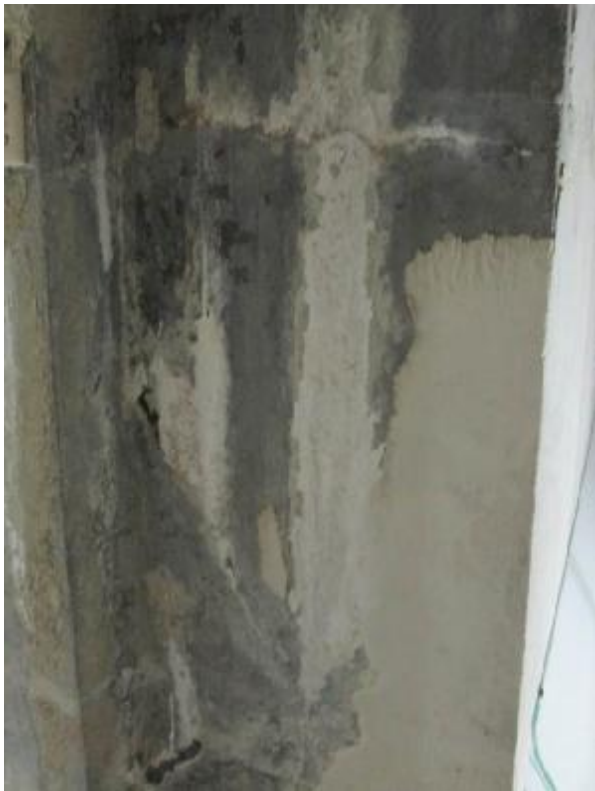
Image 1: Crack in the Pool Structure

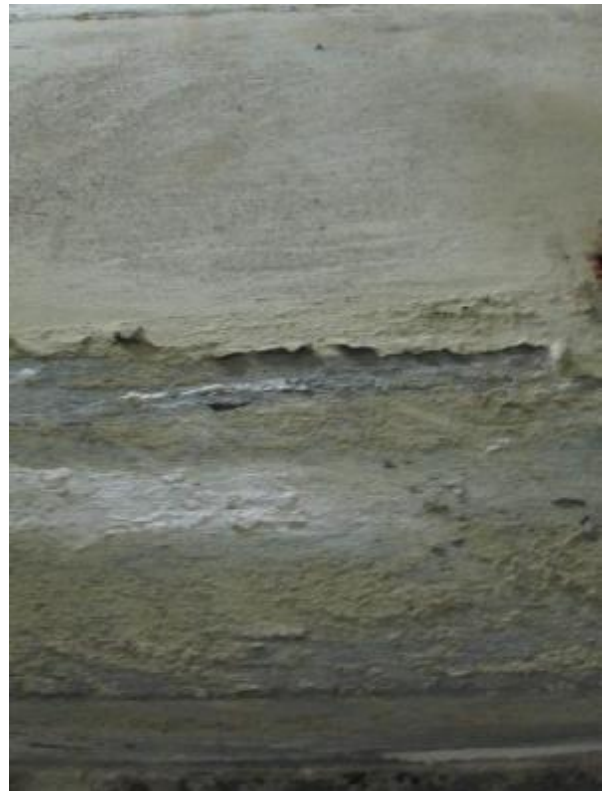
Image 2: Crack in the Pool Structure

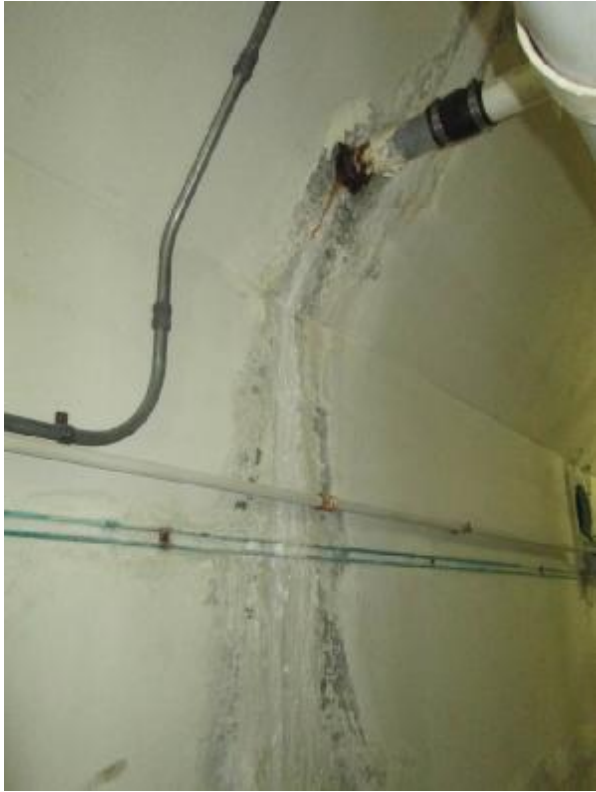
Image 3: Pool Leak Emanating from Pool Piping

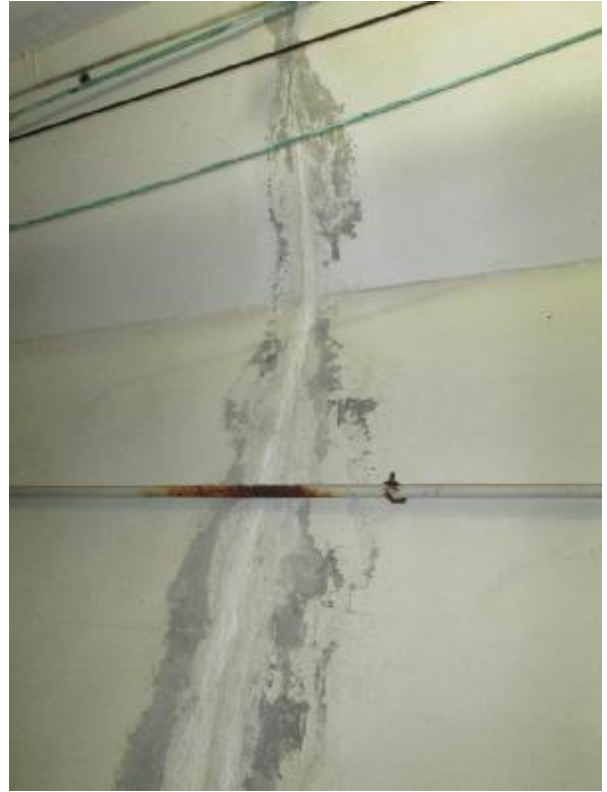
Image 4: Vertical Crack in the Pool Structure

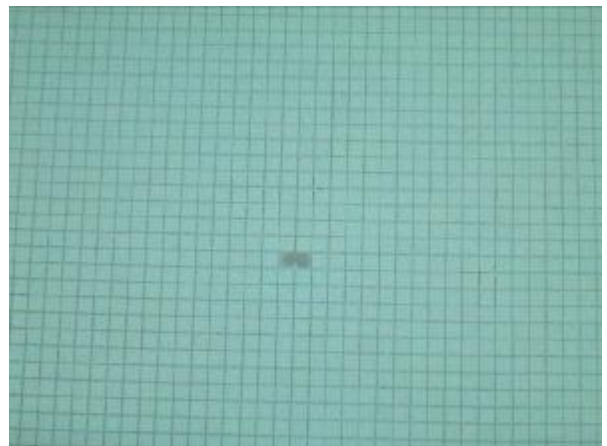
Image 12: Missing Tiles in the Shallow End

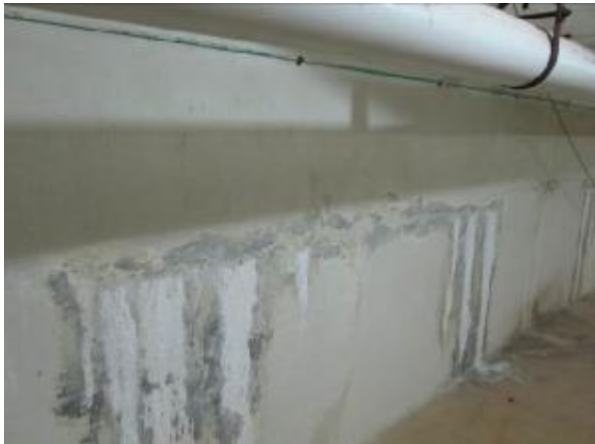
Image 9: Crack in the Pool Structure

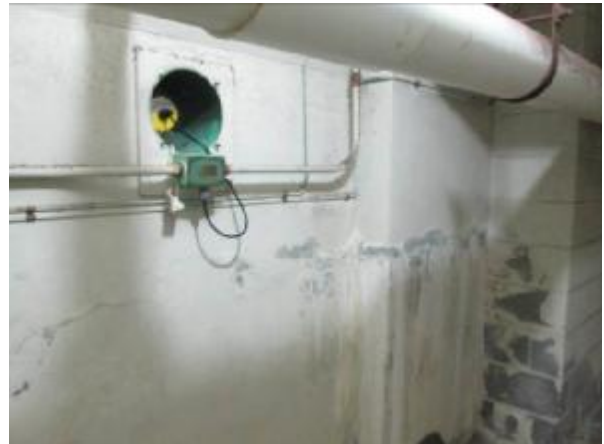
Image 10: Crack in the Pool Structure

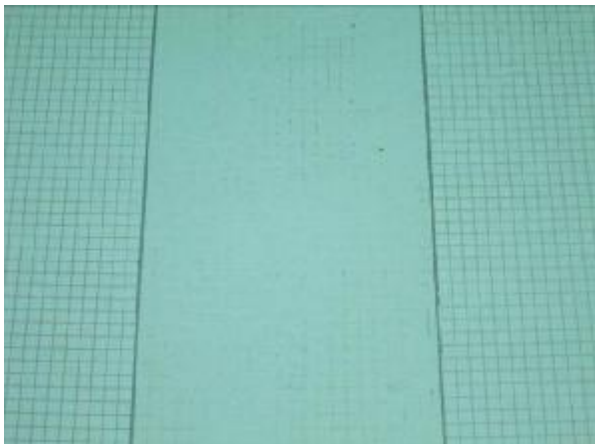
Image 13: Lime Build-Up and Missing Grout

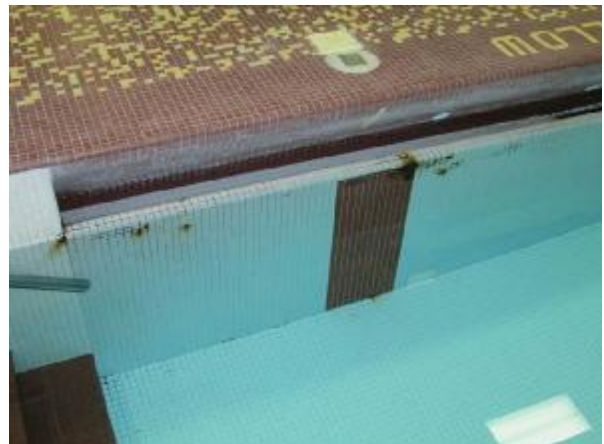
Image 14: Corrosion at the Water Line Handhold

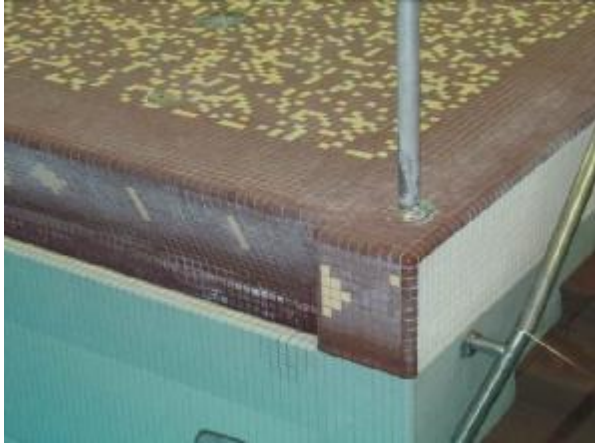
Image 15: Calcium Build-Up on the Rollout Gutter Curb above the Water Line

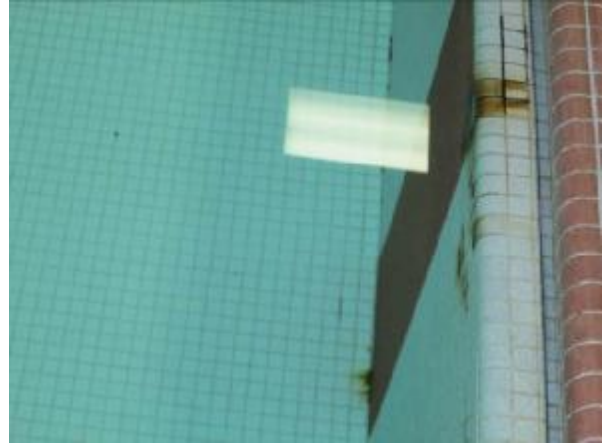
Image 16: Corrosion at the Water Line Handhold

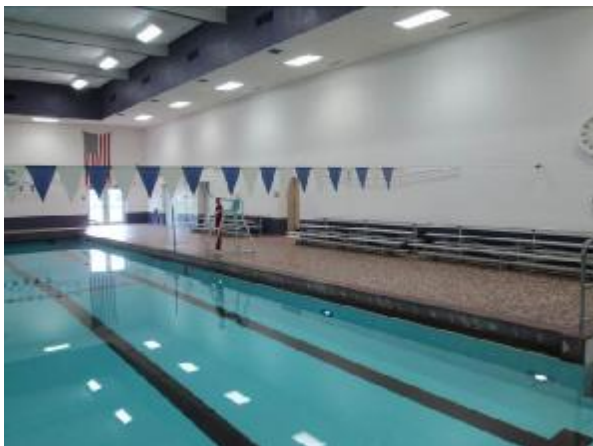
Image 21: Rollout Perimeter Overflow Gutter along the Length of the Pool

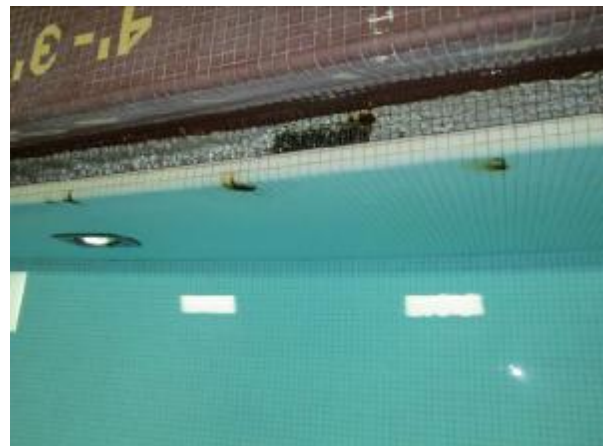
Image 22: Metallic Gutter Dropout and Handhold Corrosion

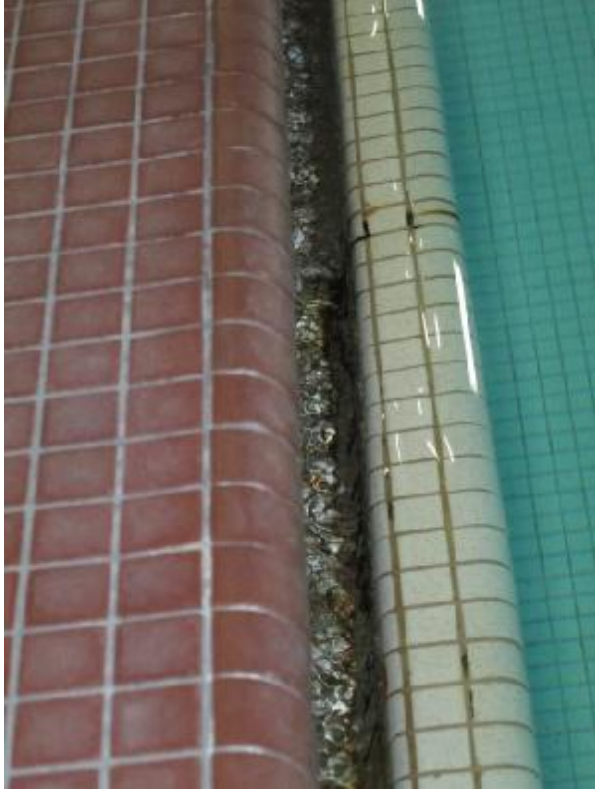
Image 23: 2" Gutter Lip Handhold

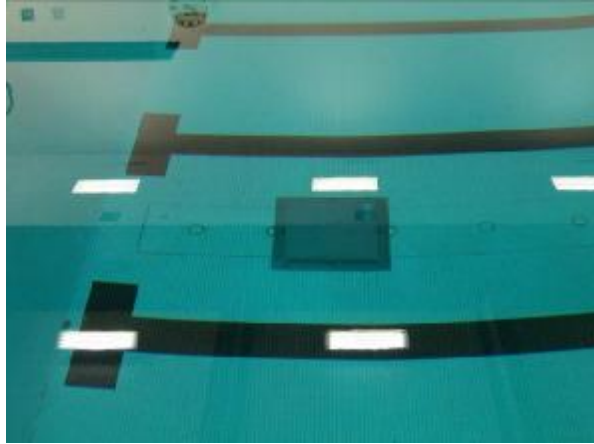
Image 25: Pool Main Drain Cover

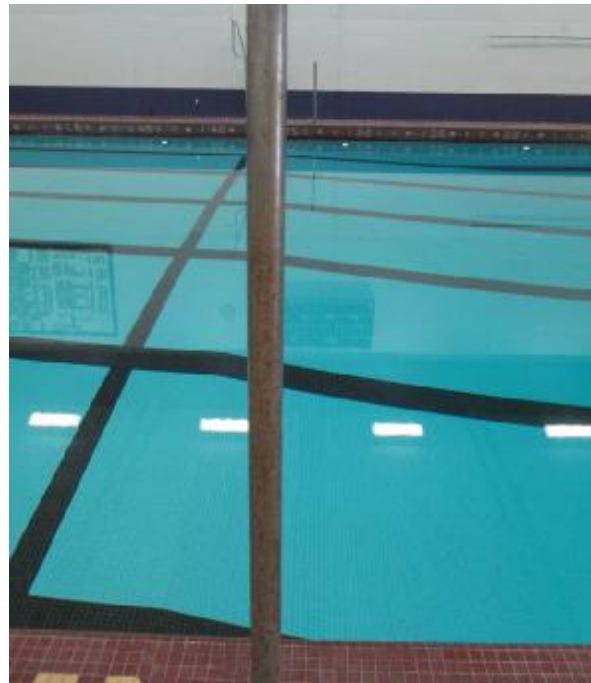
Image 53: Corrosion on Stanchion Post

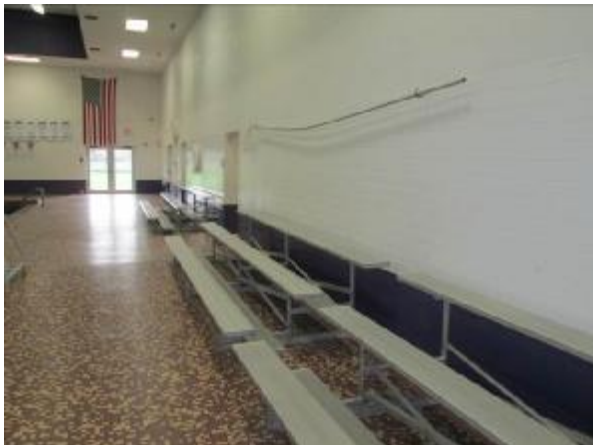
Image 54: Bent Wall Mounted Shepherd's Hook

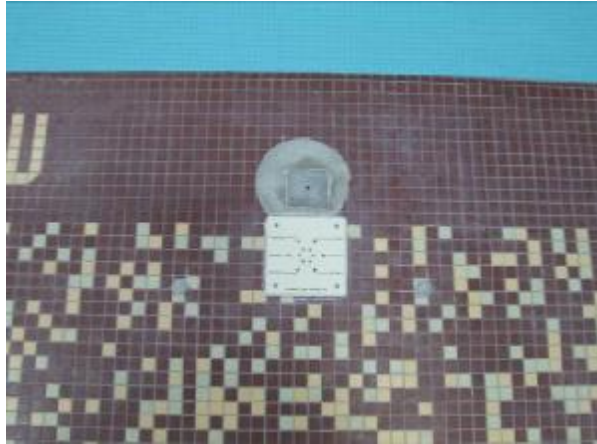
Image 57: Shallow End Deck Plate

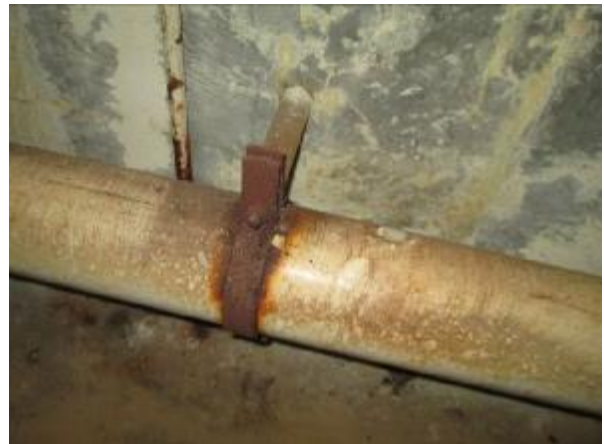
Image 73: Corroded Pipe Support

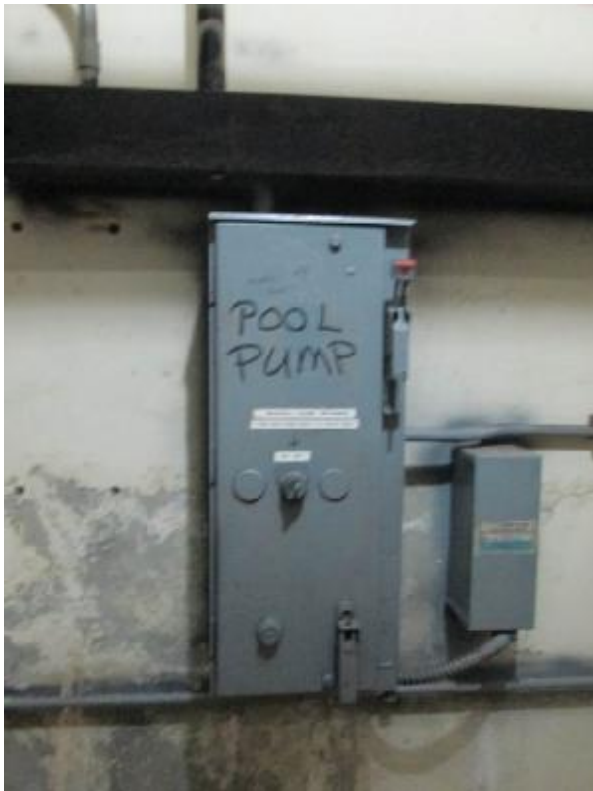
Image 78: Pump Starter

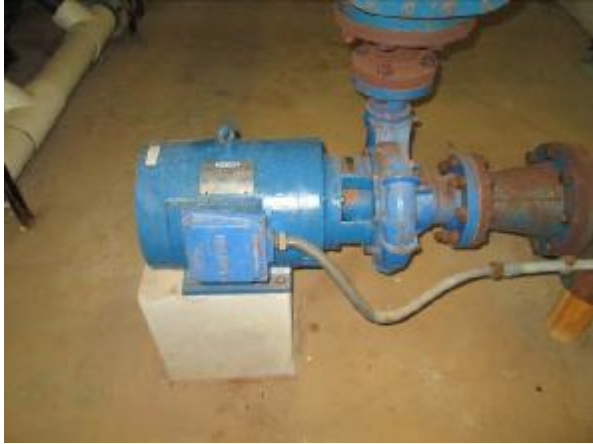
Image 80: Recirculation Pump and Base

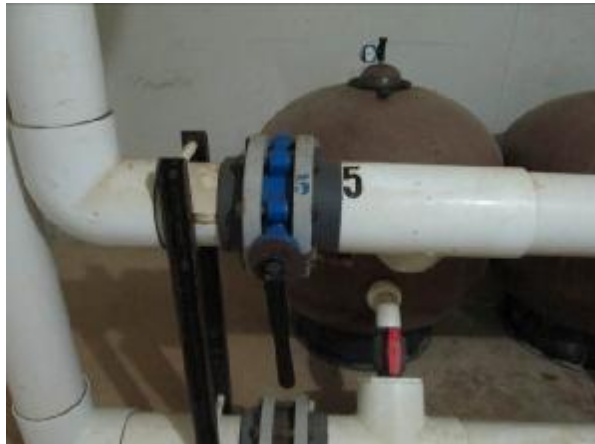
Image 82: Filter Butterfly Valve

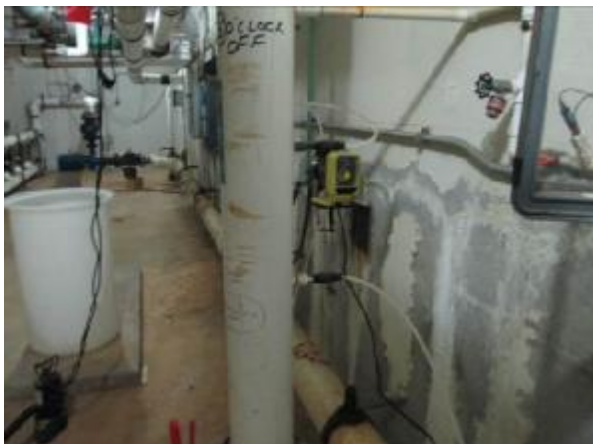
Image 96: Pool Chemical Feed Location
