Facilities Study Document | Kiel School District, Zielanis Elementary School

Building Systems Summary Checklist

Completed by: Alex Feudner and Ben Nerat, MSA Professional Services

Date of Walk-through: 05/18/2022

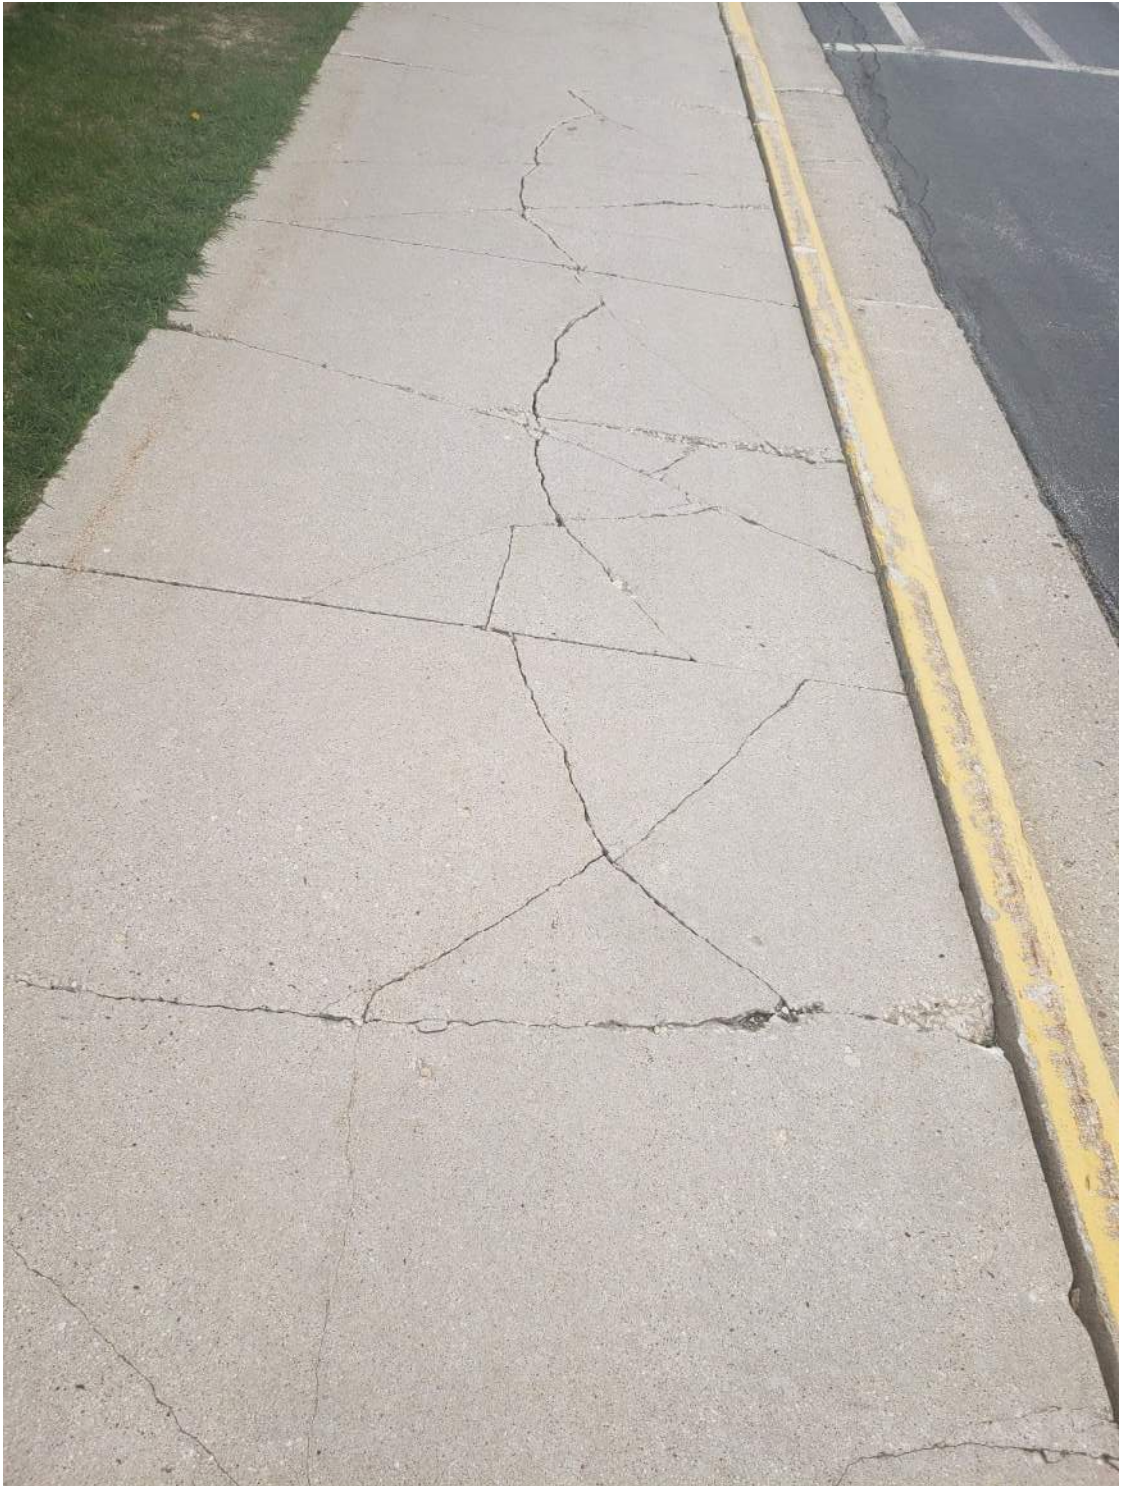
Figure 5: Severe cracking in sidewalk by north doors on west side of school.

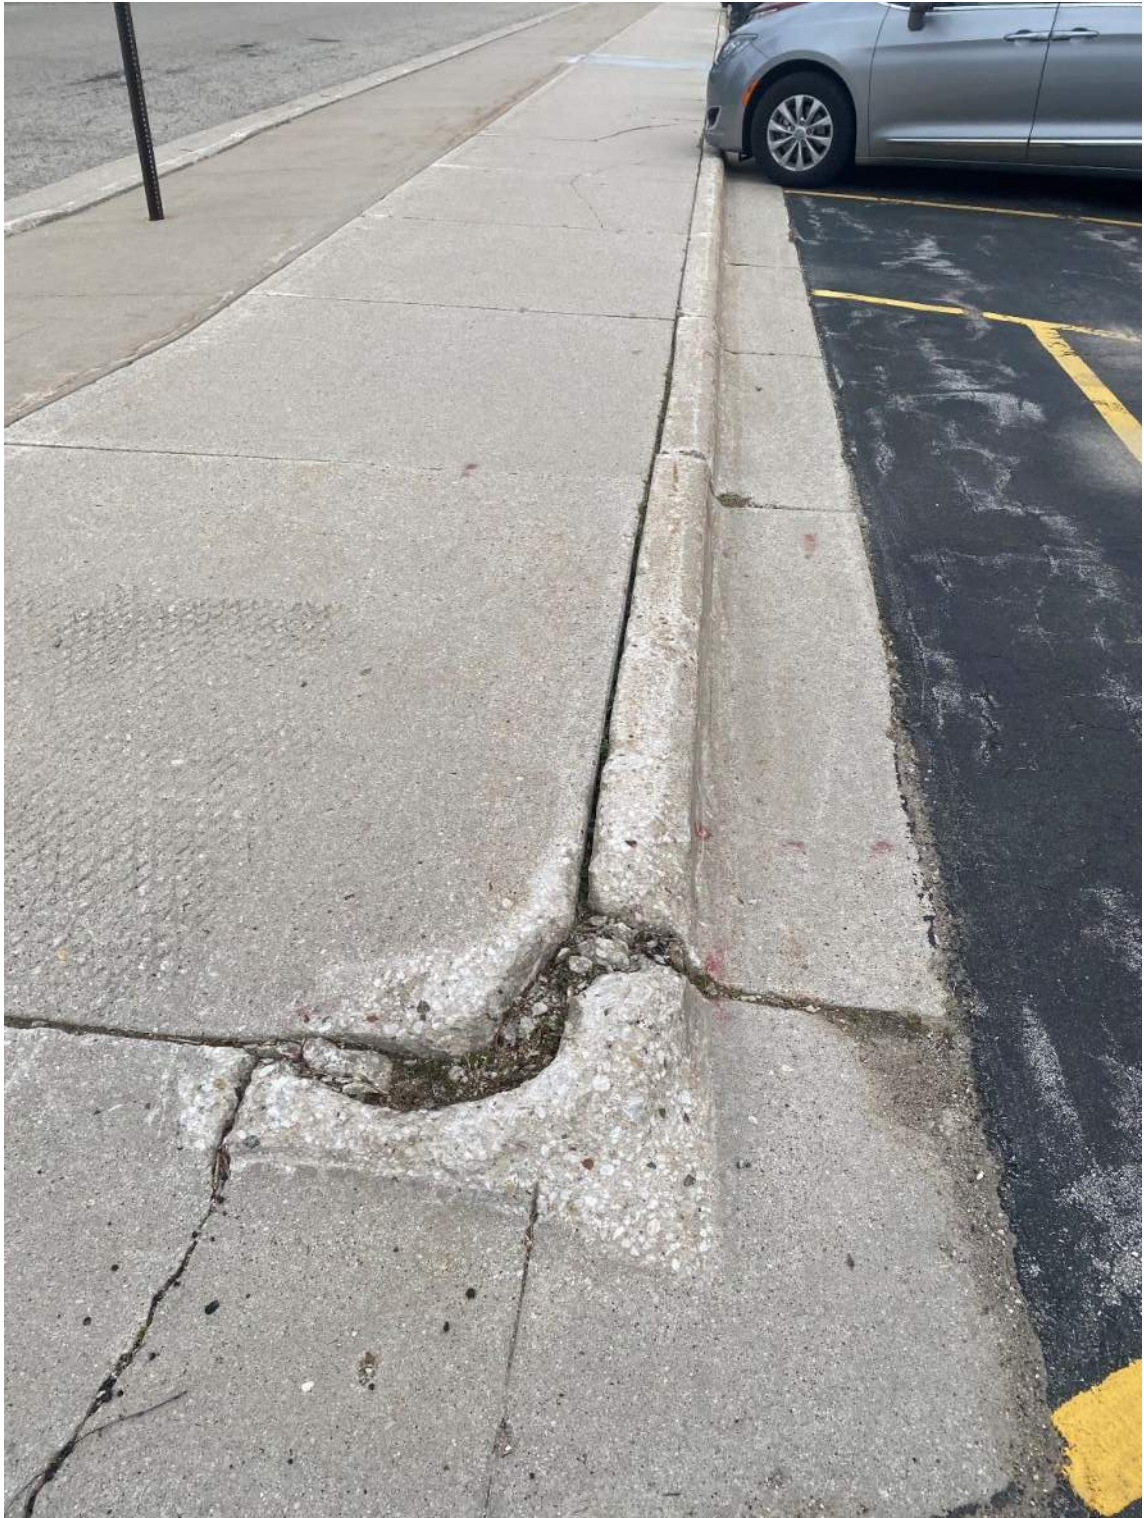
Figure 6: Deteriorated curb near south-west driveway apron

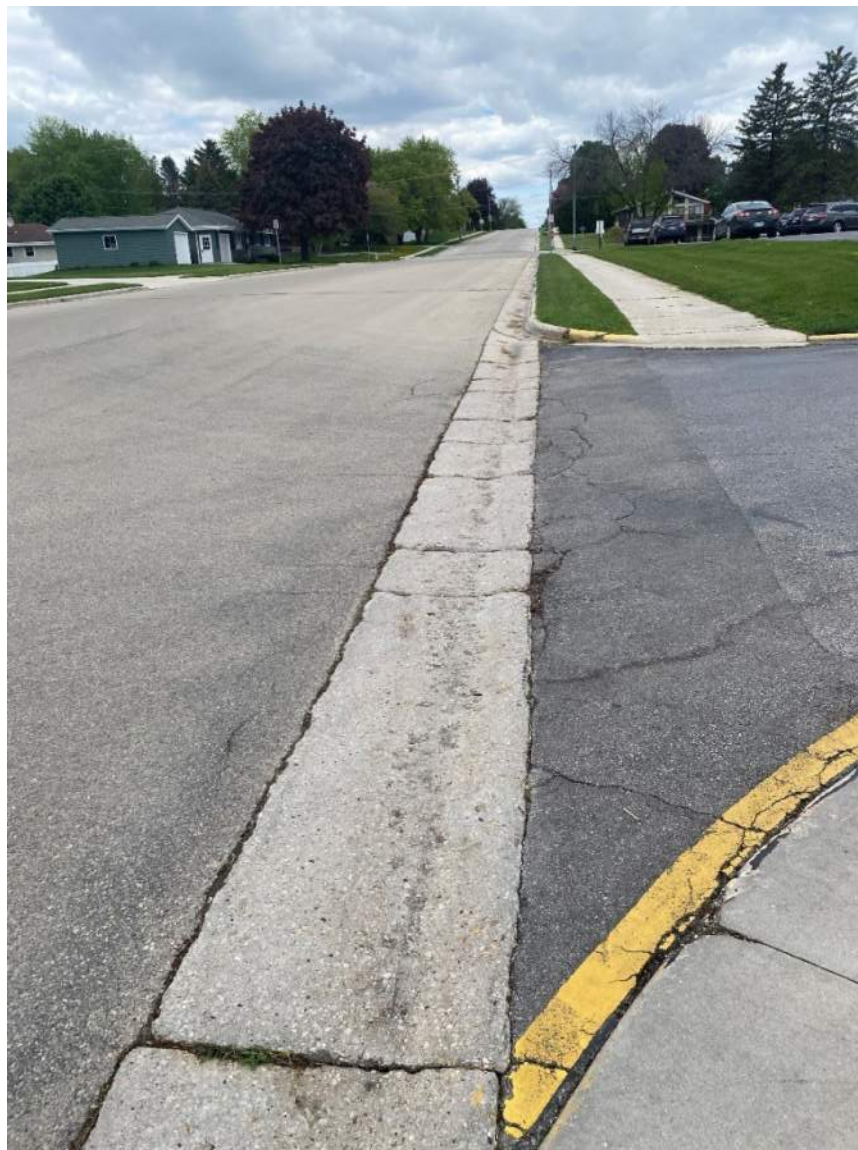
Figure 7: South driveway apron

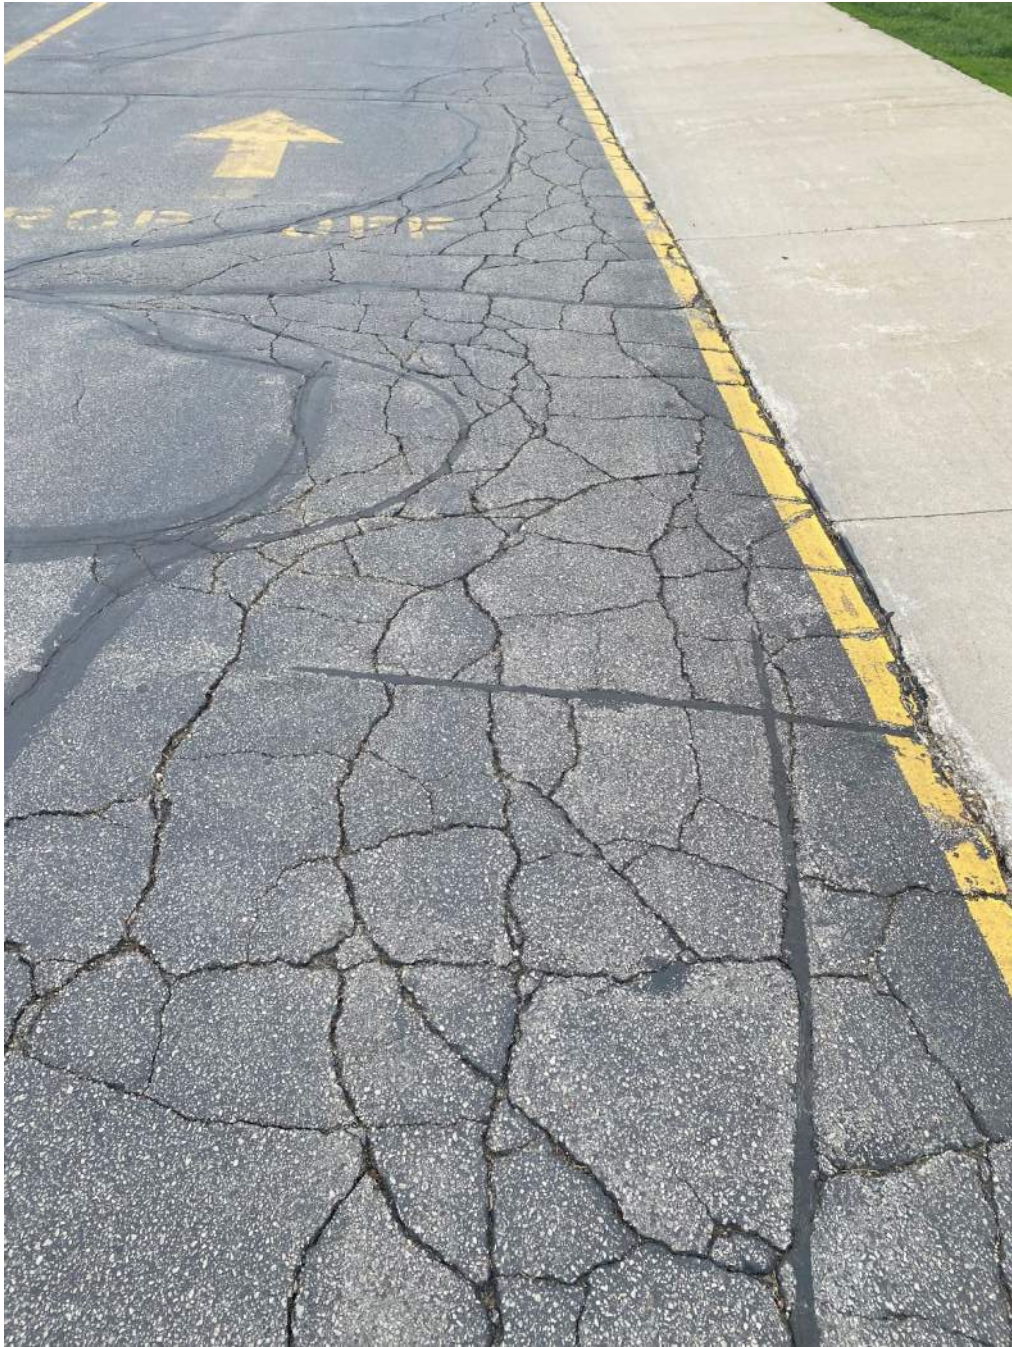
Figure 8: Alligator cracking in east driveway in south parking lot

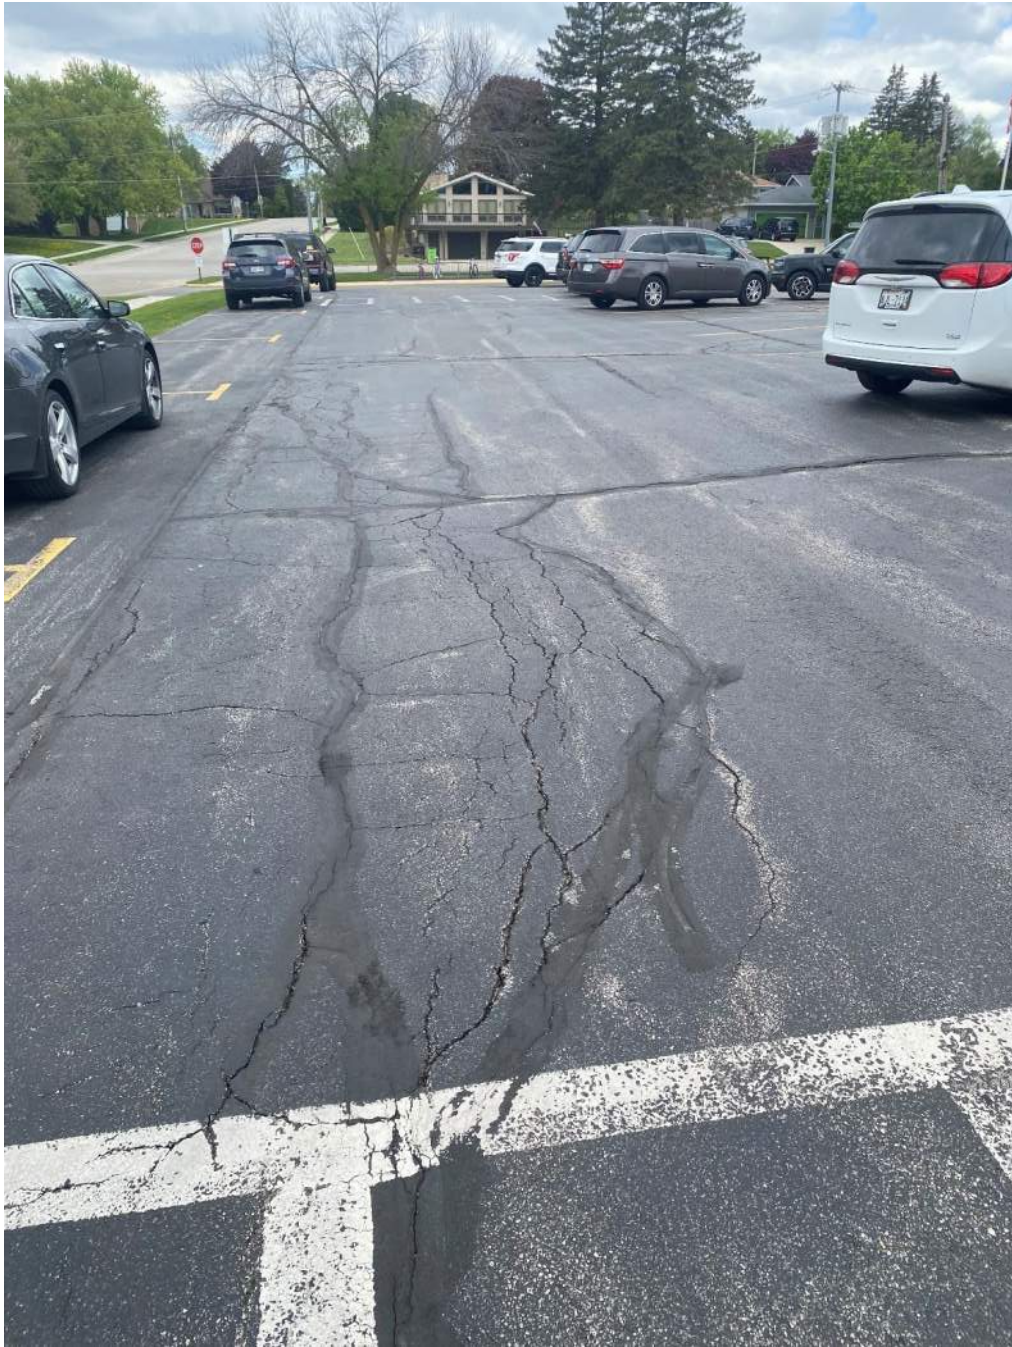
Figure 9: South parking lot cracking

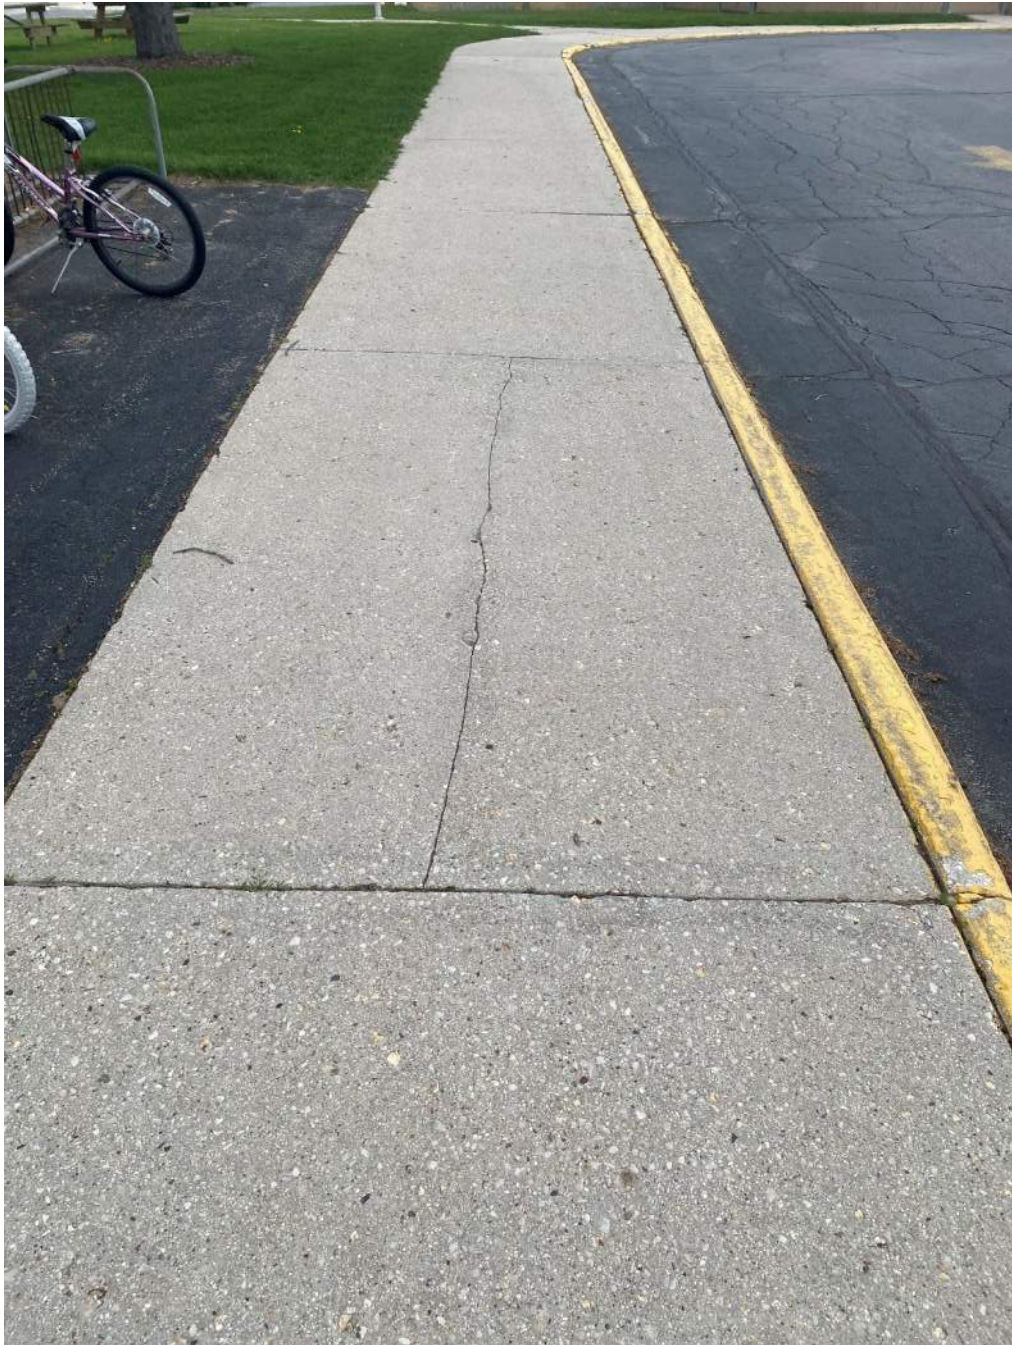
Figure 10: Crack in west sidewalk

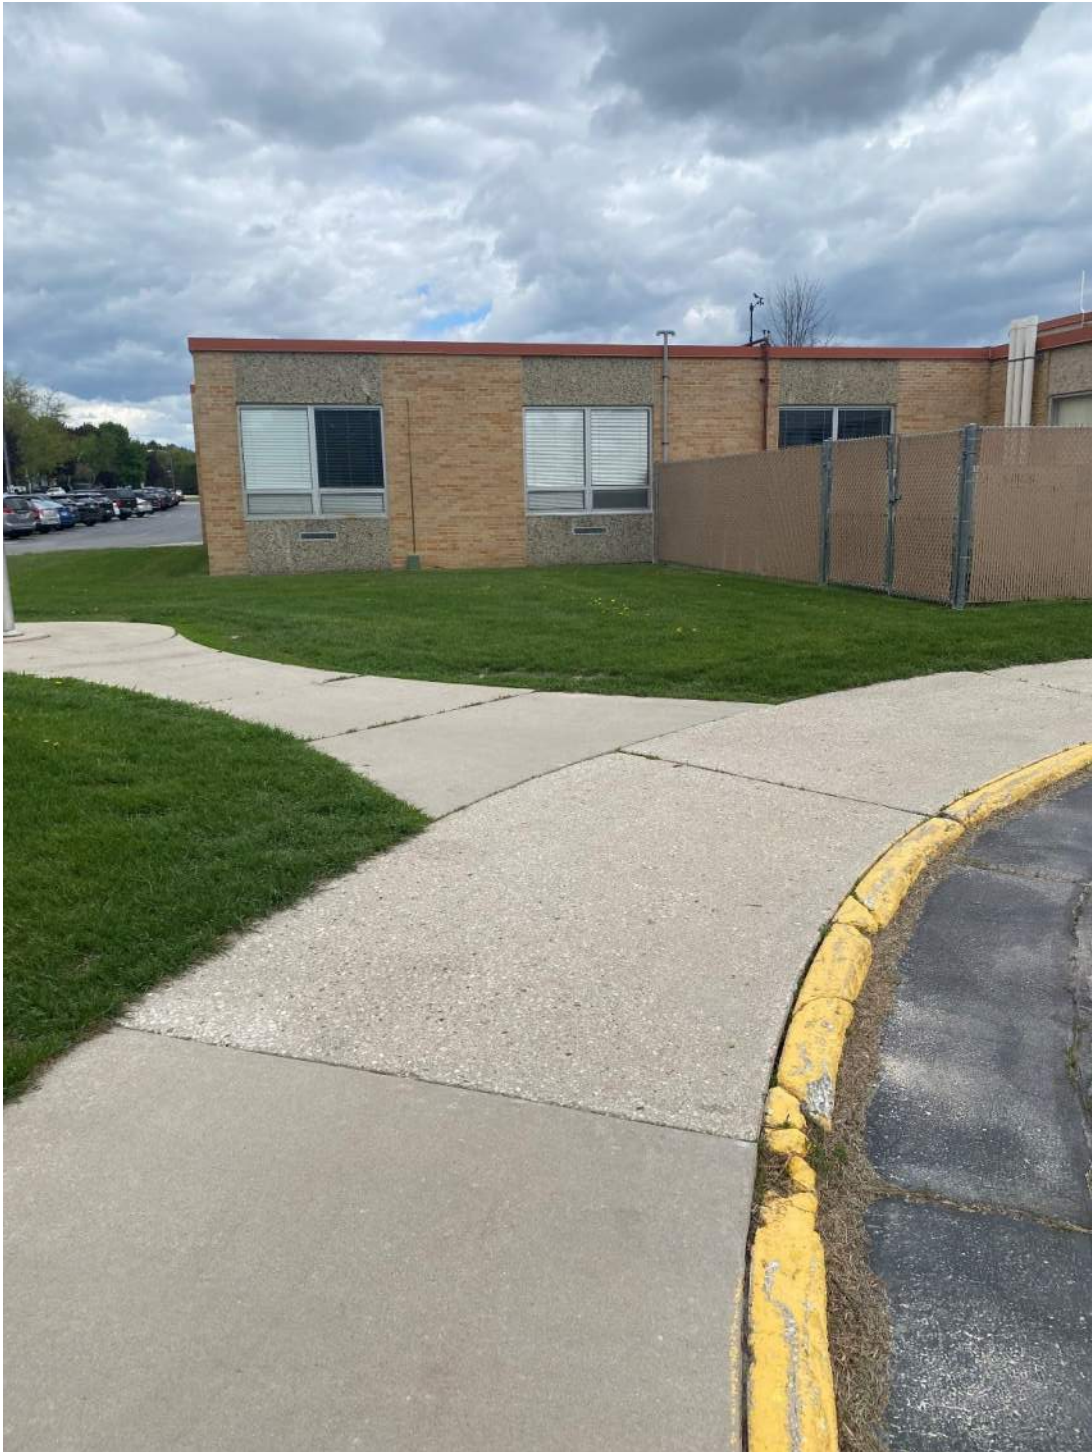
Figure 11: Cracked and deteriorating curb in north-west corner of south parking lot

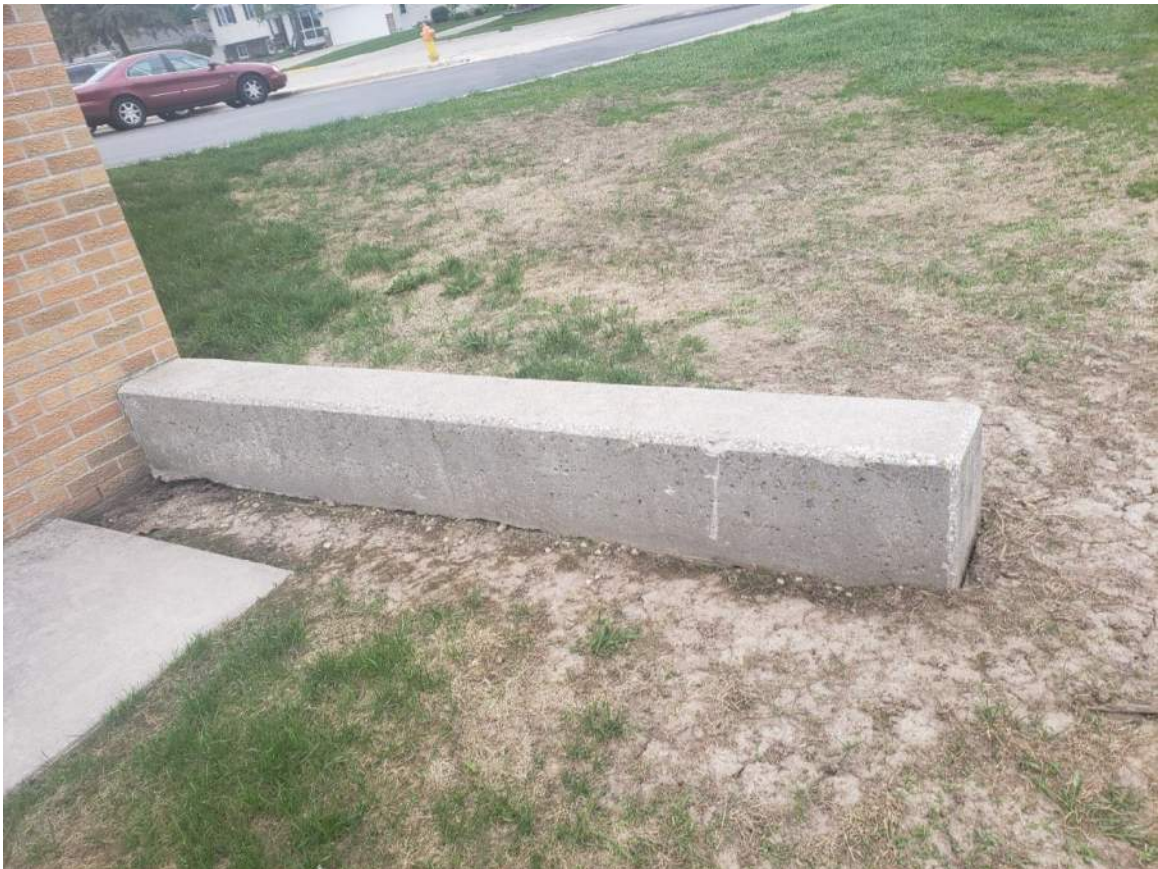
Figure 13: Concrete seating area

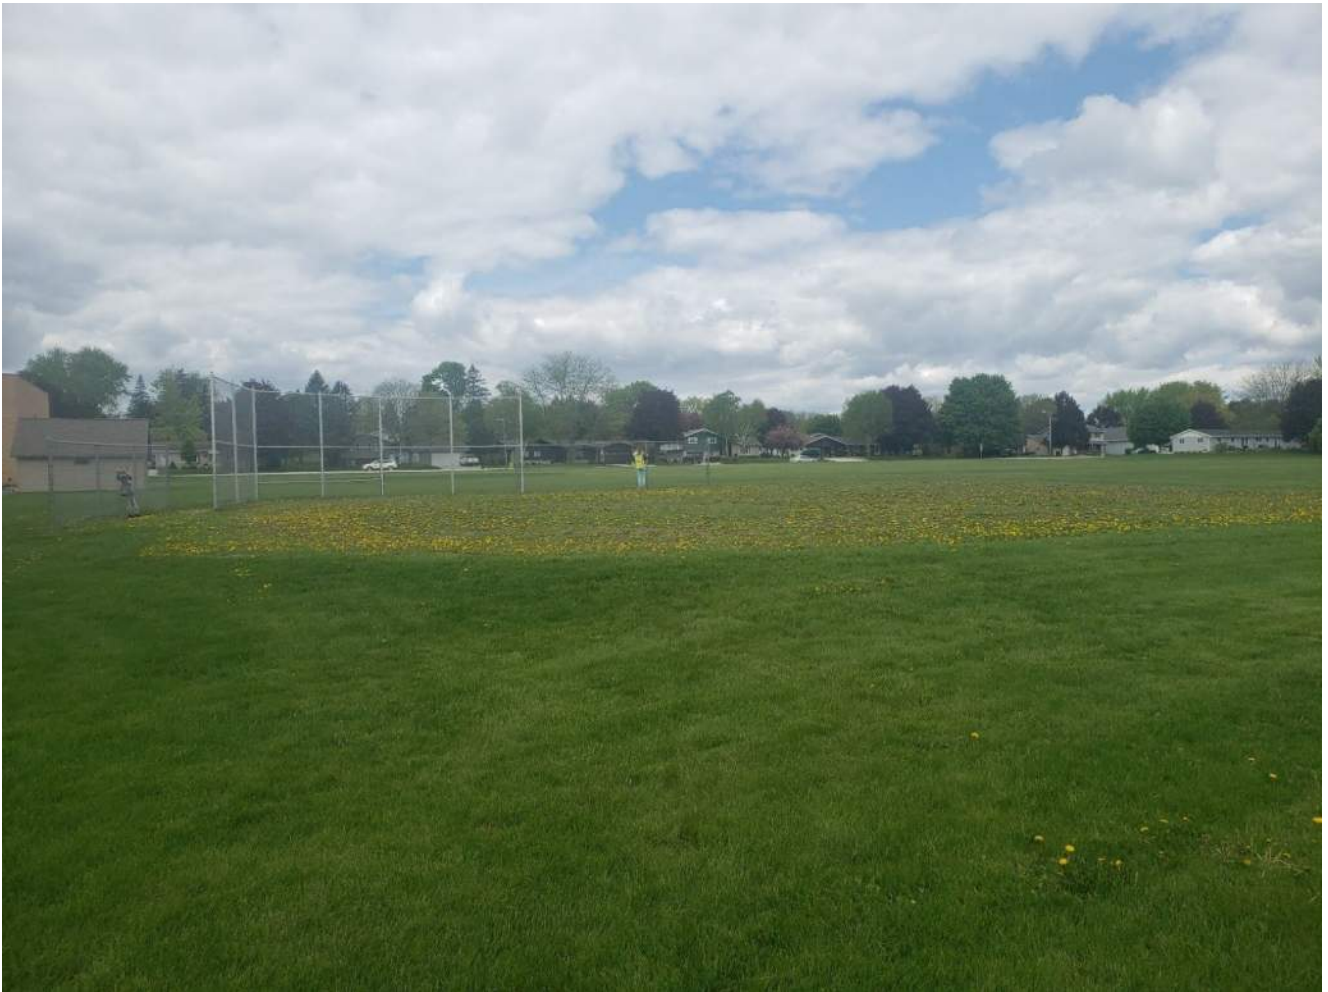
Figure 14: Existing ball field in poor condition

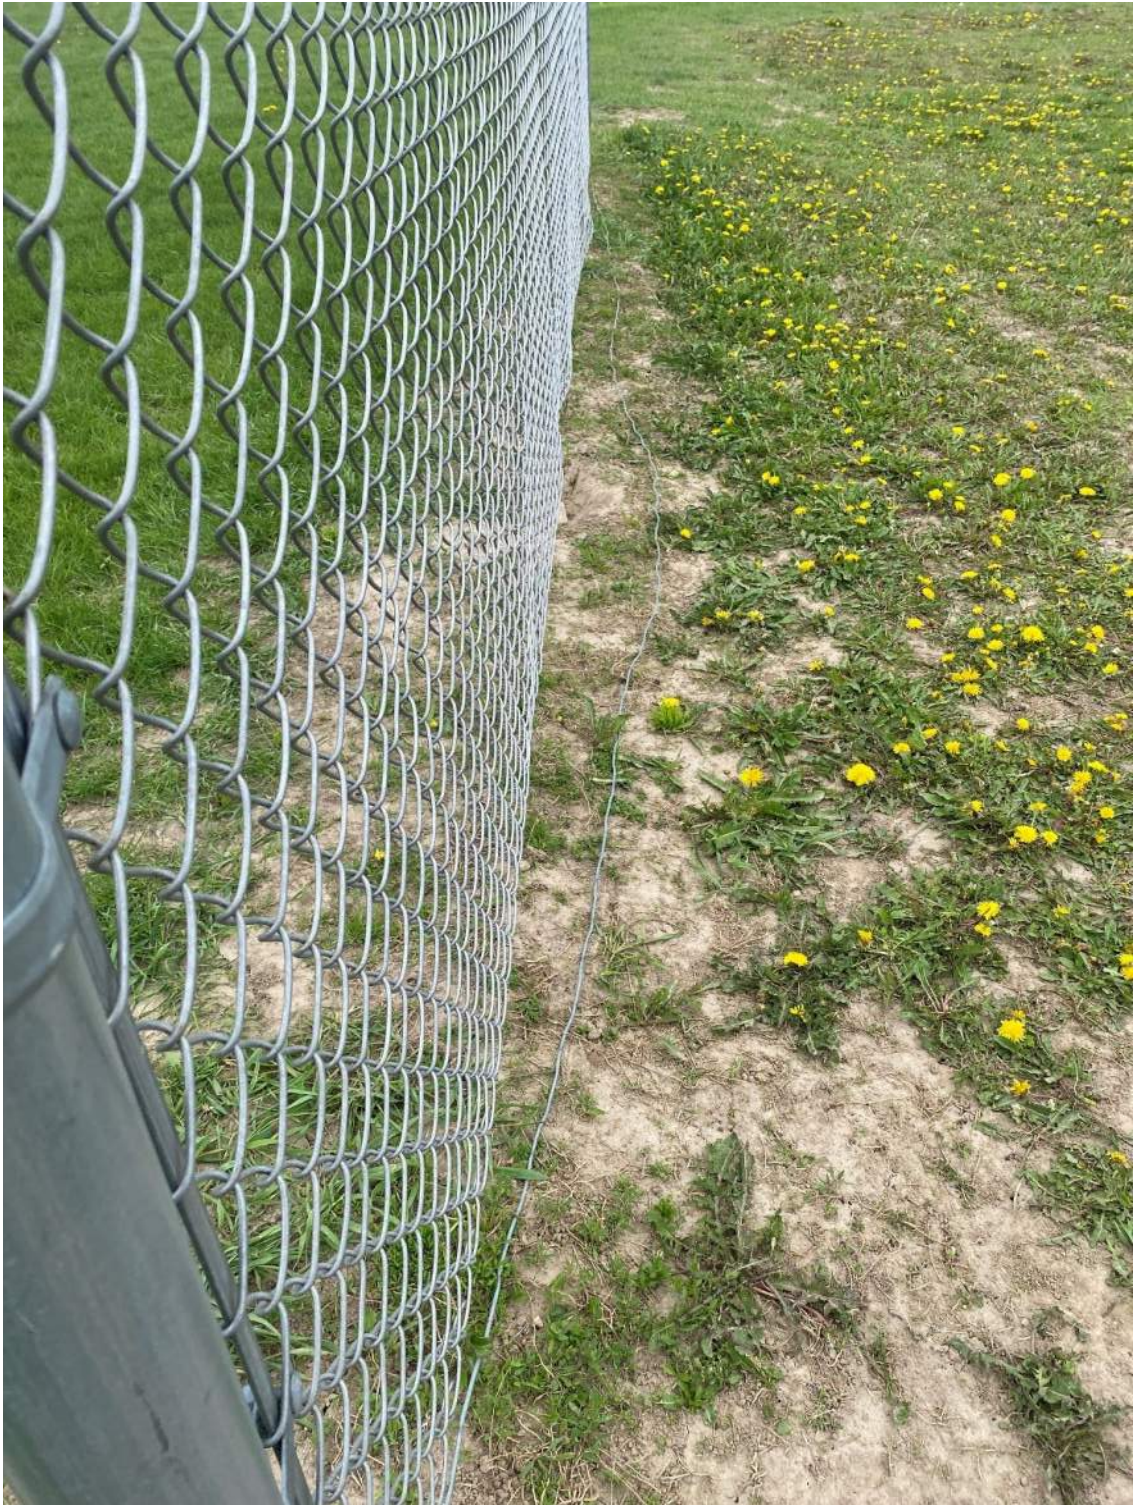
Figure 15: Broken fence with loose wire next to ball field

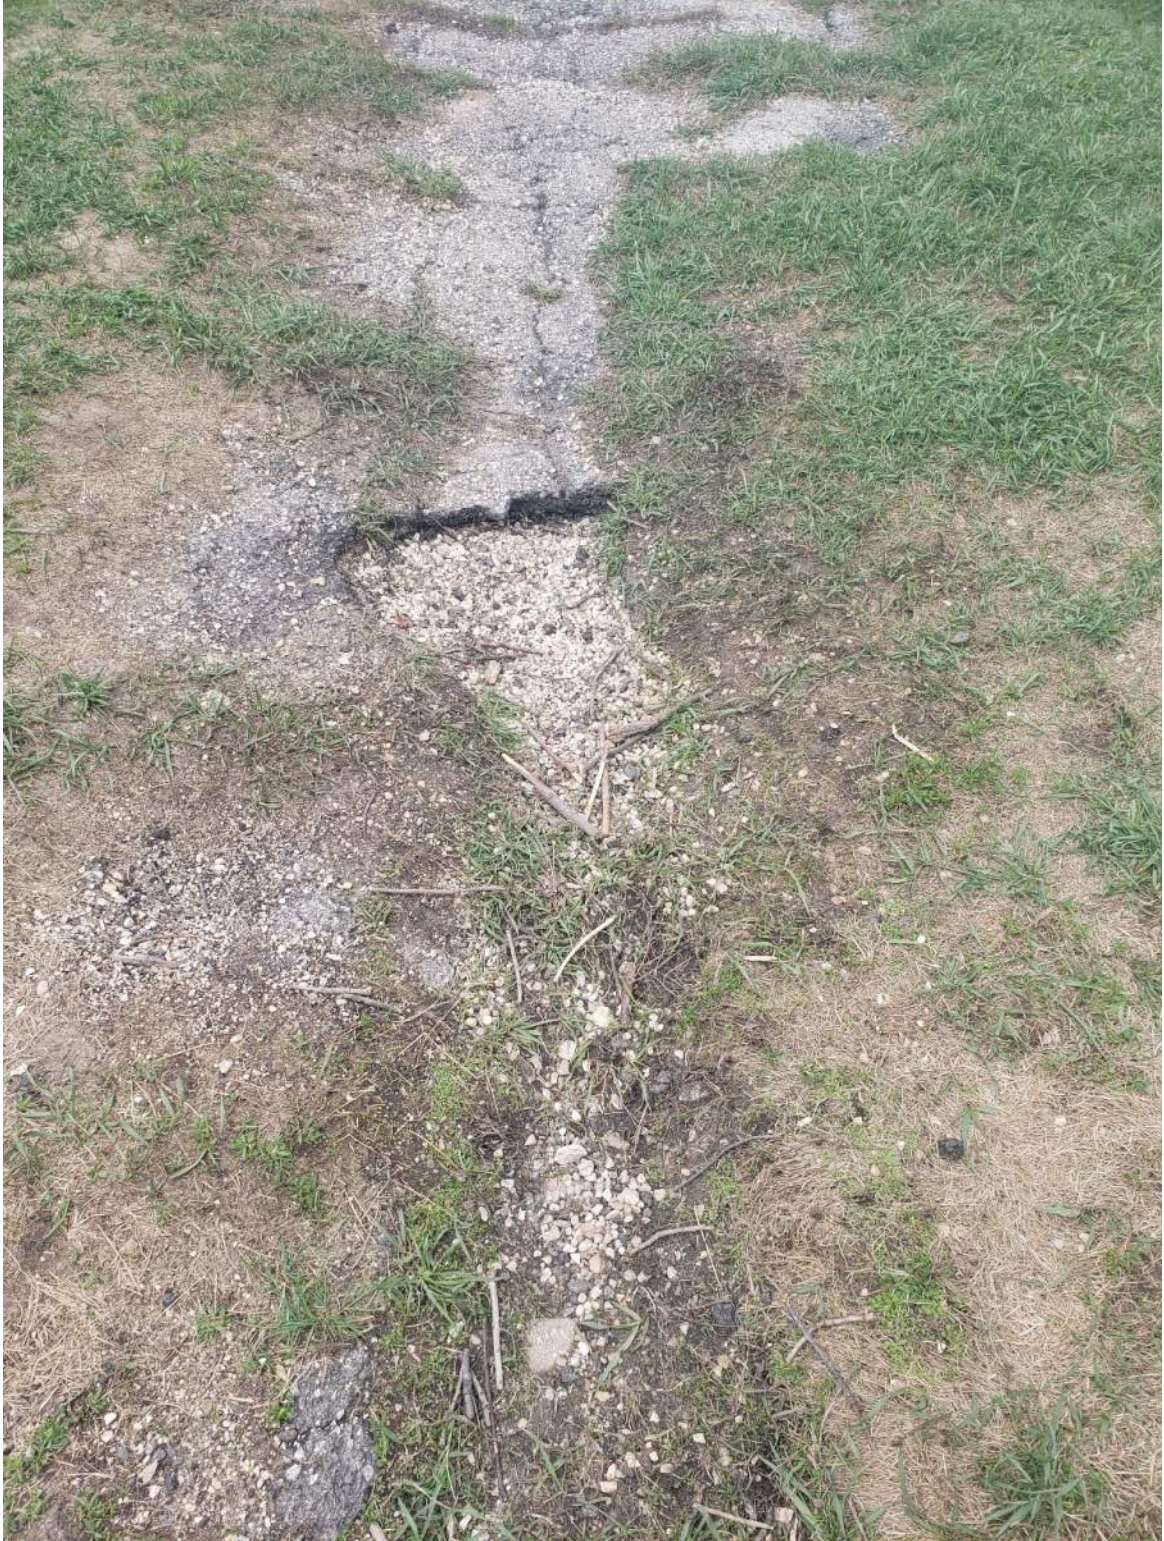
Figure 16: Swale near NE portion of play yard in poor condition

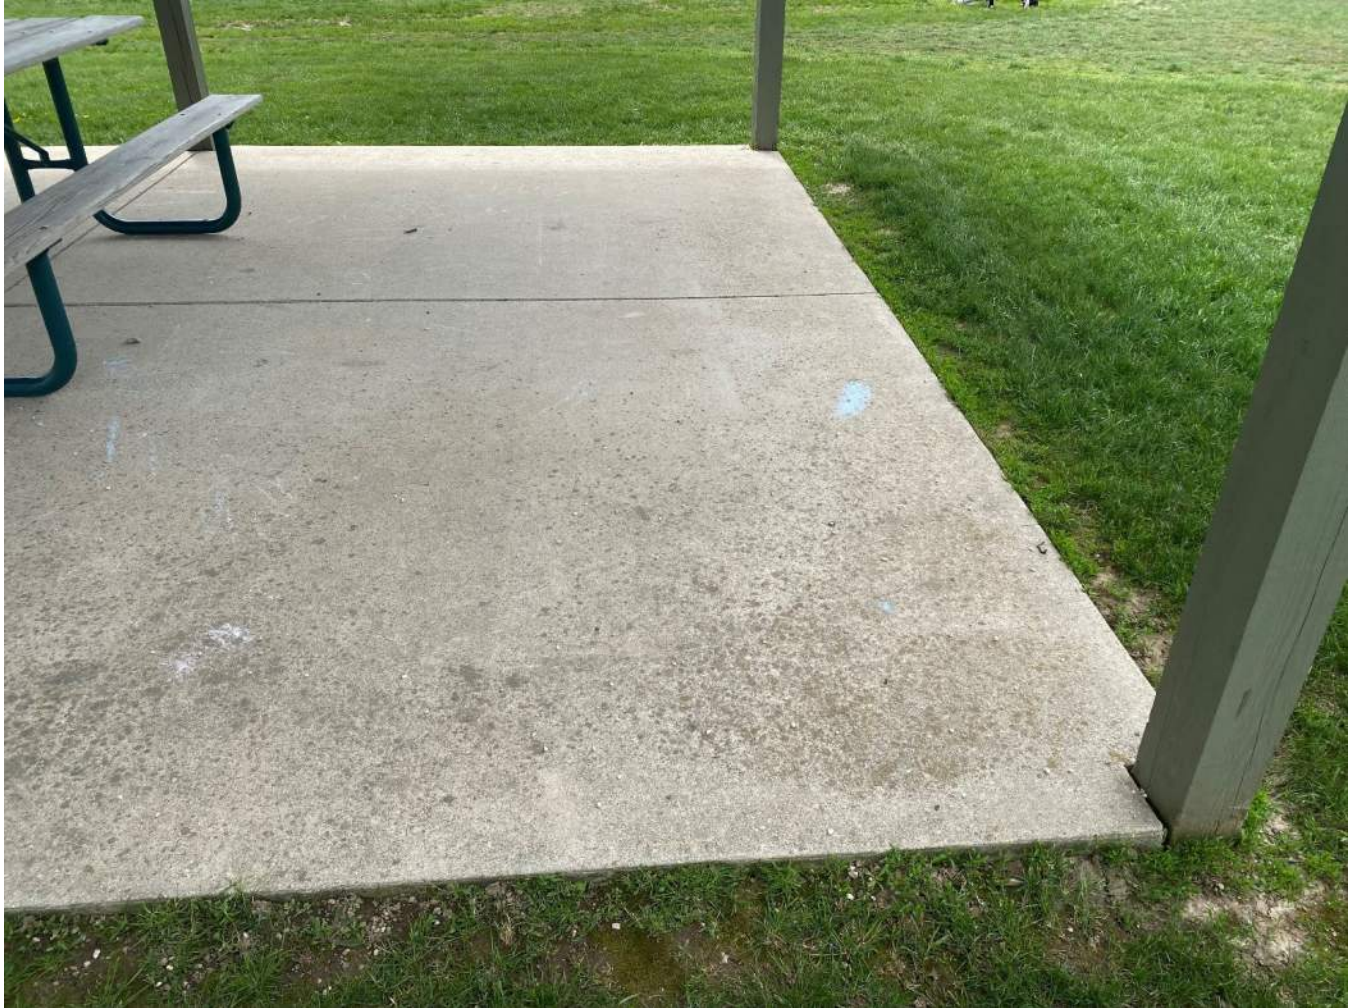
Figure 17: Concrete picnic table pad in good condition

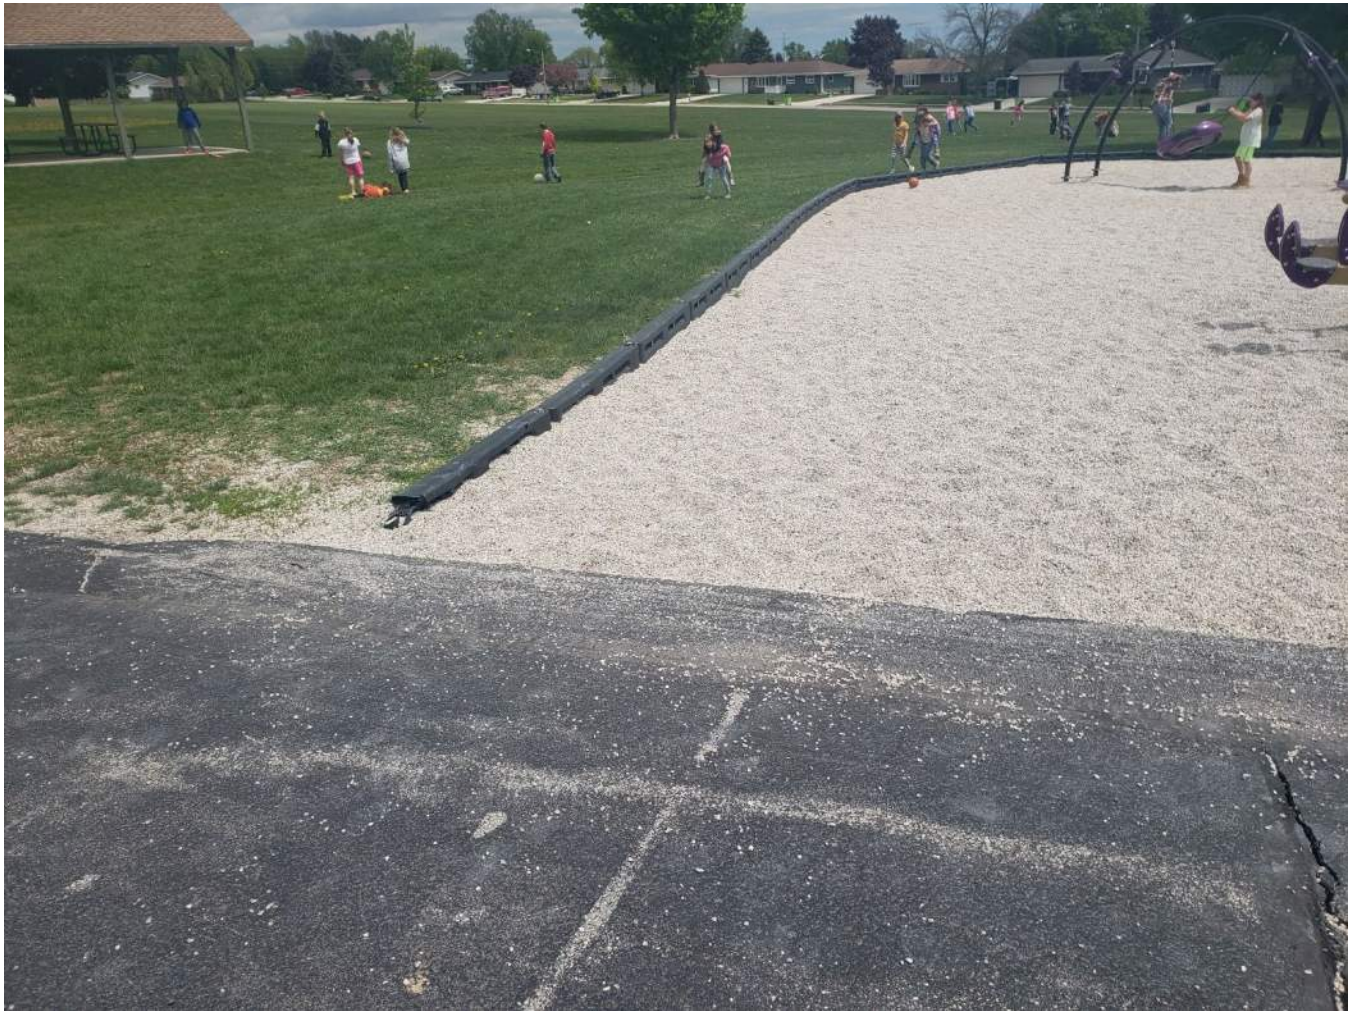
Figure 22: Gravel play area in good condition

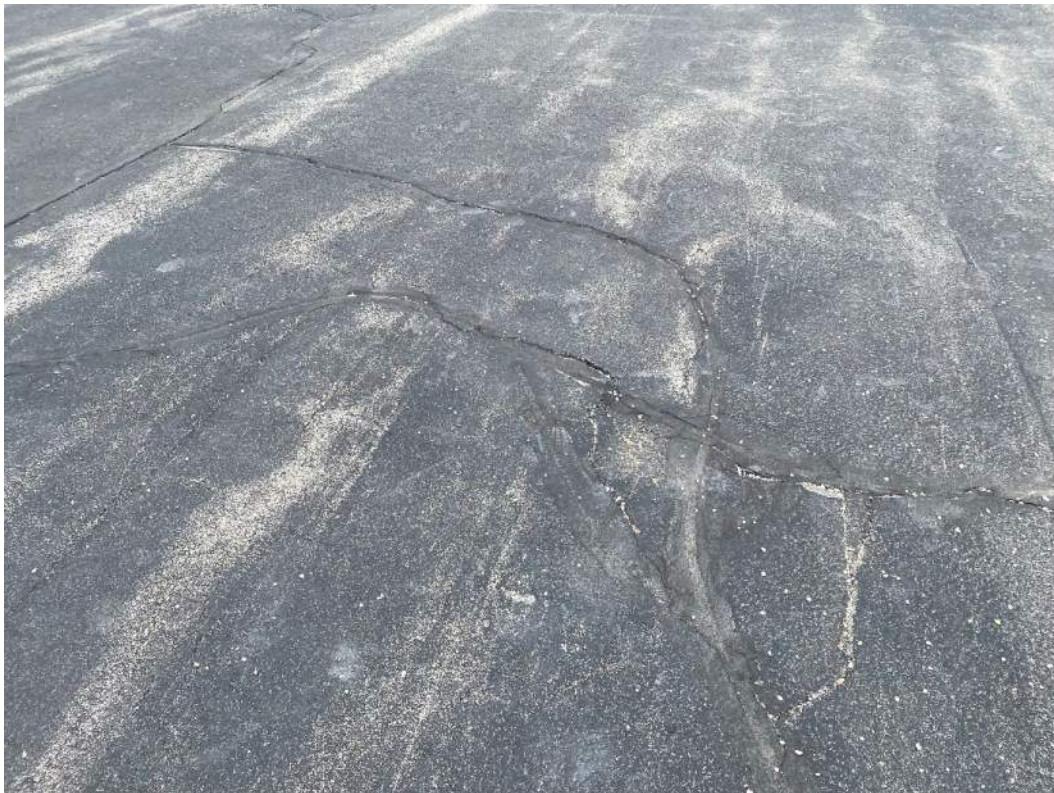
Figure 24: Cracks in play area surface

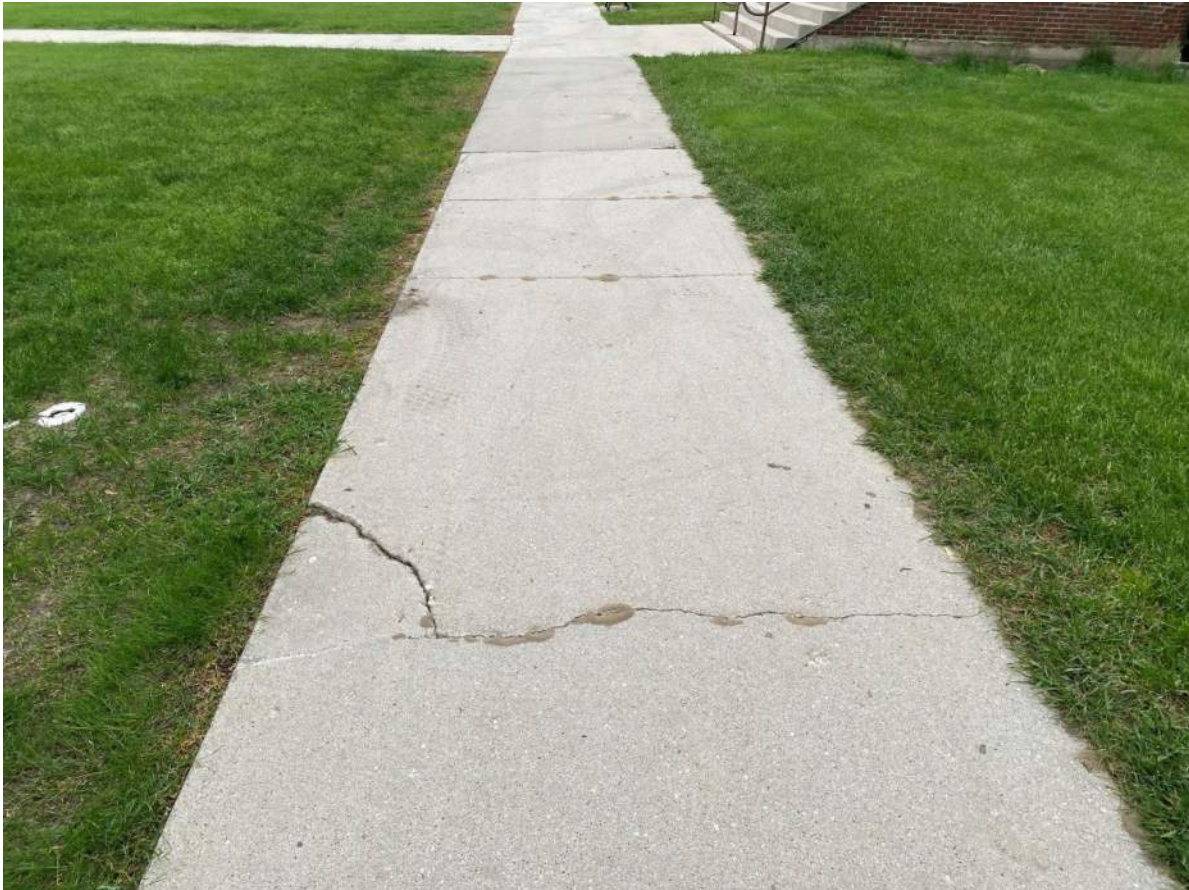
The front east to west sidewalk is in fair to poor condition. There are some areas of settling and cracking occurring, but most of the sidewalk just has common signs of aging such as chipped edges (Figure 6).

Figure 6: Cracking in east to west sidewalk.

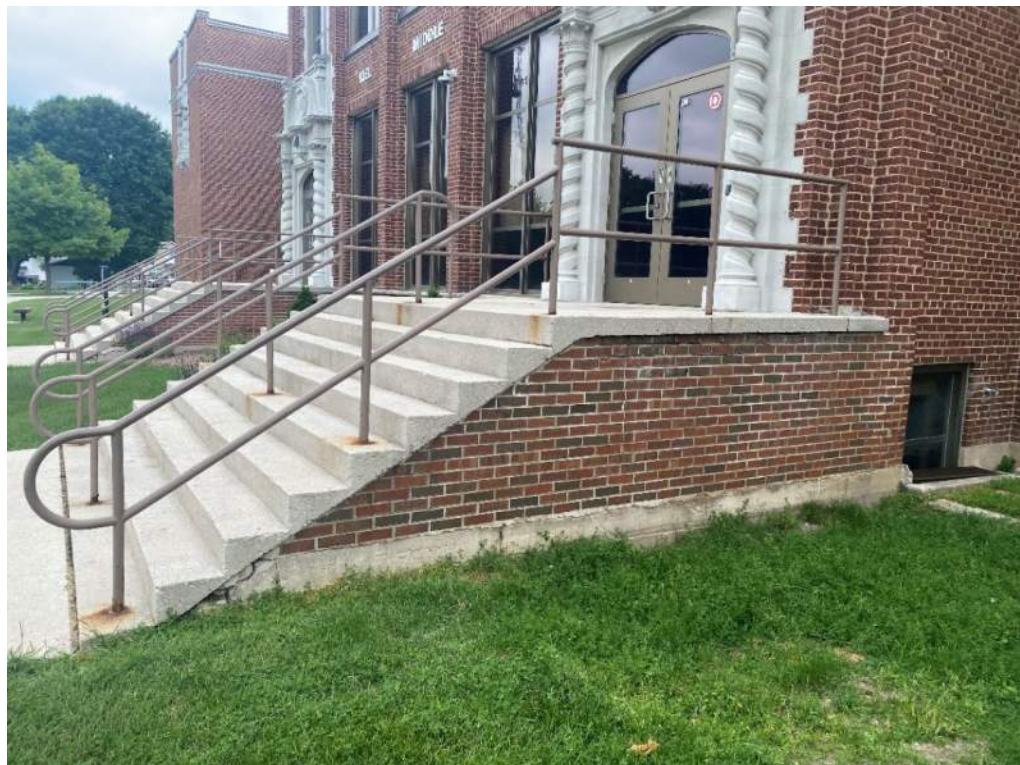
Figure 8: Side of center east concrete stairs.

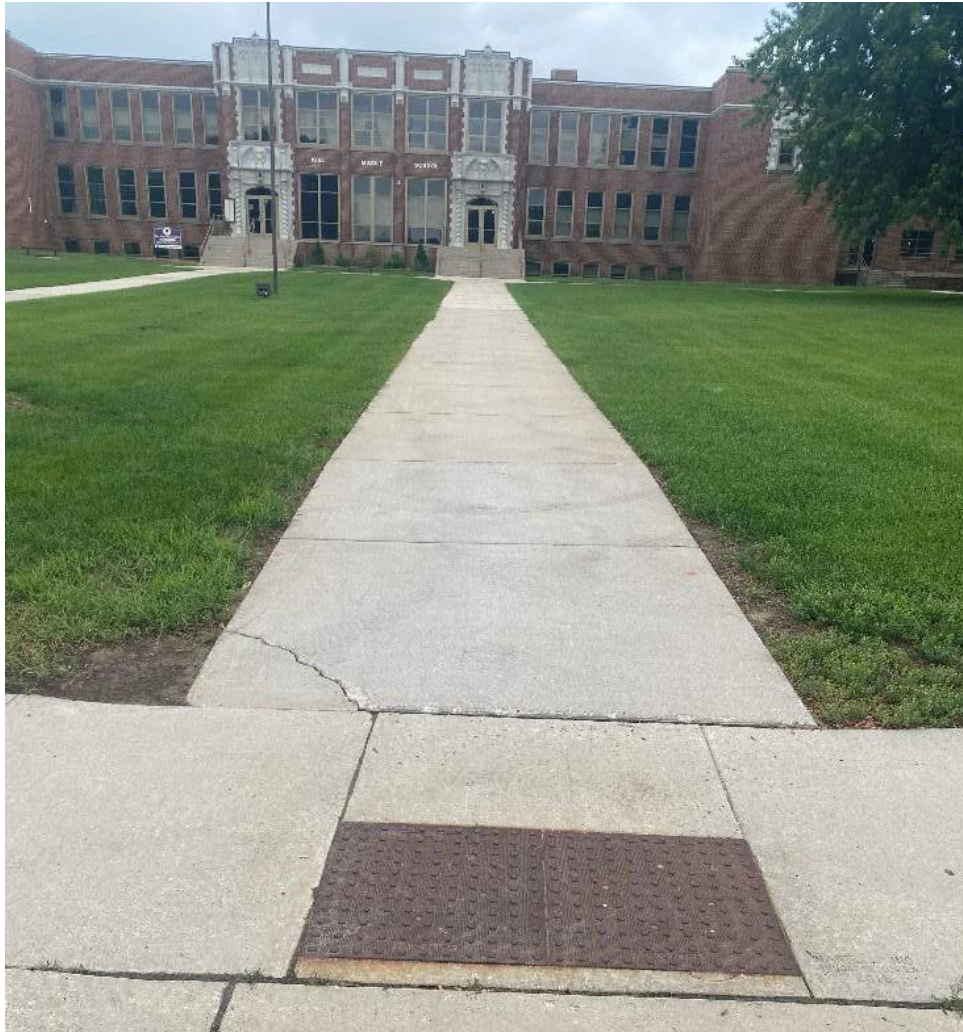
Figure 11: Corner of concrete sidewalk slab cracked off at south slab of center east sidewalk.
