Facilities Study Document | Kiel School District, Zielanis Elementary School

Building Systems Summary Checklist

Completed by: Alex Feudner and Ben Nerat, MSA Professional Services

Date of Walk-through: 05/18/2022

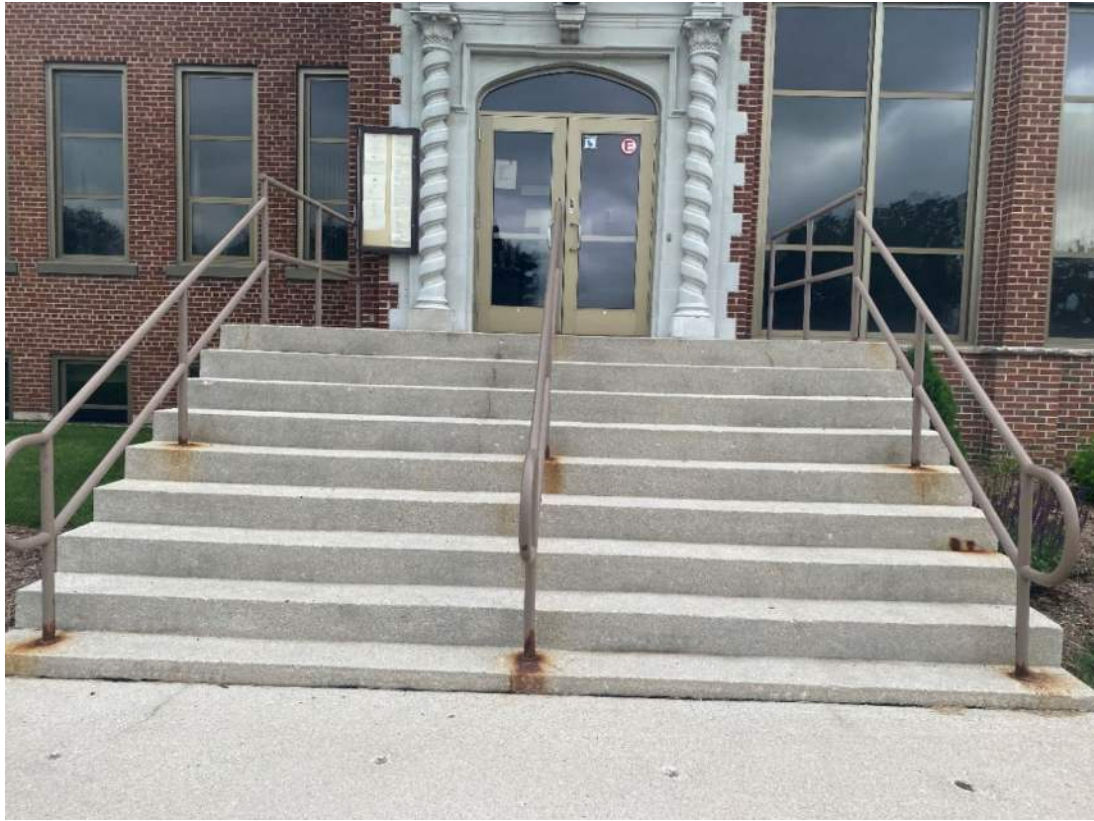
The center west sidewalk concrete staircase is in poor condition (Figure 12). There are many cracks on the concrete slab (Figure 14), as well as cracking and missing concrete on the stair's foundation (Figure 13). The bottoms of the railings are rusting. The concrete sidewalk that connects the stairs to Paine Street has some slabs that have large cracks in it. There is one slab towards the north end that has a large horizontal crack all the way across it (Figure 15). The same slab also has an angled crack further north (Figure 16). This area of concrete appears older than the concrete on the south half of the sidewalk. There are two slabs in the newer portion that have the corners completely broken off from the slab (Figure 17). All these cracked slabs could be replaced while keeping the other slabs that have no cracking.

Figure 12: Front center west stairs.

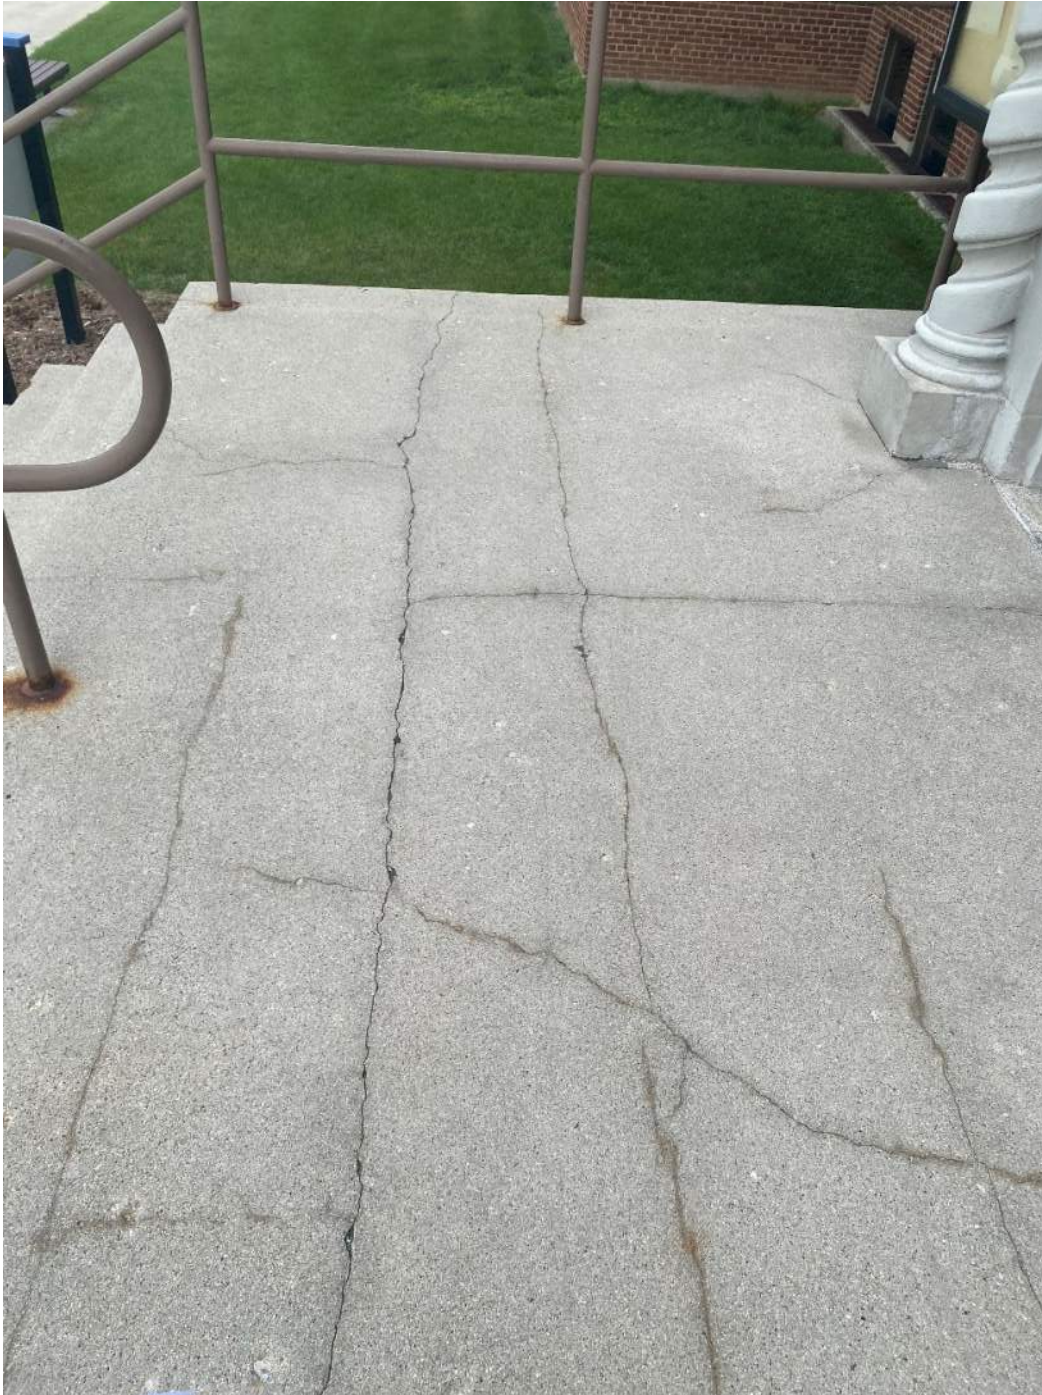
Figure 14: Top of front center west stair in poor condition.

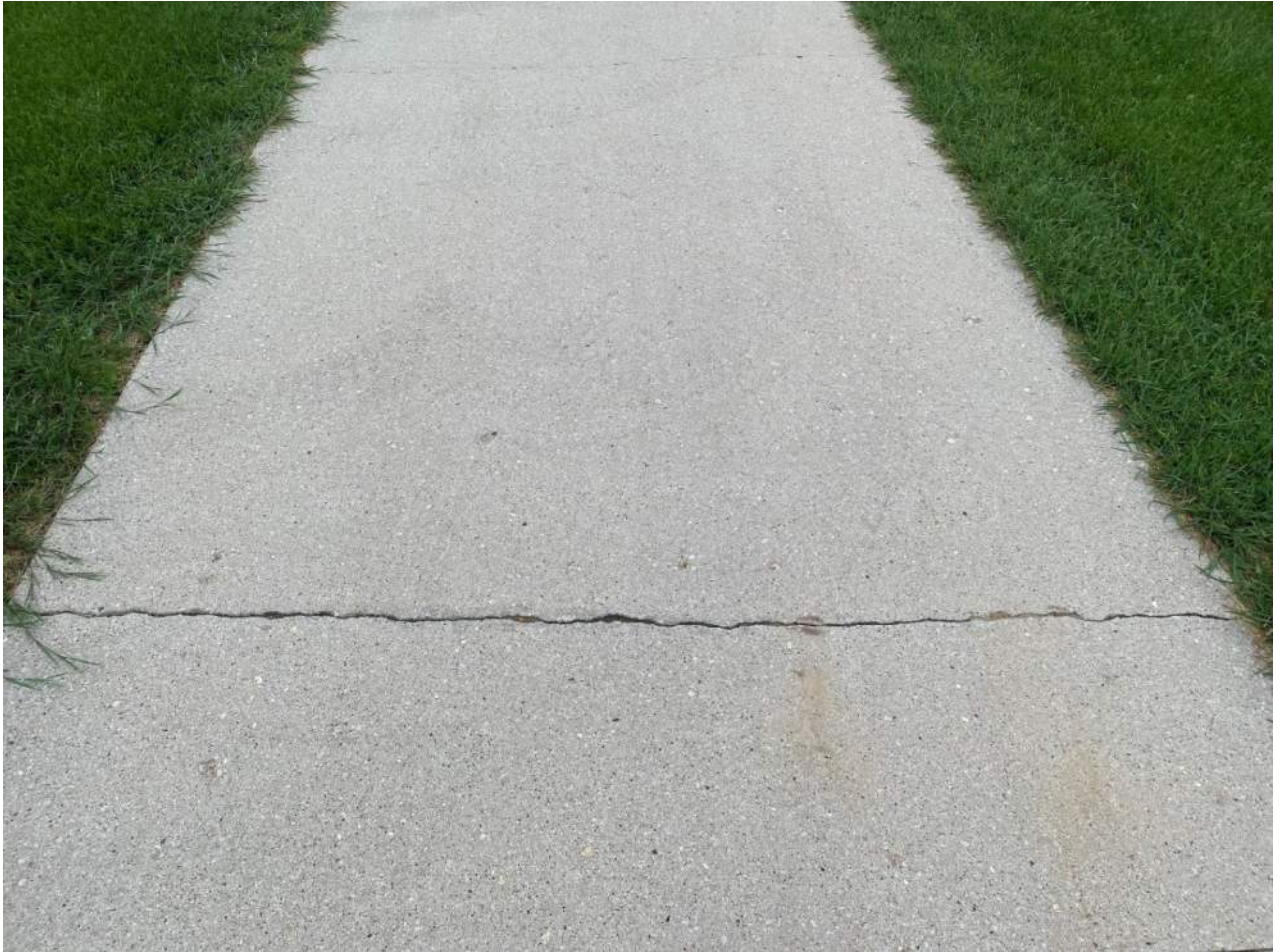
Figure 15: Horizontal crack in front center west sidewalk.

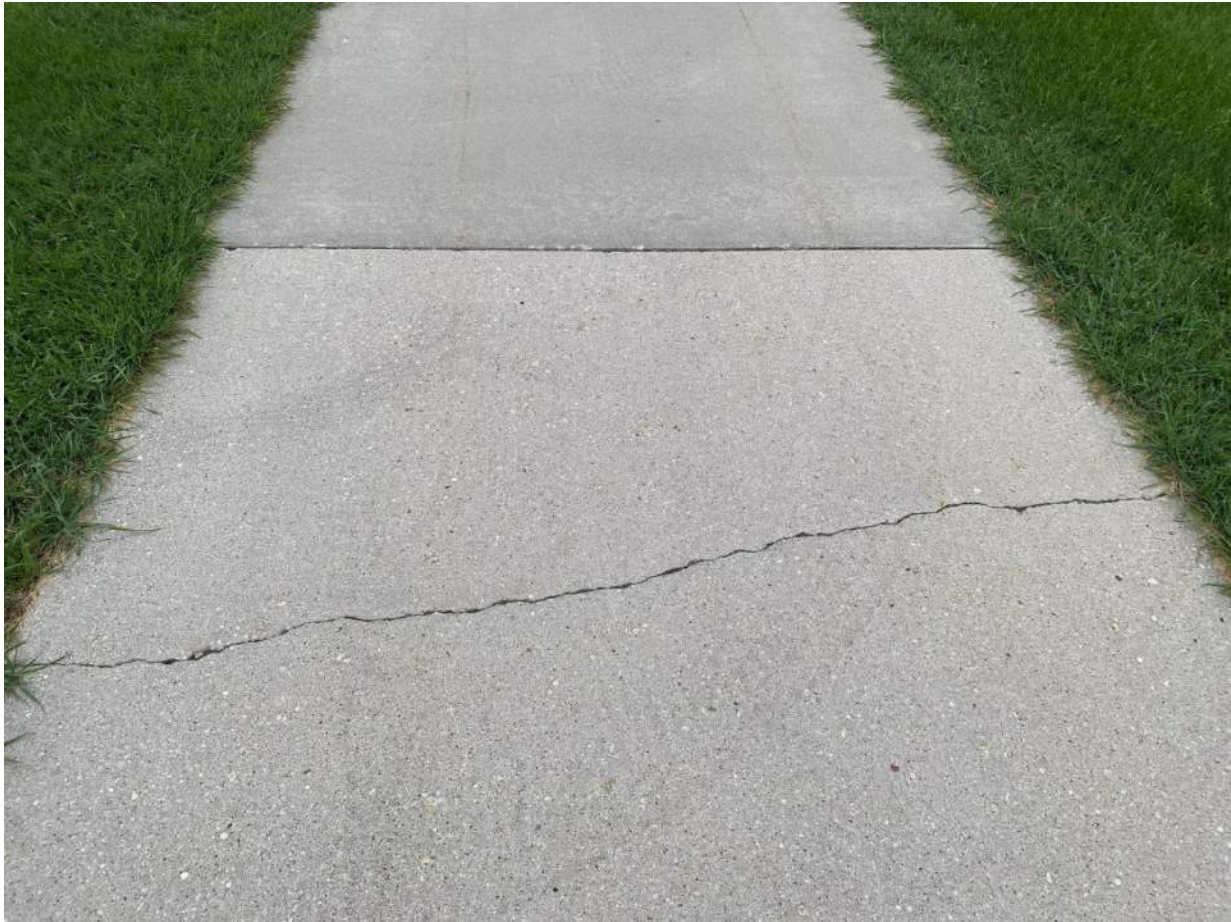
Figure 16: Diagonal crack in front center west sidewalk.

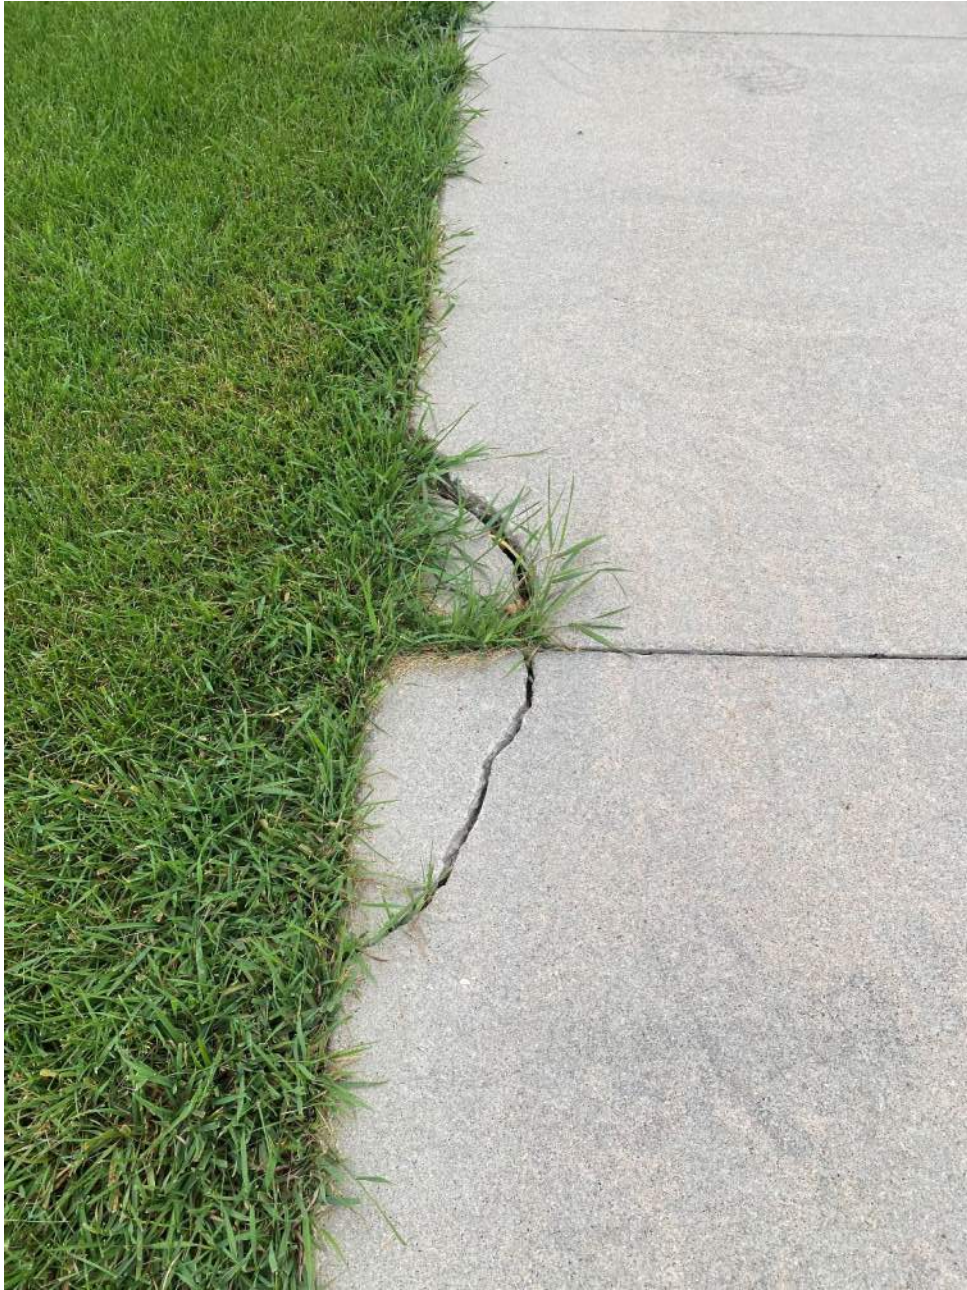
Figure 17: Corners cracked off front center west concrete sidewalk.

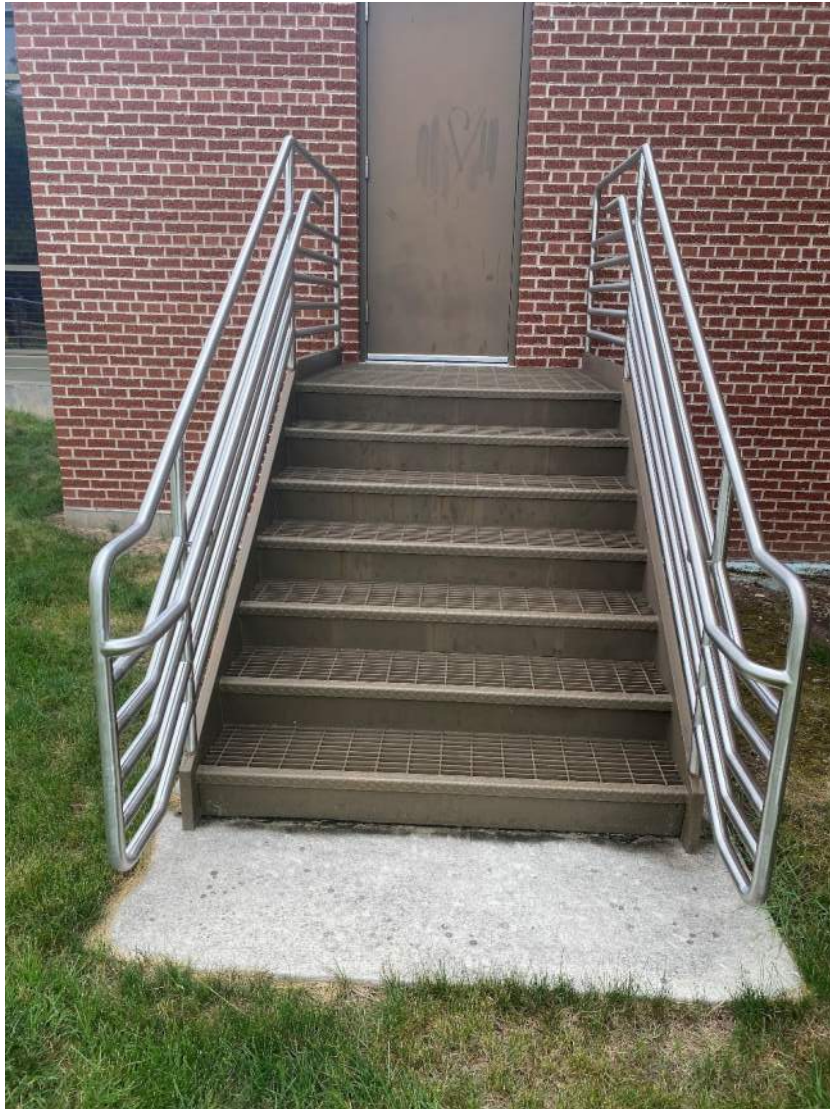
The metal stairway is in good condition and there is no visible rusting (Figure 18). The concrete pad it sits on is also in good condition with no visible cracks.

Figure 18: Front metal stair in good condition.

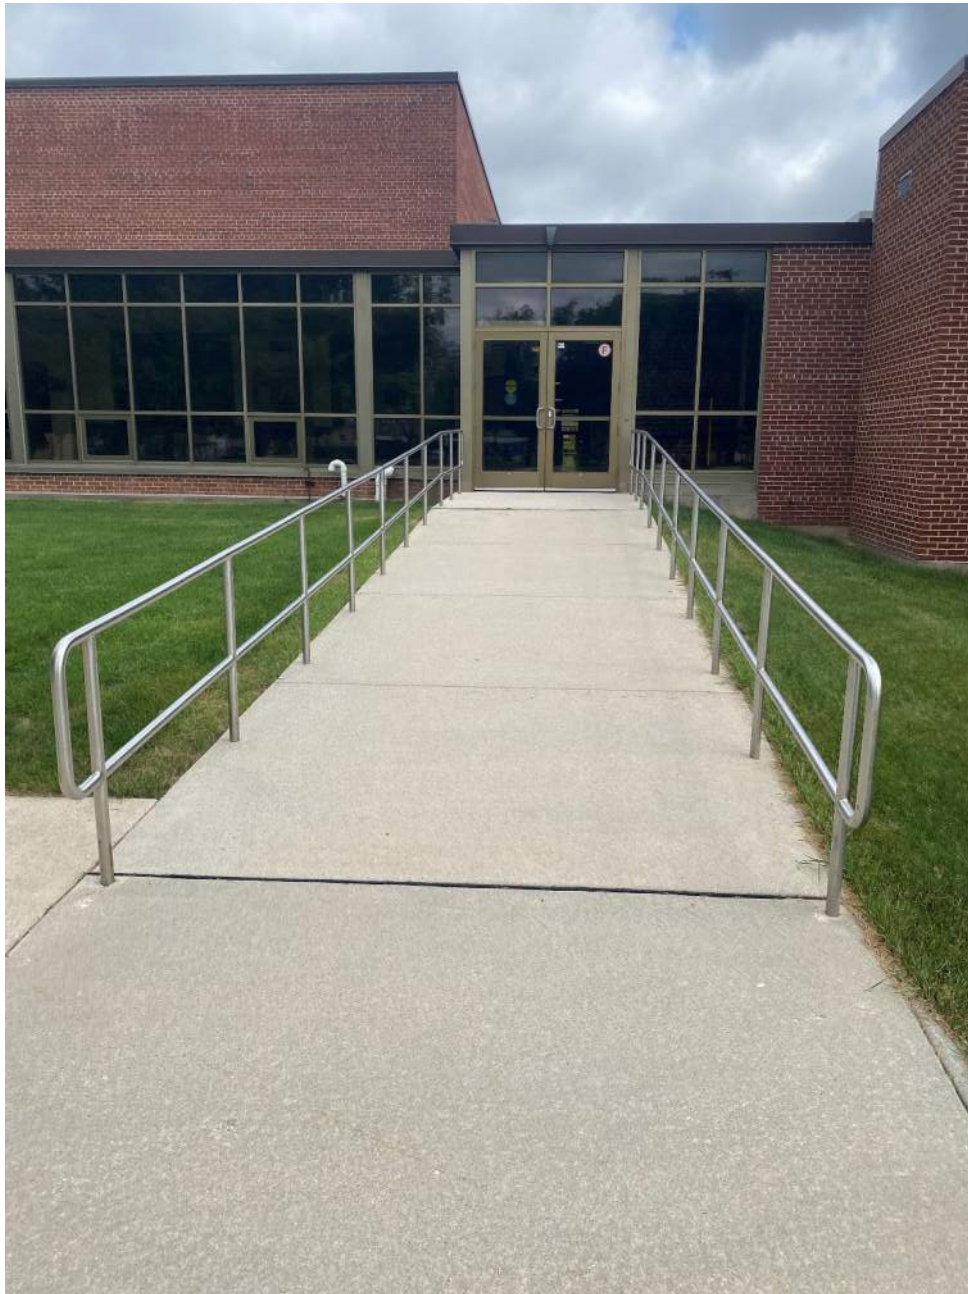
The front concrete ramp is in good to fair condition. The metal railing is in good condition with no rusting (Figure 19). The concrete ramp is in good condition, except for where the railing is attached to the concrete (Figure 20). There is cracked concrete around most of the metal posts, but the cracking is localized to the area around each railing post.

Figure 19: Front concrete ramp in good to fair condition.

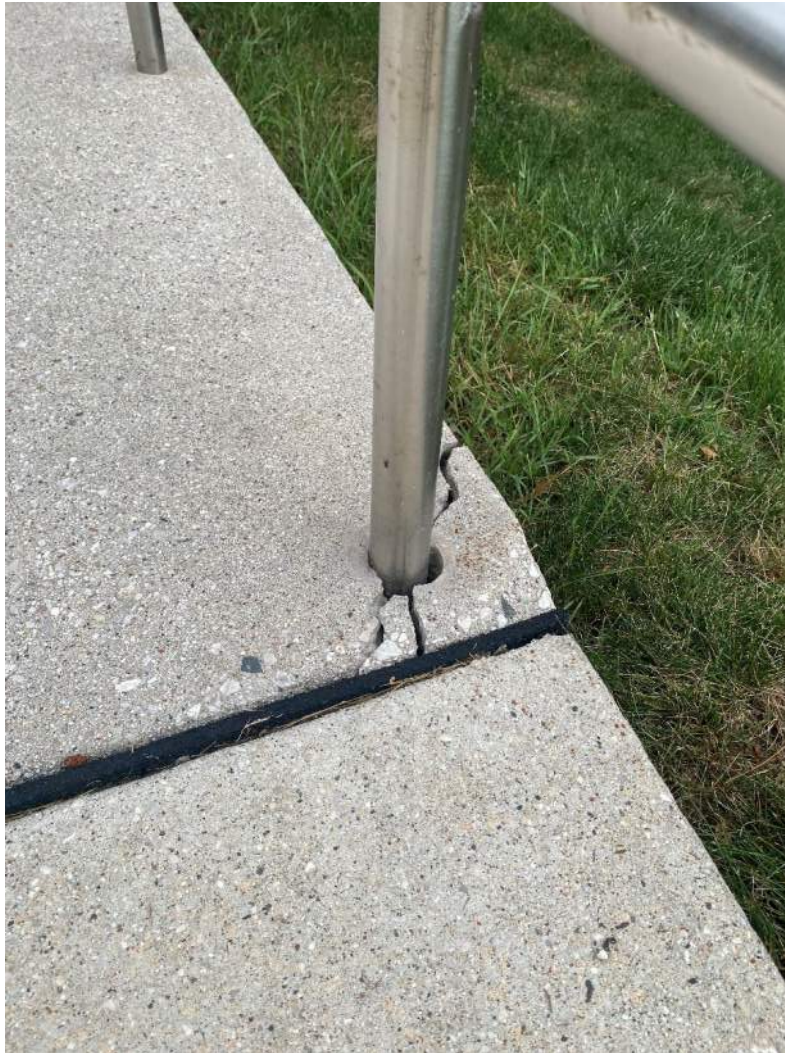
Figure 20: Cracking concrete at railing poles on front concrete ramp.

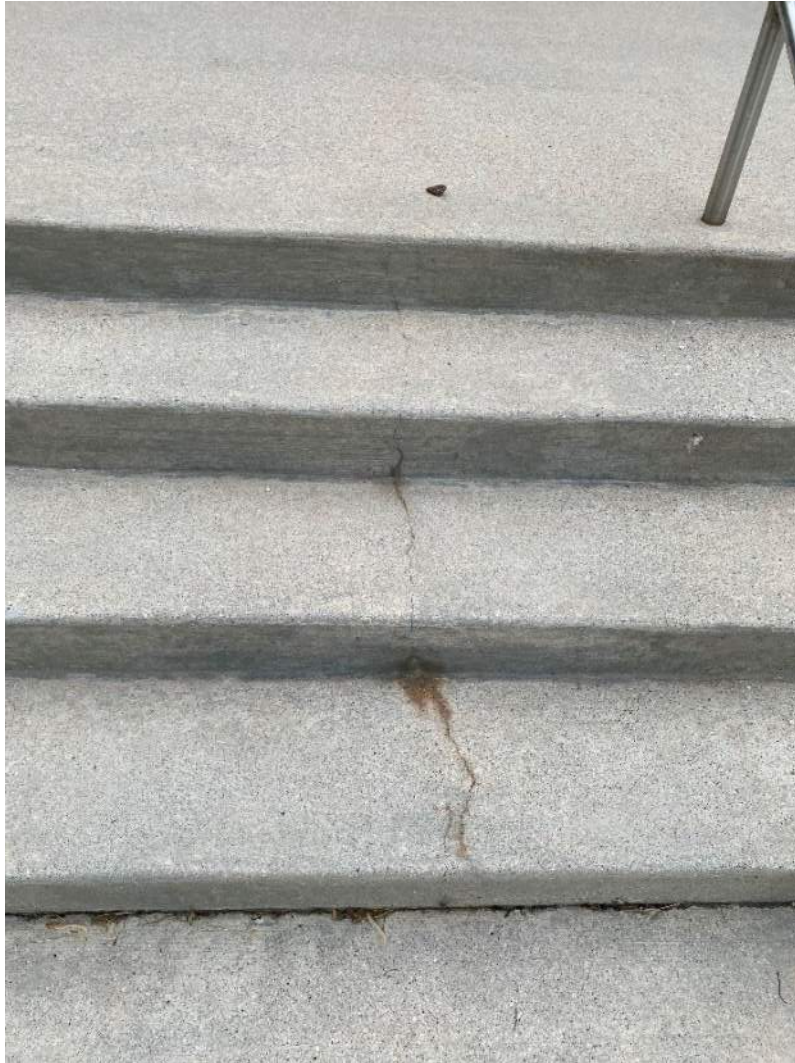
Figure 25: Crack on stairs of front west stairway.

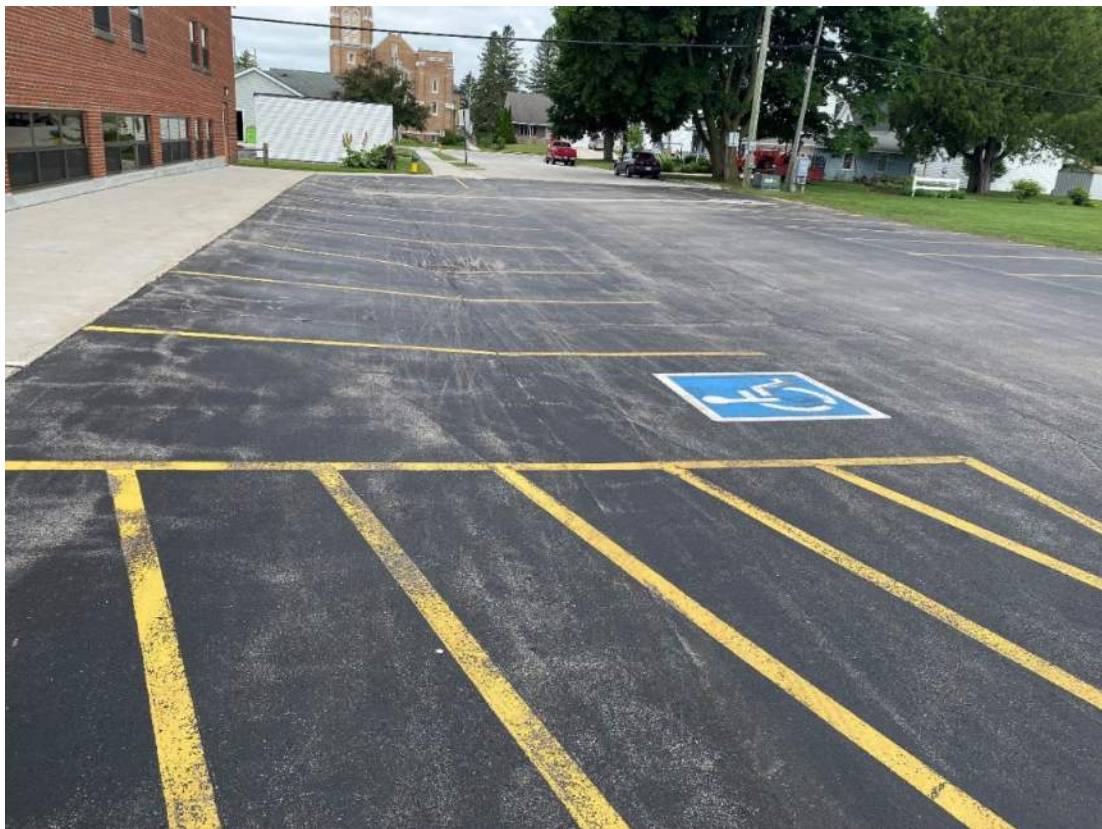
Figure 34: Longitudinal cracking in parking stalls in northwest parking lot.

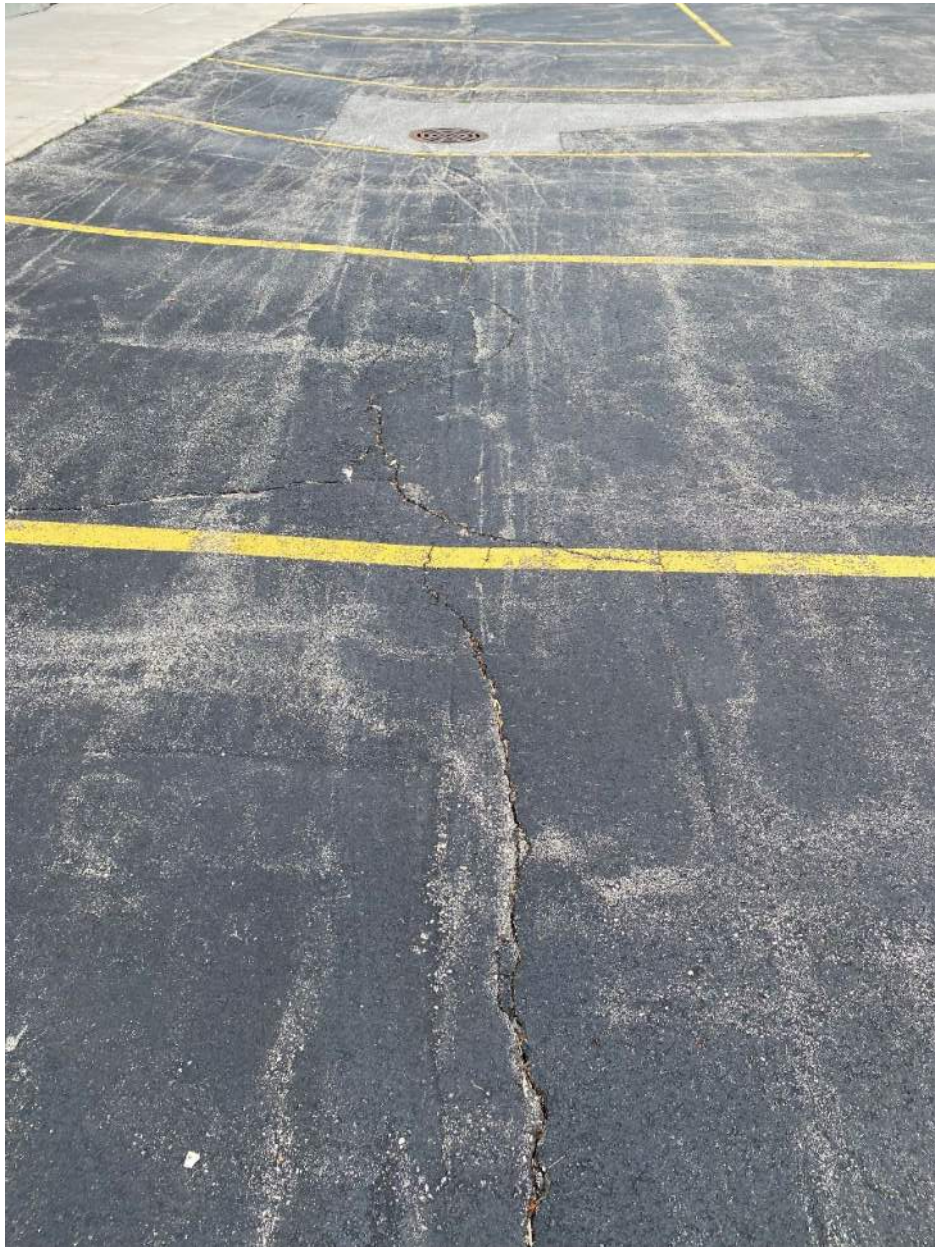
Figure 75: Longitudinal cracking in northwest parking lot.

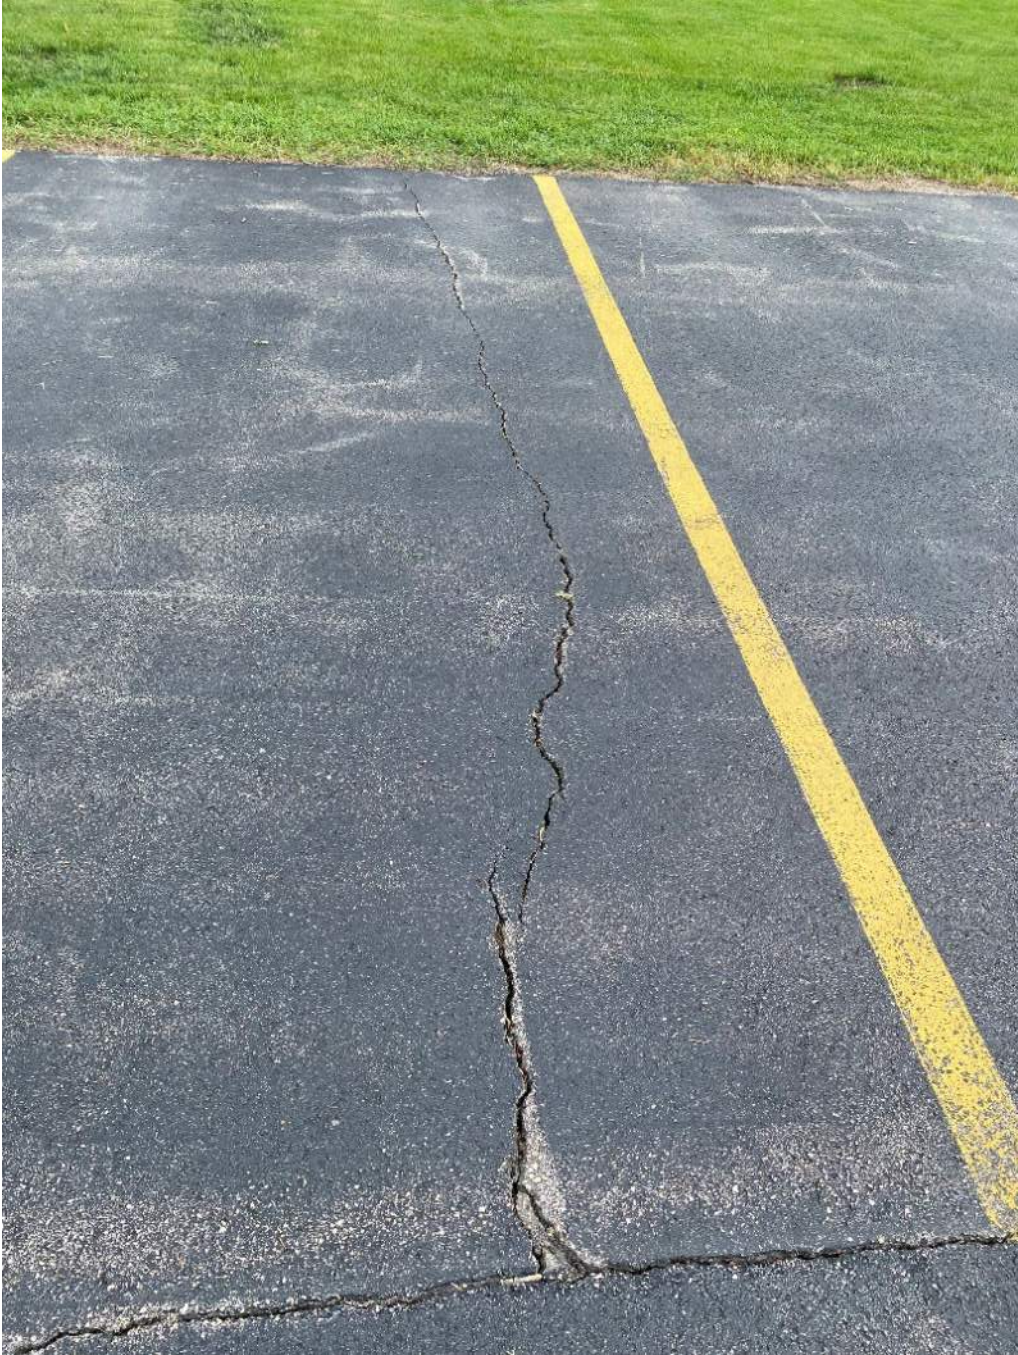
Figure 86: Longitudinal and transverse cracking in parking stalls in northwest parking lot.

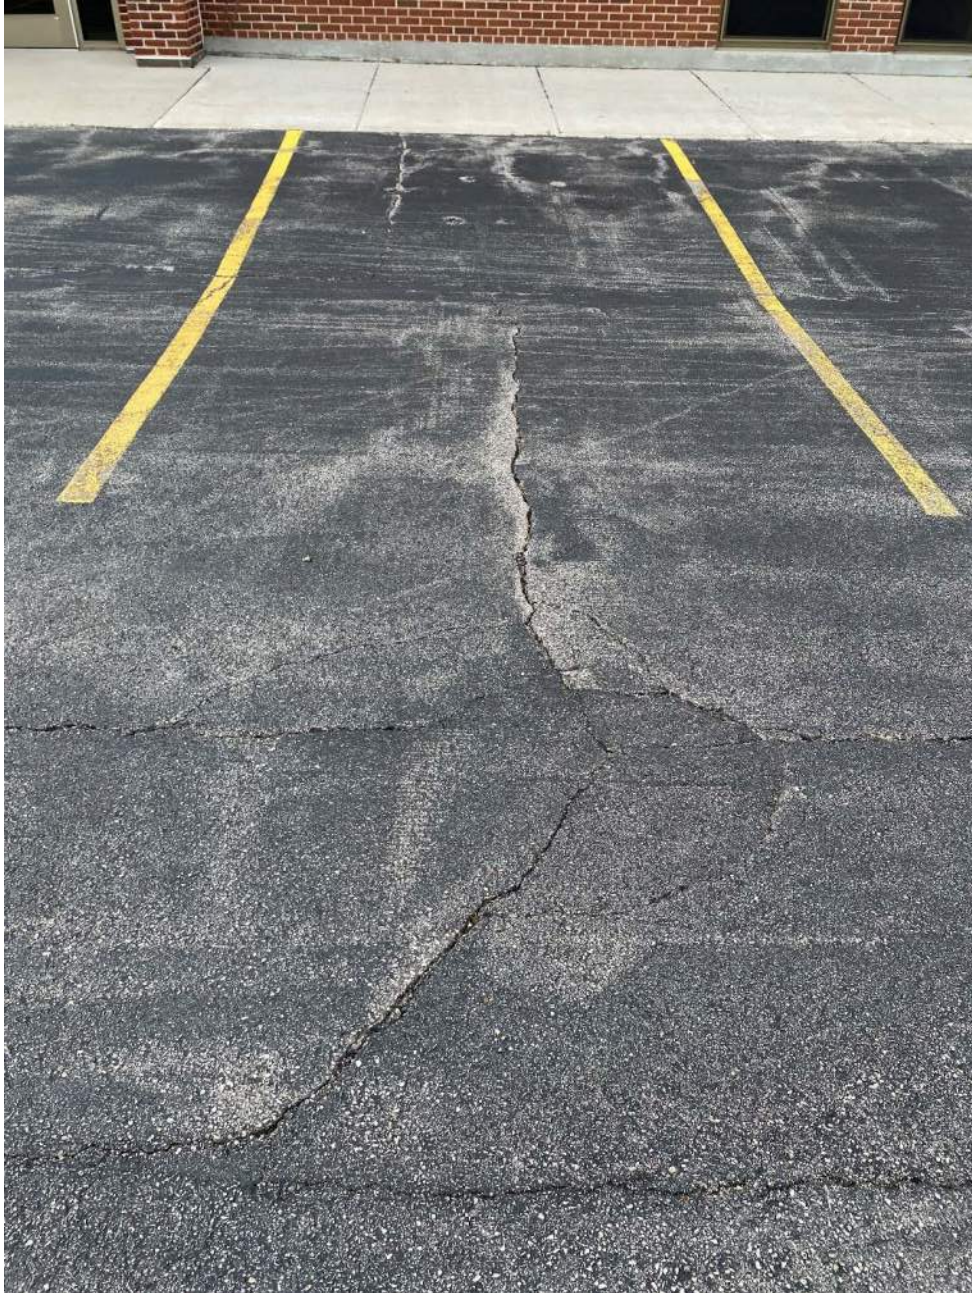
Figure 37: Cracking and settling in northwest parking lot.

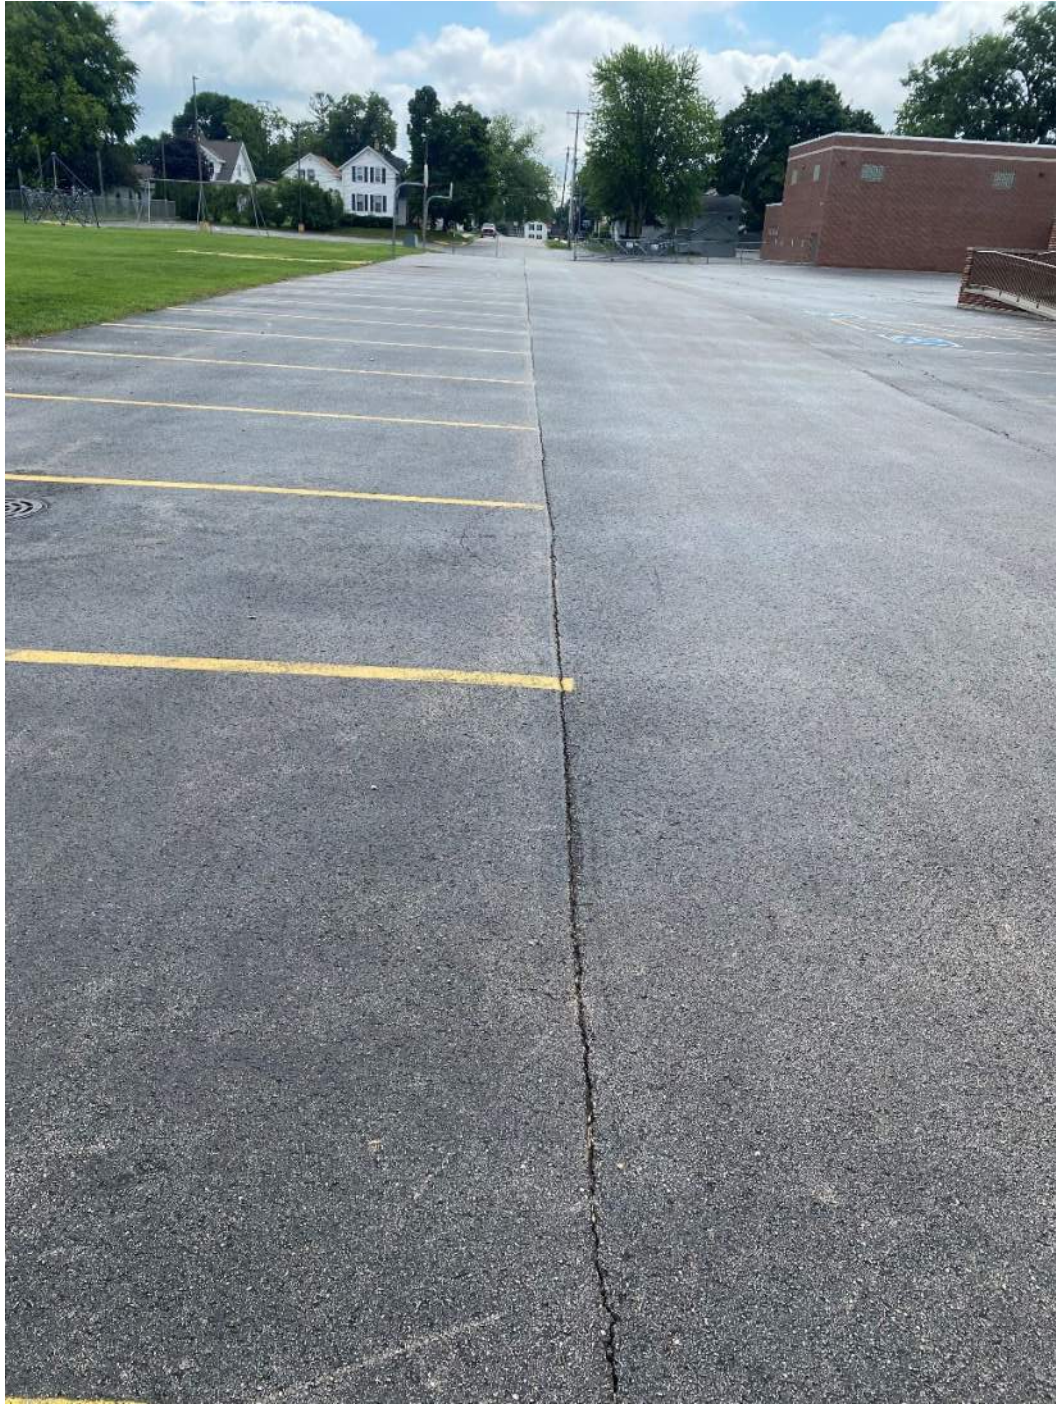
Figure 38: Newer pavement in drive lane of northwest parking lot in fair condition.

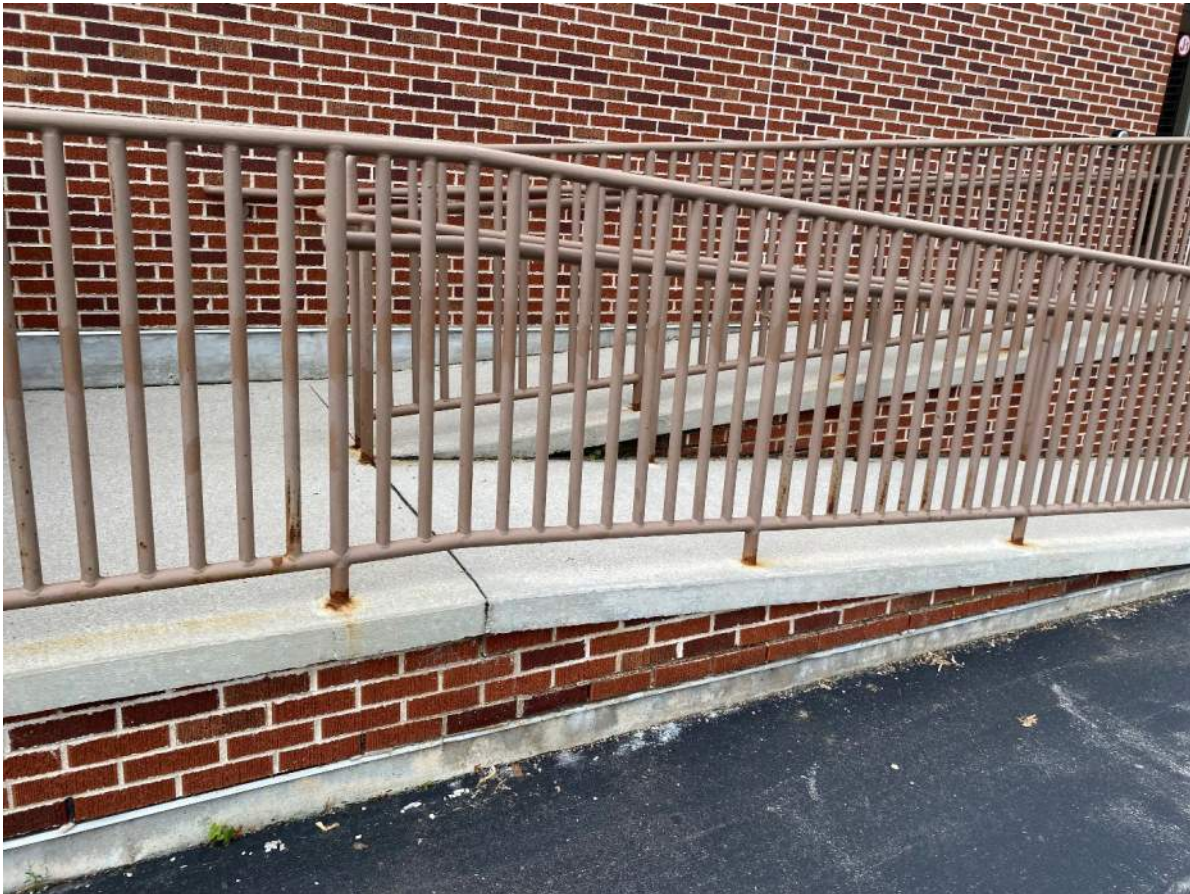
Overall, the back concrete ramp is in fair condition. The brick base has minimal cracking (Figure 39). There are two cracks in the concrete pavement, but majority of the concrete is not cracked or chipped (Figure 40). The railing is rusted especially at the base.

Figure 39: Back concrete ramp in fair condition.

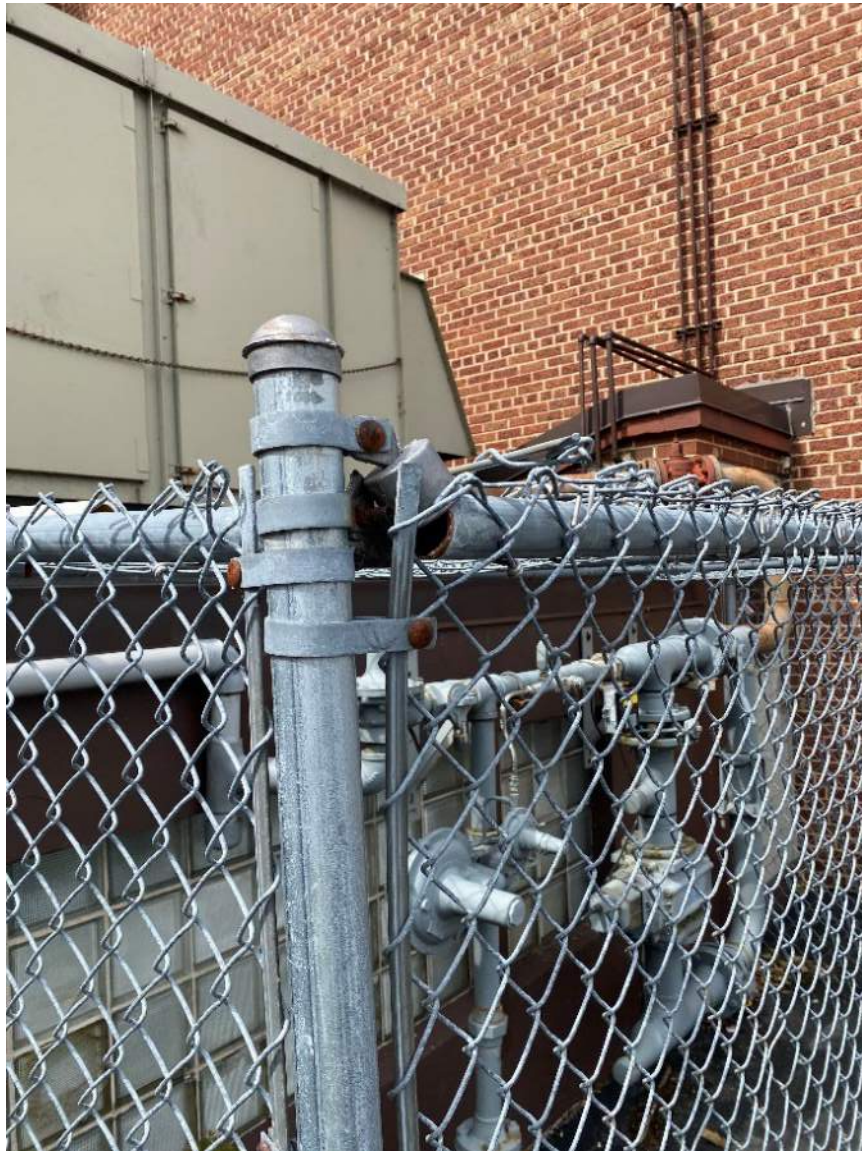
The metal fence enclosing the mechanical equipment on the back side of the school is in fair condition. There appears to be damage to the top portion of fencing (Figure 47). There is also rusting beginning.

Figure 47: Damaged fencing surrounding mechanical equipment on back side of school.

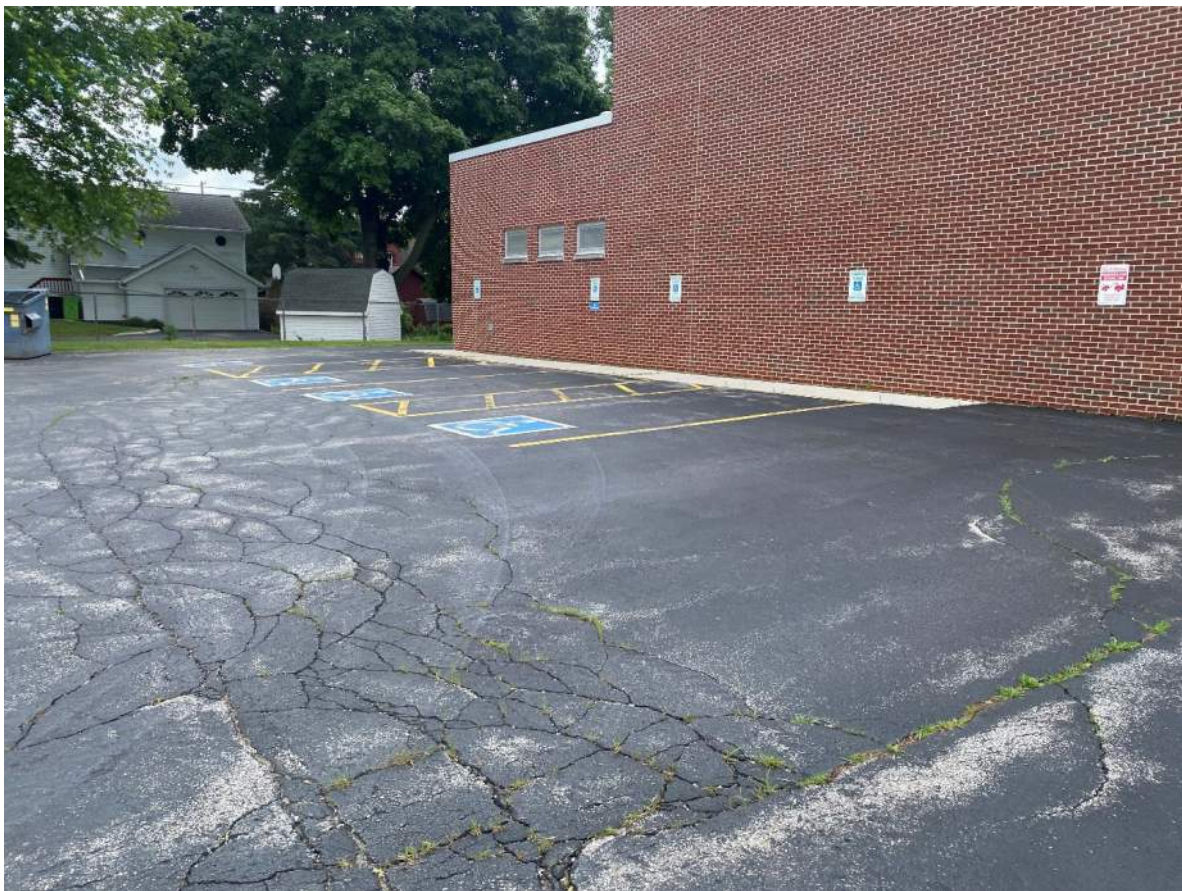
The back ADA asphalt parking area is in poor condition. Majority of the pavement is covered in alligator cracking (Figure 48,49&50). The pavement marking is also wearing off. The concrete sidewalk south of the ADA stalls is in fair condition. The pavement appears old and chipped, but there is minimal cracking (Figure 51). There is some newer pavement north of the accessible stalls that is part of the drive lane that is in fair condition. There are longitudinal cracks in that pavement, but there is no alligator cracking.

Figure 48: ADA parking area in poor condition due to alligator cracking.

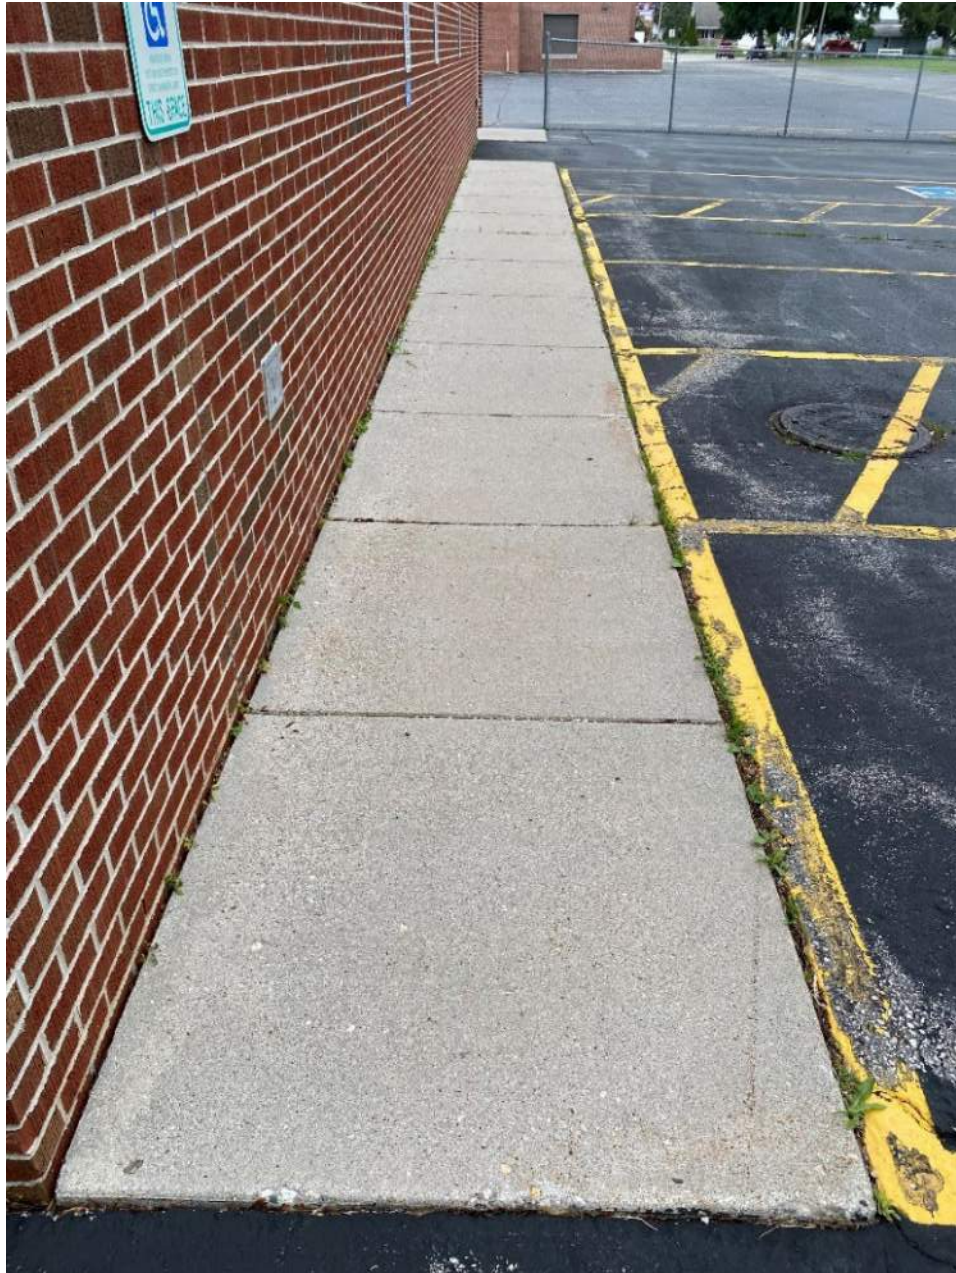
Figure 51: Concrete sidewalk near back east ADA parking stalls in fair condition.

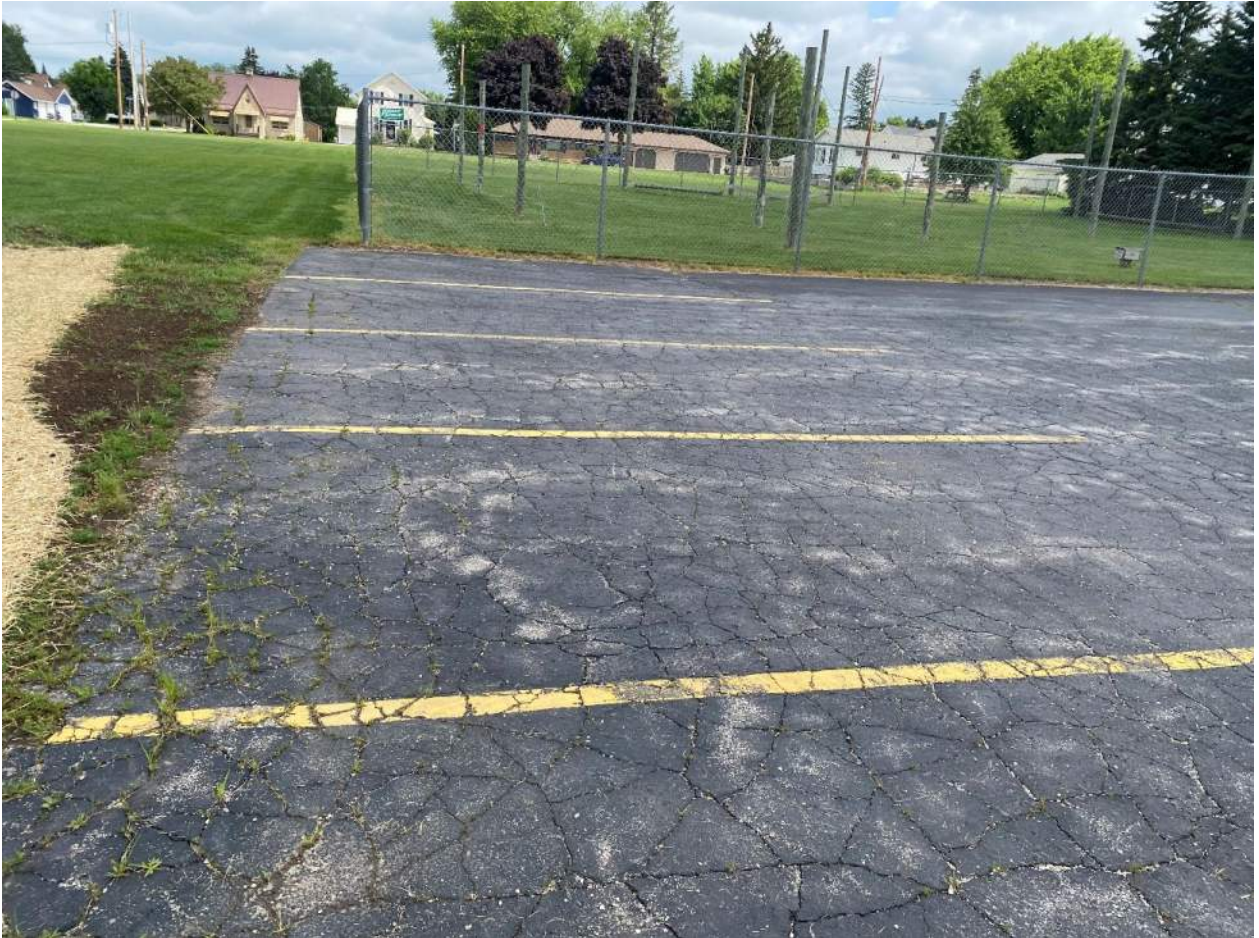
The northeast asphalt parking lot is in very poor condition. The pavement is covered in alligator and block cracks and has grass growing through the cracks (Figure 52&53). The pavement markings are also chipping and fading. There is also settling causing standing water on the pavement in certain spots.

Figure 52: Northeast parking lot covered in alligator cracking.
