Facilities Study Document | Kiel School District, Zielanis Elementary School

Building Systems Summary Checklist

Completed by: Alex Feudner and Ben Nerat, MSA Professional Services

Date of Walk-through: 05/18/2022

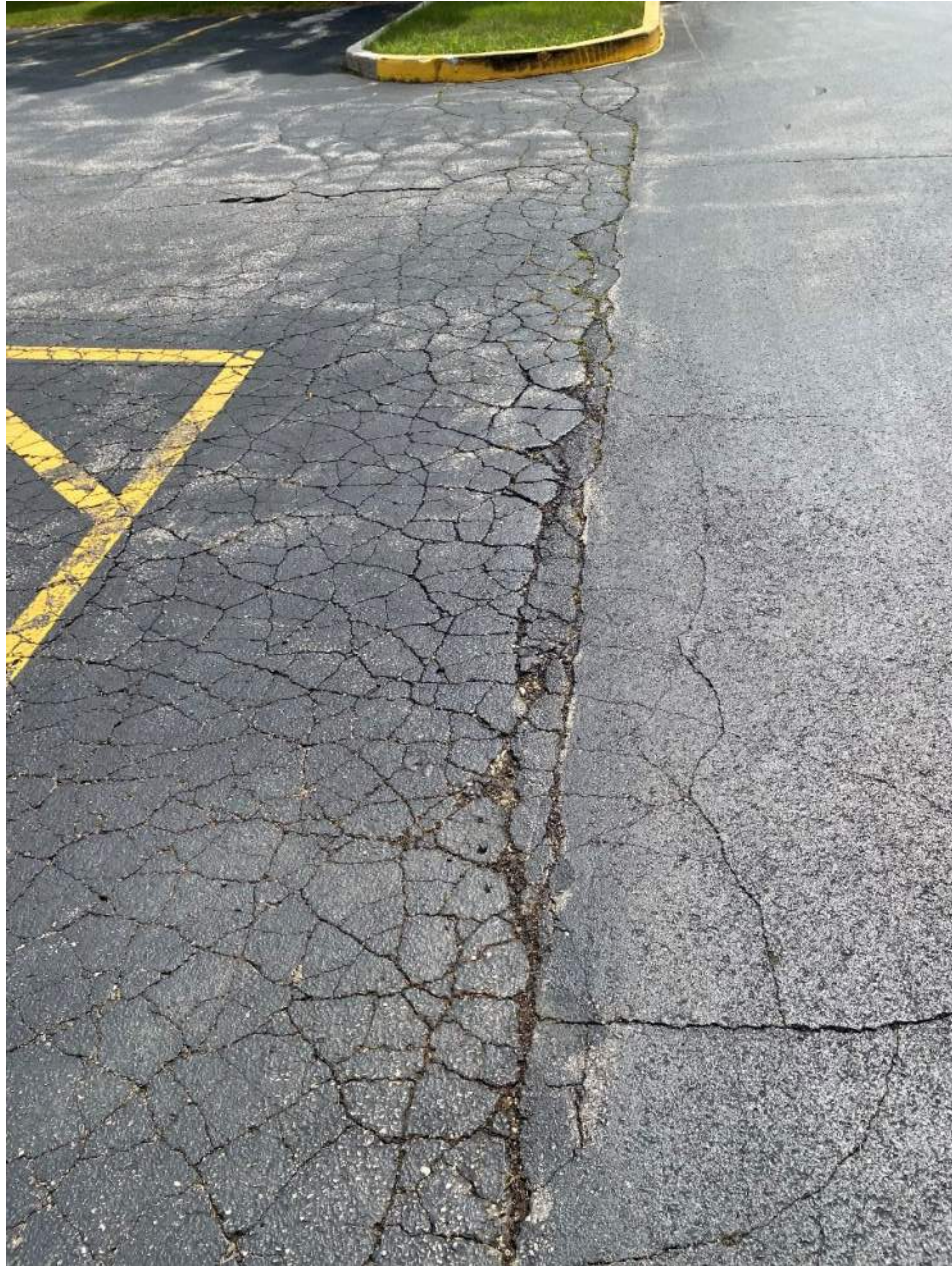
Figure 53: Alligator cracking near entrance to back northeast parking lot.

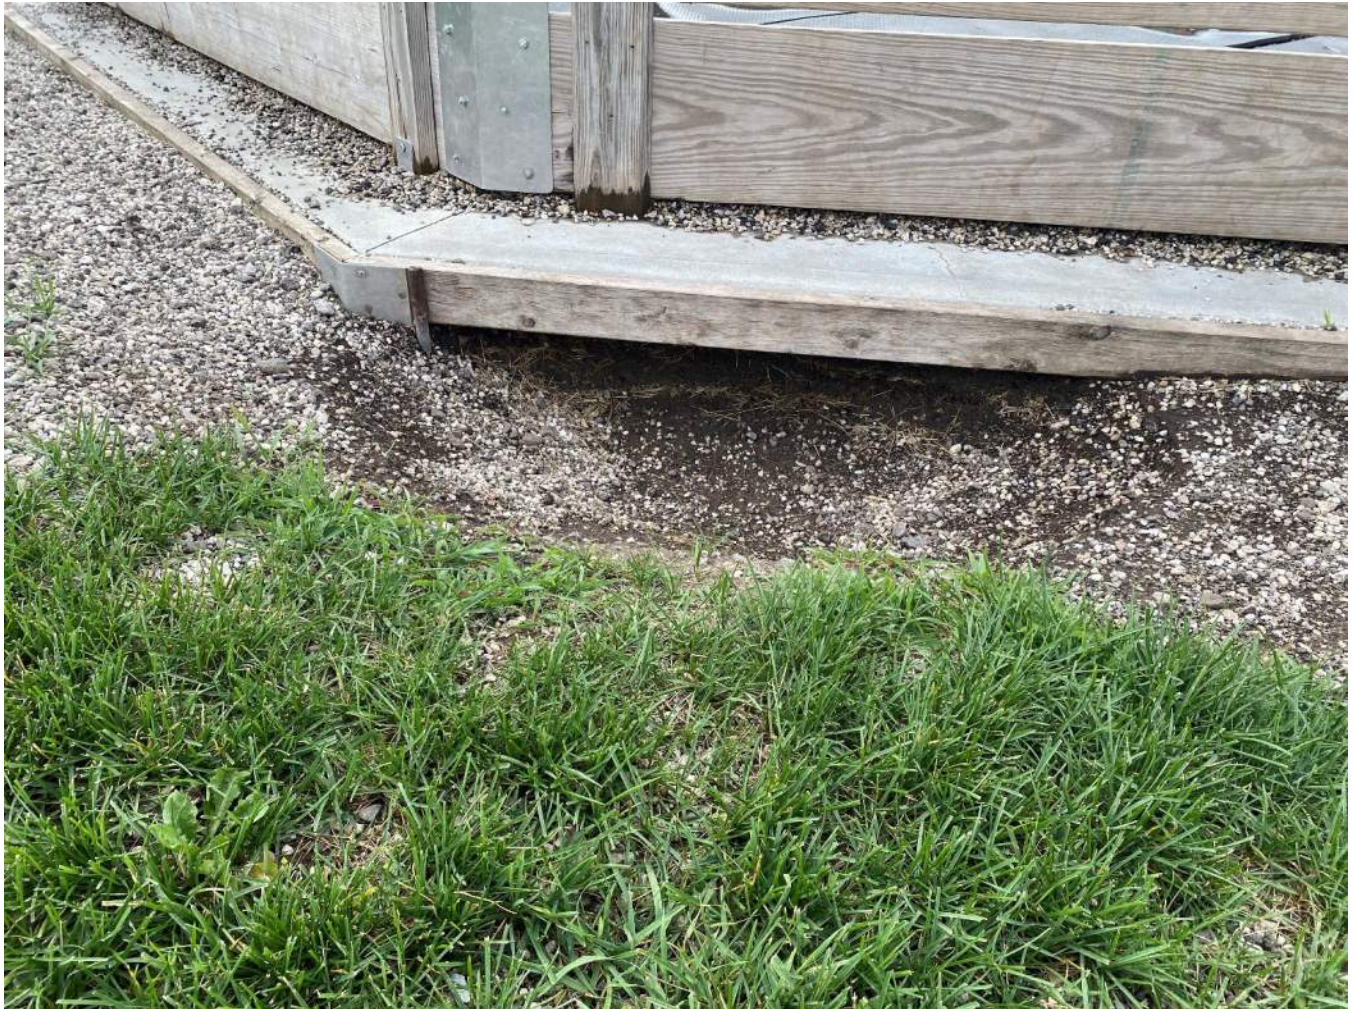
The wooden octagon is in good to fair condition. There was water sitting on the rubber pads inside the enclosure. Some of the gravel base is missing under the concrete pad (Figure 56). There are also some cracks radiating out of the concrete pad (Figure 57). The climbing net is in good condition and looks very new. The swing set is in fair to poor condition due to some of the swings breaking apart (Figure 58).

Figure 56: Missing gravel base under wooden octagon play area.

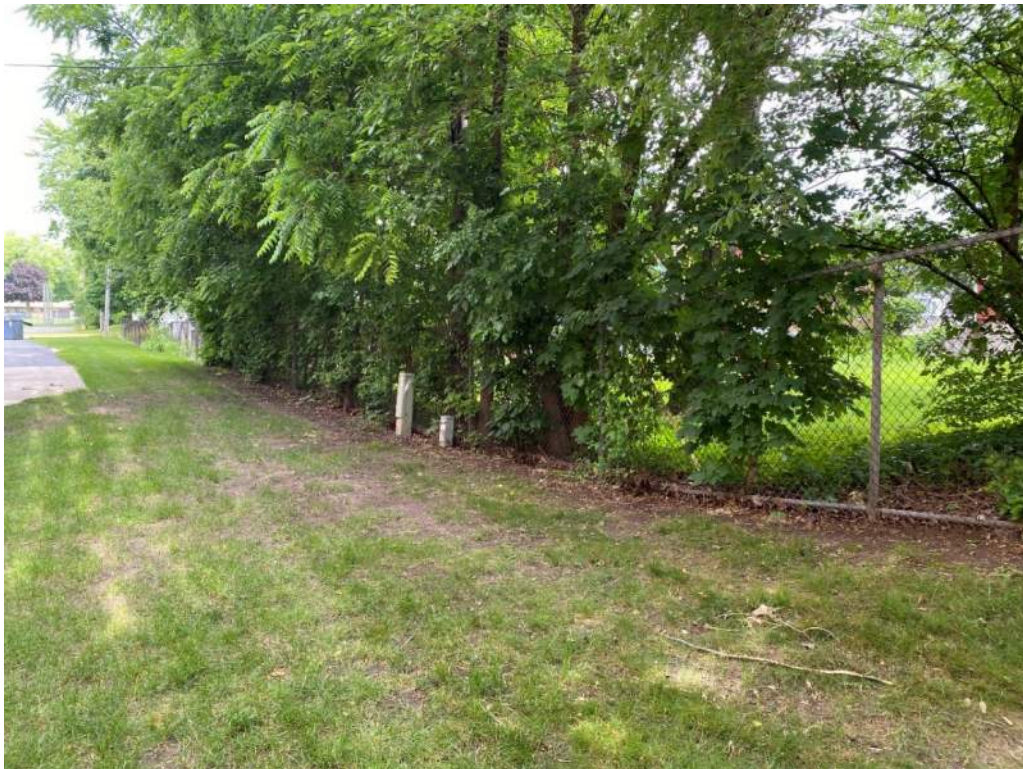
Figure 61: Metal fence on east property line falling over and overgrown with trees.

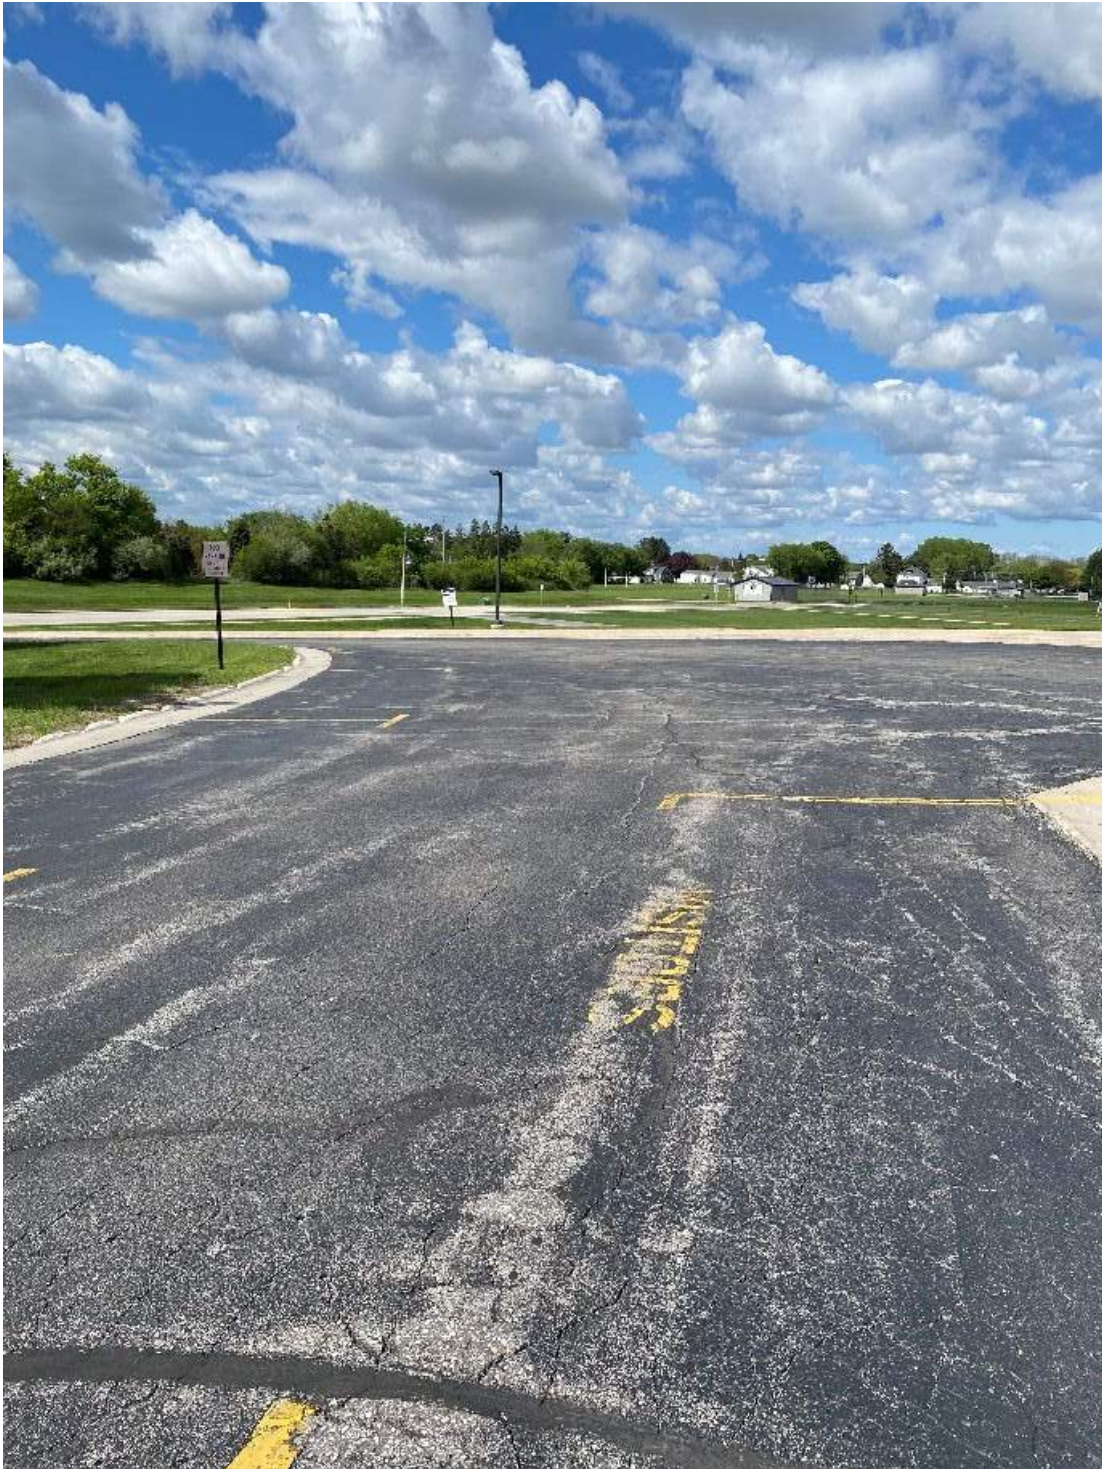
Figure 3: Faded pavement markings in Bus/Visitor Parking Loop.

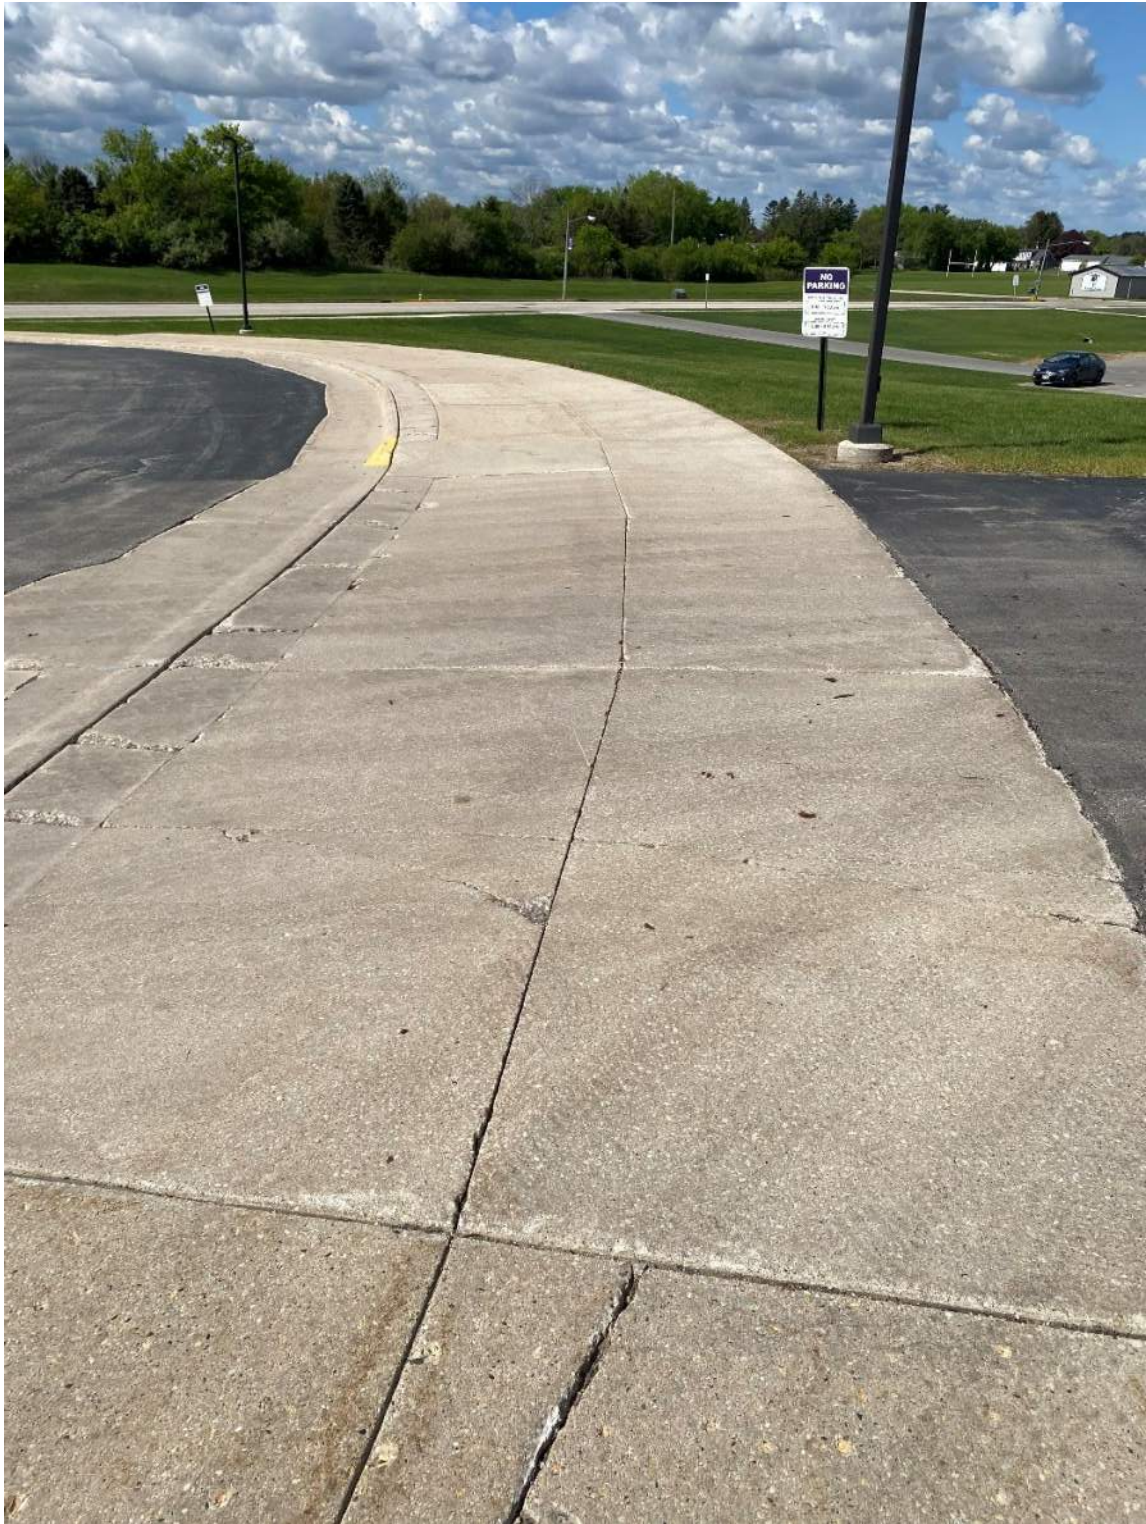
Figure 6: Cracked concrete sidewalk driveway apron into garbage dumpster area along Bus/Visitor Parking Loop.

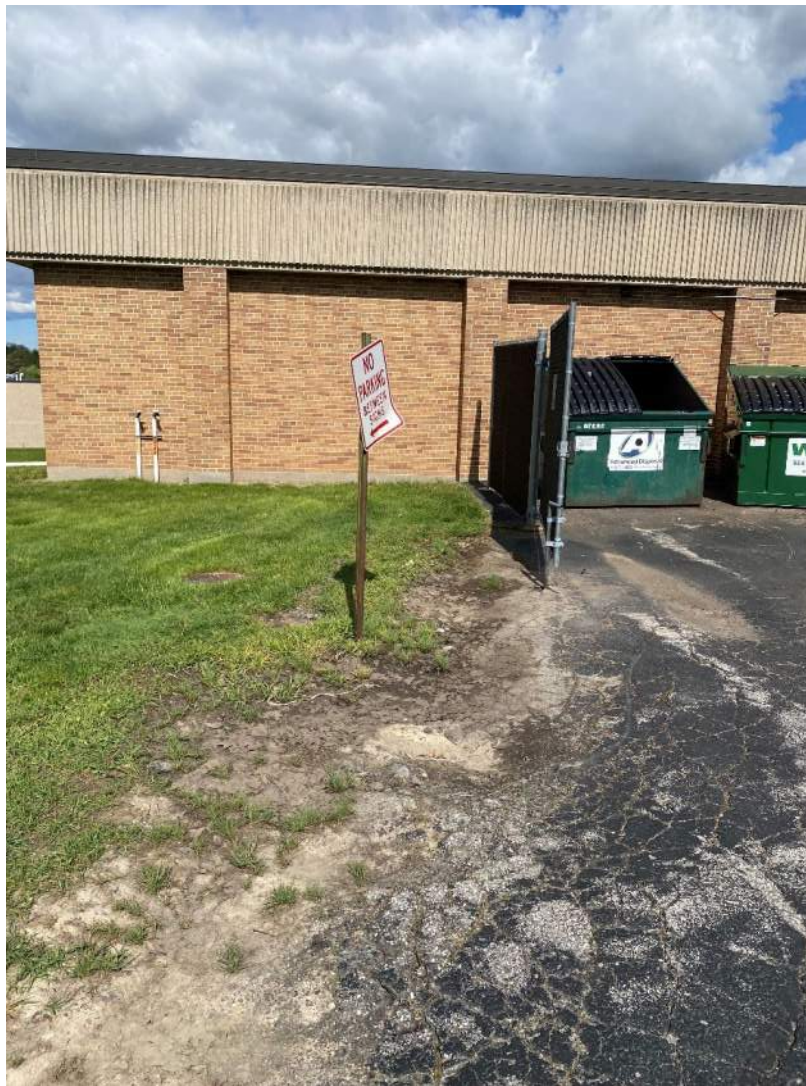
Figure 7: Significant edge cracking in Garbage Dumpster Parking Lot.

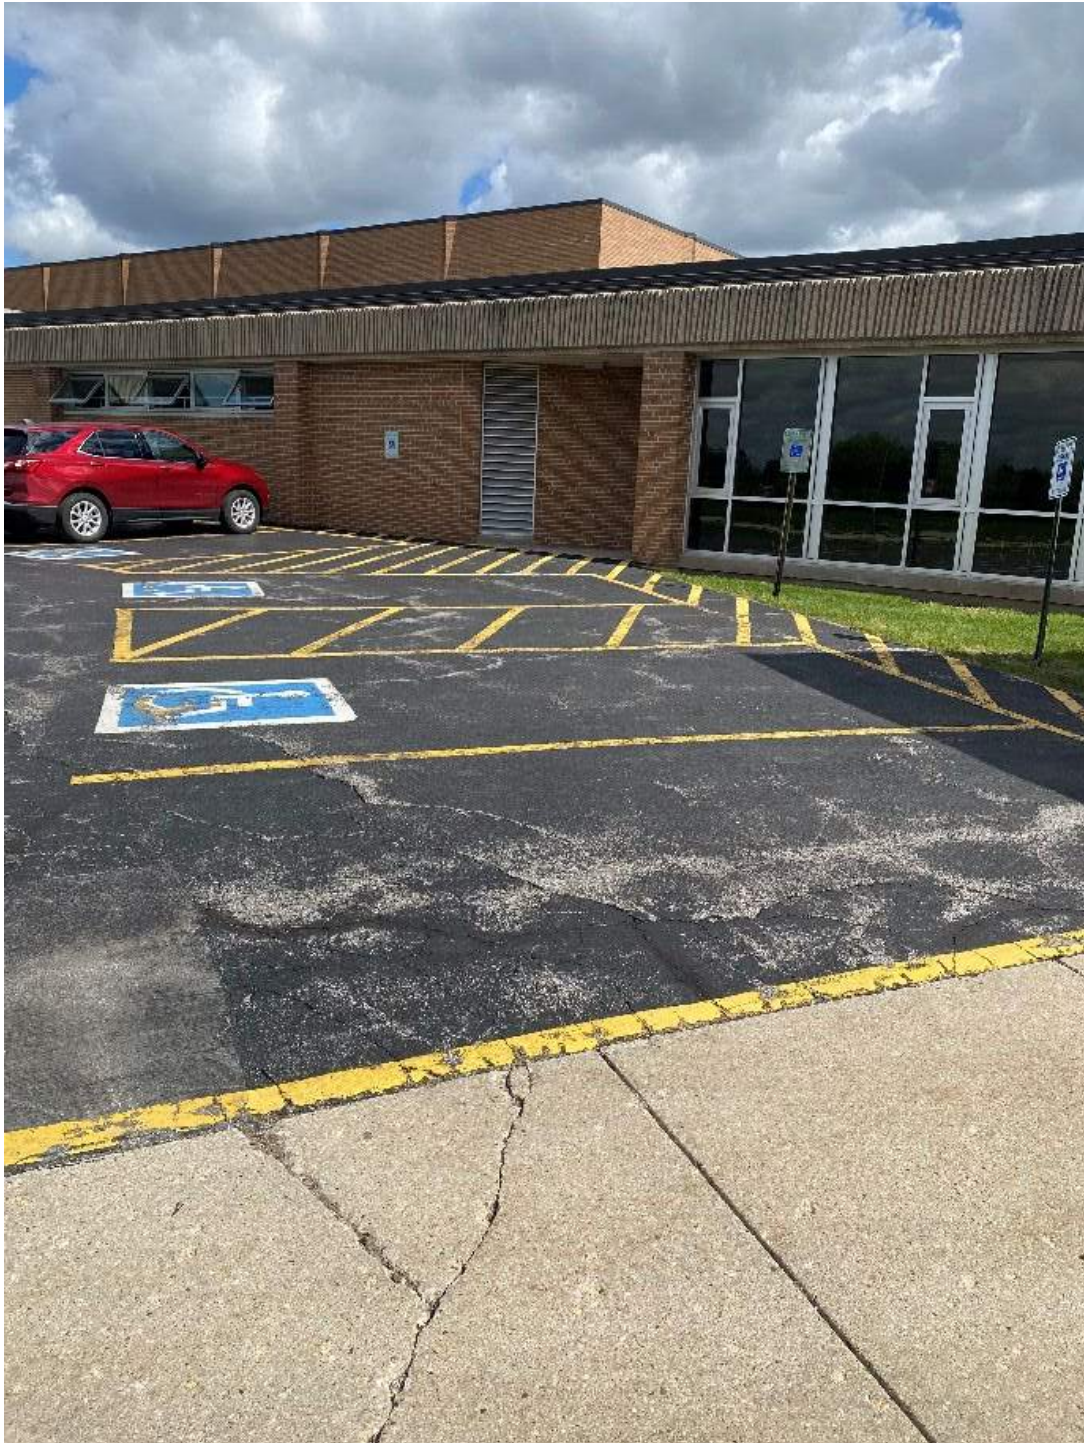
Figure 8: Pavement markings and signposts in poor condition in the Garbage Dumpster Parking Lot.

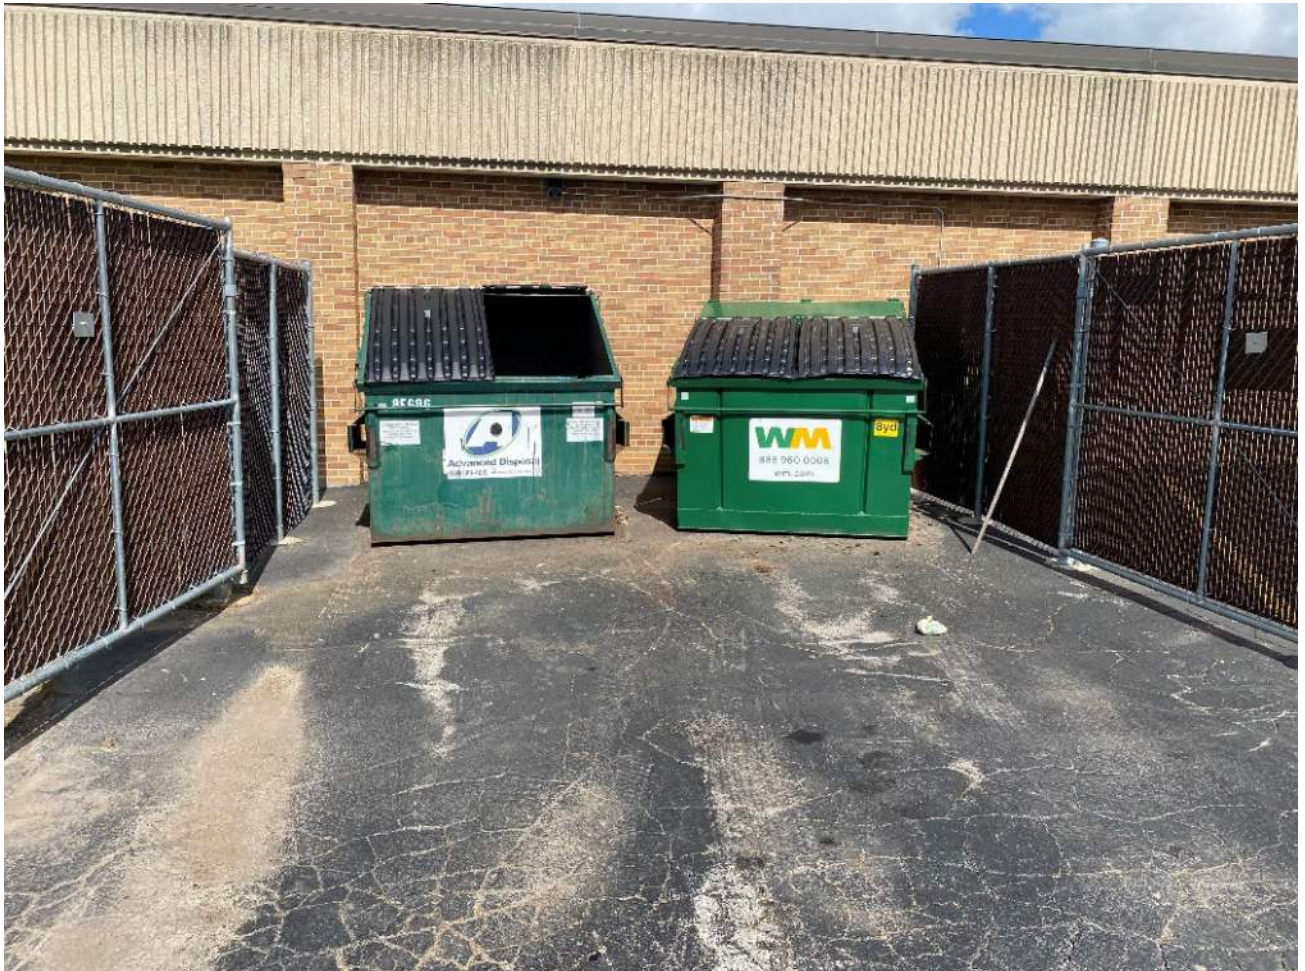
The Garbage Dumpster Parking Lot is a small asphalt lot that has one driveway that is used as both the entrance and exit. The driveway is located off the exit drive lane for the Bus/Visitor Parking Lot. The lot includes a fenced in dumpster enclosure, four accessible stalls and ten regular stalls. The asphalt pavement is in poor to very poor condition. The main drive areas are significantly cracked with block and alligator cracking. The south edge of the lot had pieces of asphalt breaking off into the grass (Figure 7). There is also rutting in the pavement in front of the dumpsters. The pavement markings are in poor condition with lots of fading and chipping (Figure 8). Many of the signs are on posts that are leaning to the side or bent (Figure 7 & 8). Overall, the fencing around the garbage dumpsters appears to be in good condition, but the gate is staked into the pavement in an open position which allows open access to humans and animals (Figure 9).

Figure 9: Dumpster enclosure fencing in good condition.

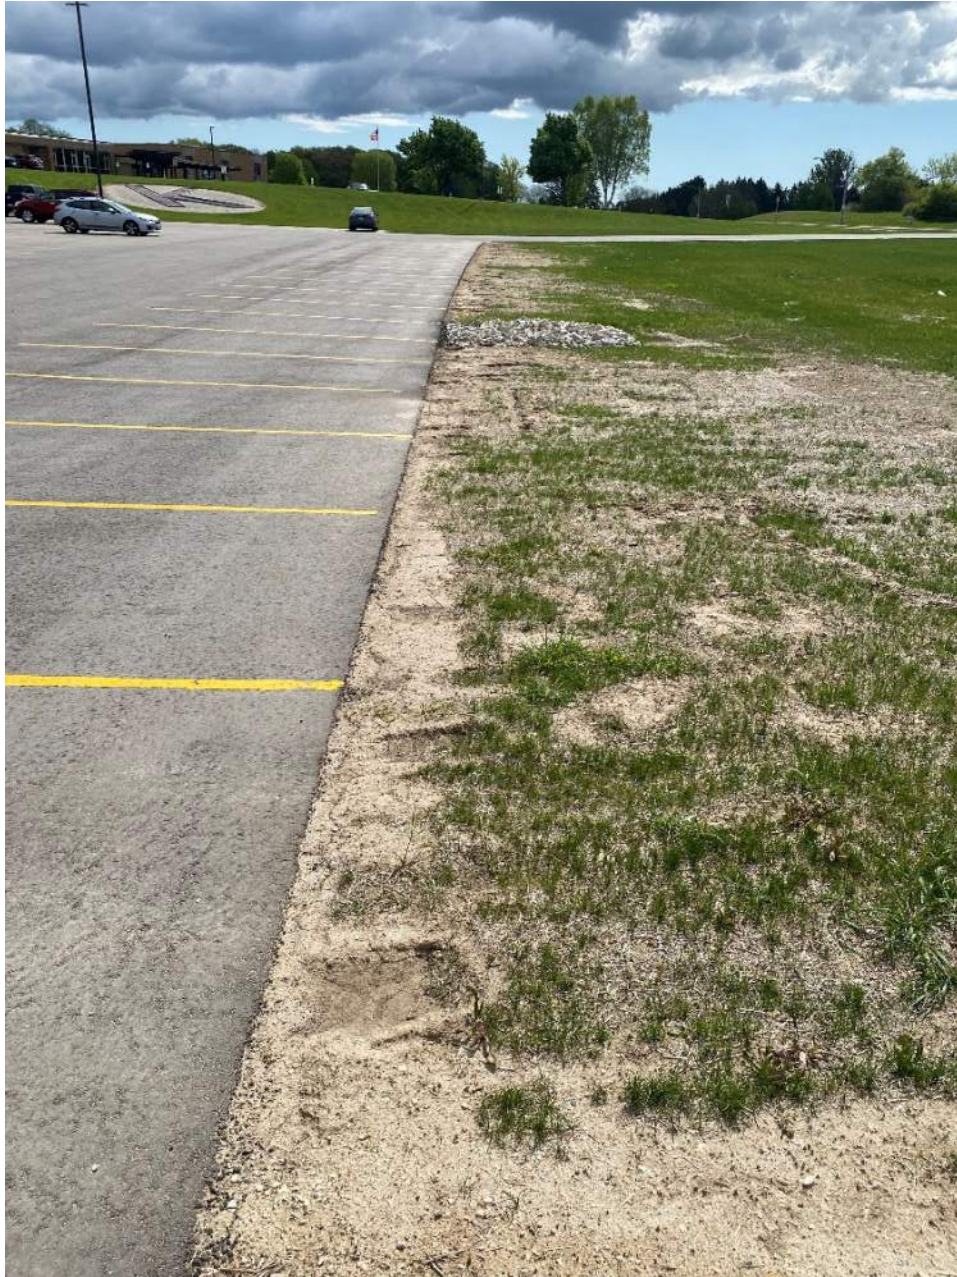
Figure 10: Erosion and dead grass on south end of PAC Parking

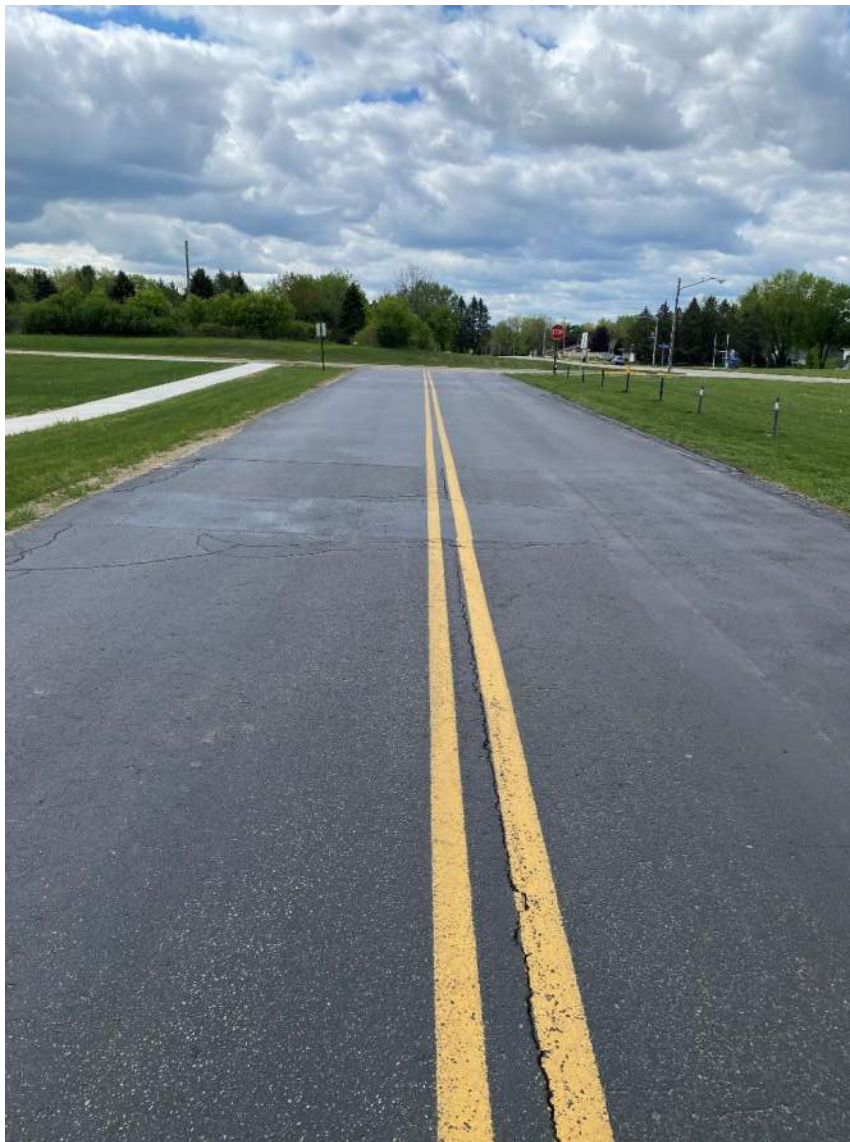
building and extends north. The condition of the asphalt drive is fair from the southwest corner of the school building to the south (Figure 11). The portion of the roadway that borders the west side of the school is in poor condition due to block and alligator cracking (Figure 12). There are many longitudinal and transverse cracks throughout the entire drive (Figure 13). There are multiple patches on the roadway, but some of the patches are cracking. There is edge cracking along the edges of the drive where there is no curb and gutter. The concrete driveway is in good to fair condition. It shows signs of typical wear and tear, but few cracks in the concrete except for the curb and gutter portion and flares. Pavement markings are in good to fair condition with some fading beginning. The curb and gutter near the north portion of the roadway is in excellent condition, as it was recently installed.

Figure 11: South portion of Access Drive in fair condition.

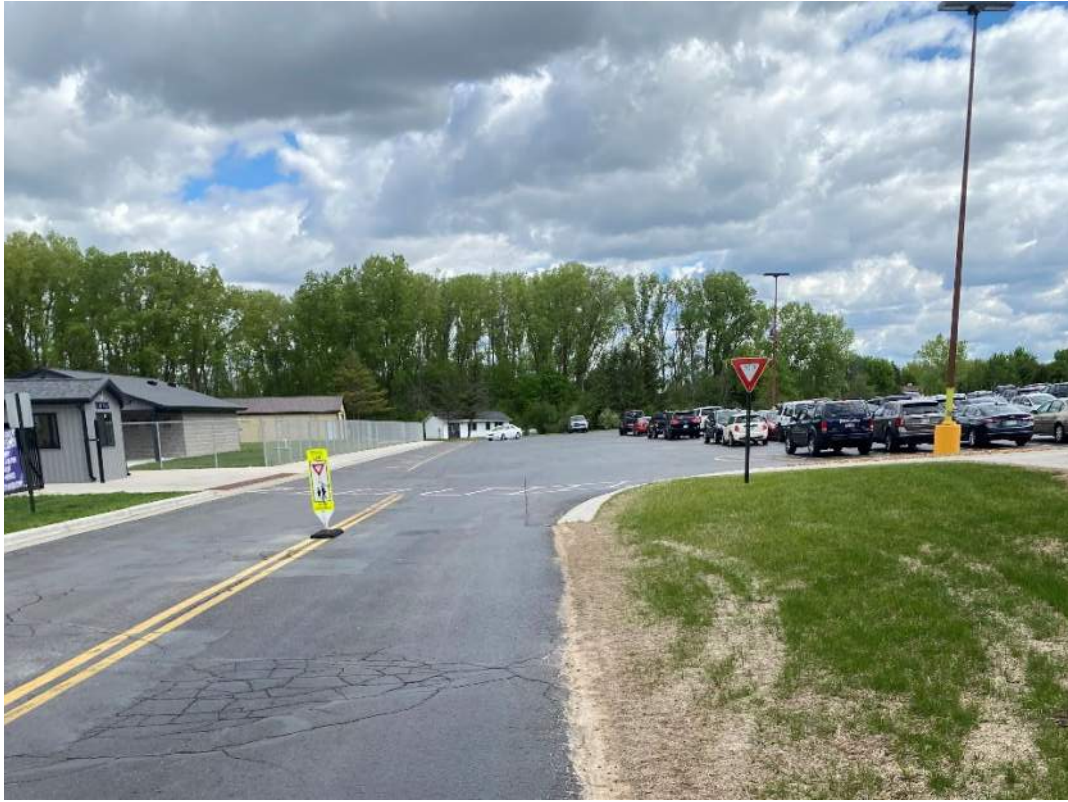
Figure 12: Alligator Cracking on north portion of Access Drive.

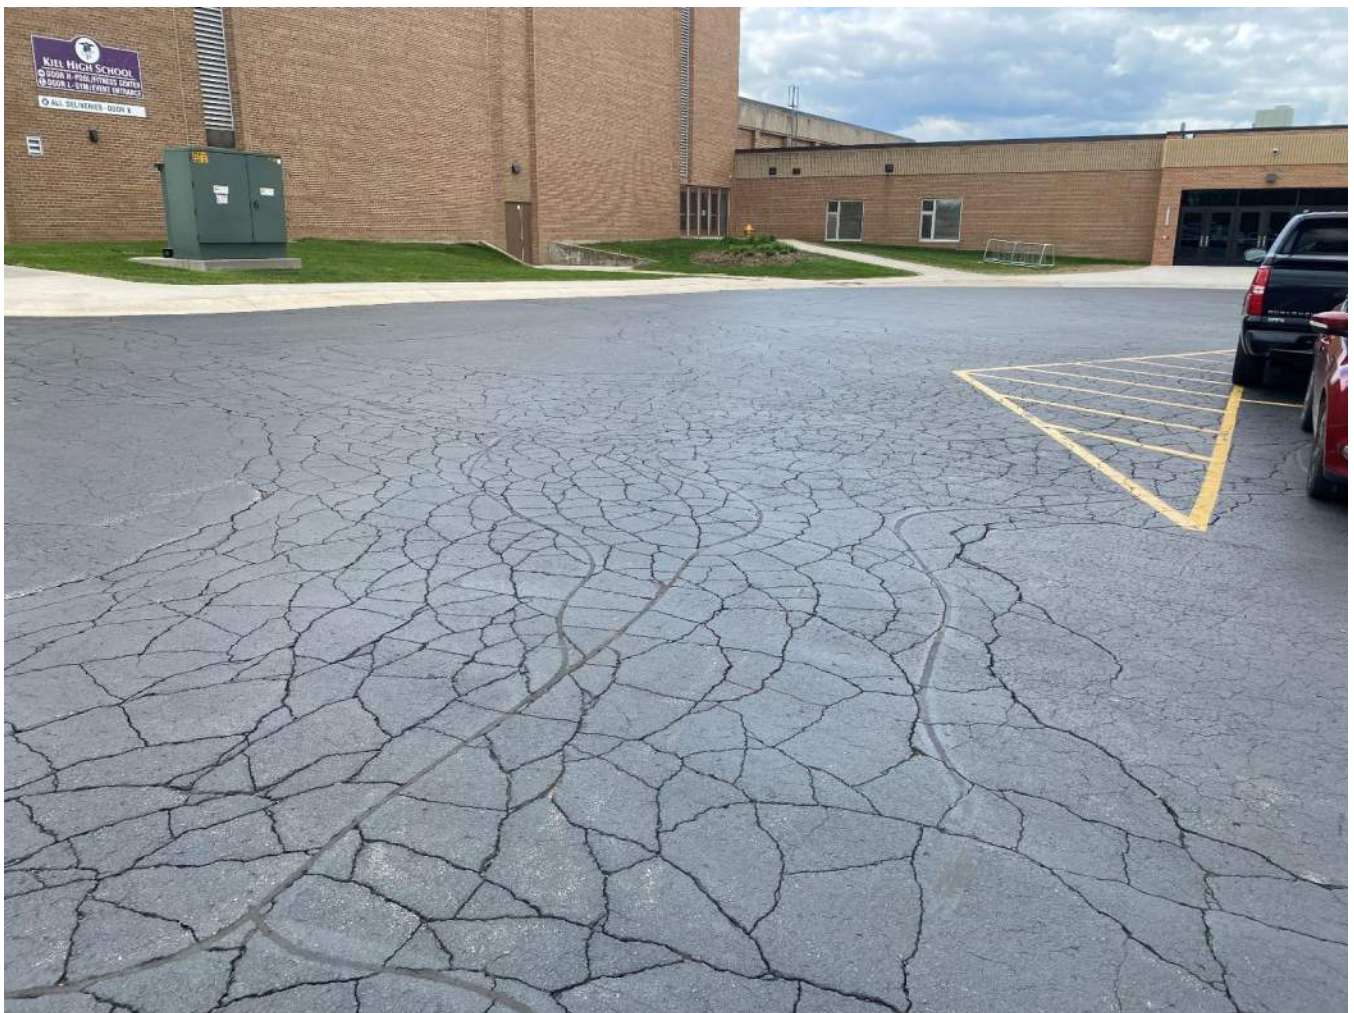
Figure 14: Alligator cracking in Student Parking Lot

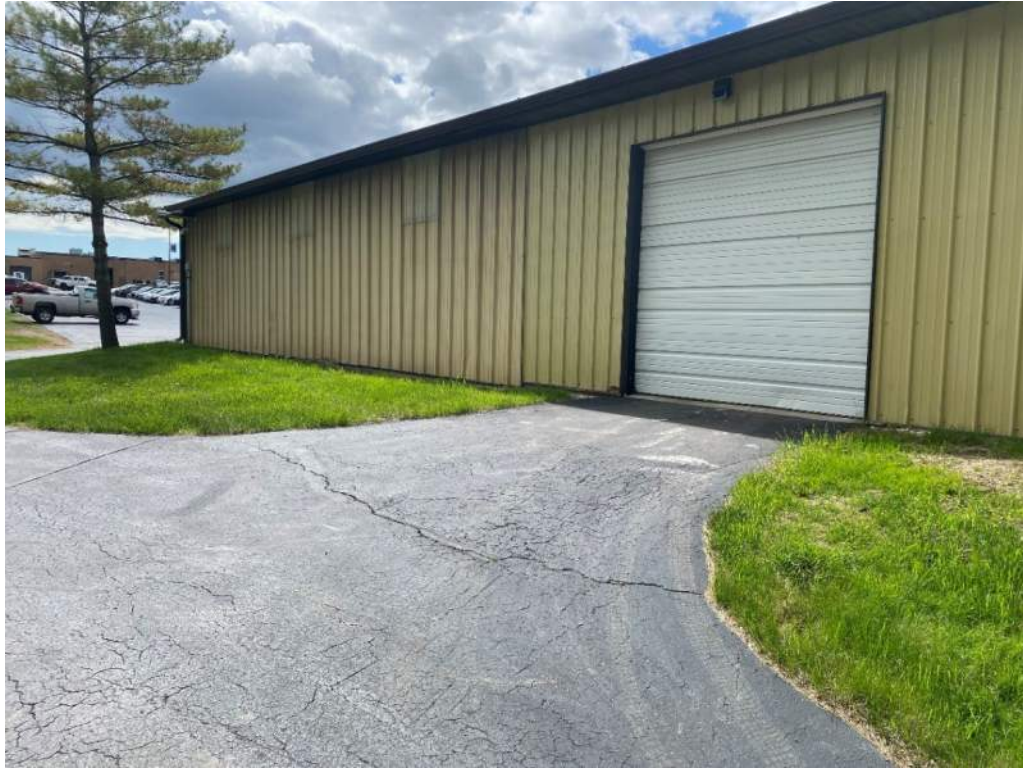
Figure 15: Pavement cracking near shed in northwest corner of Student Parking Lot

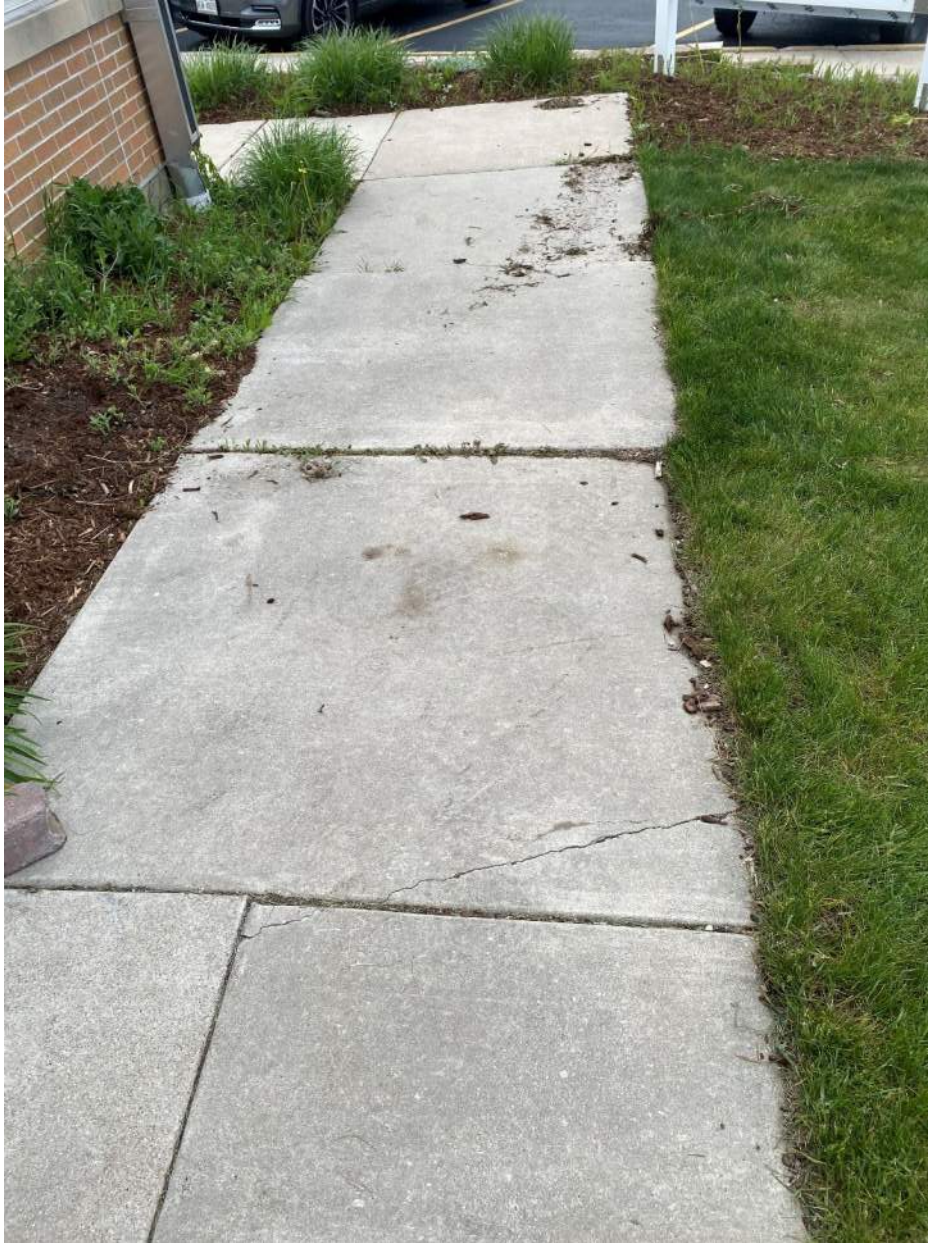
Figure 17: Cracked and uneven sidewalk around greenhouse

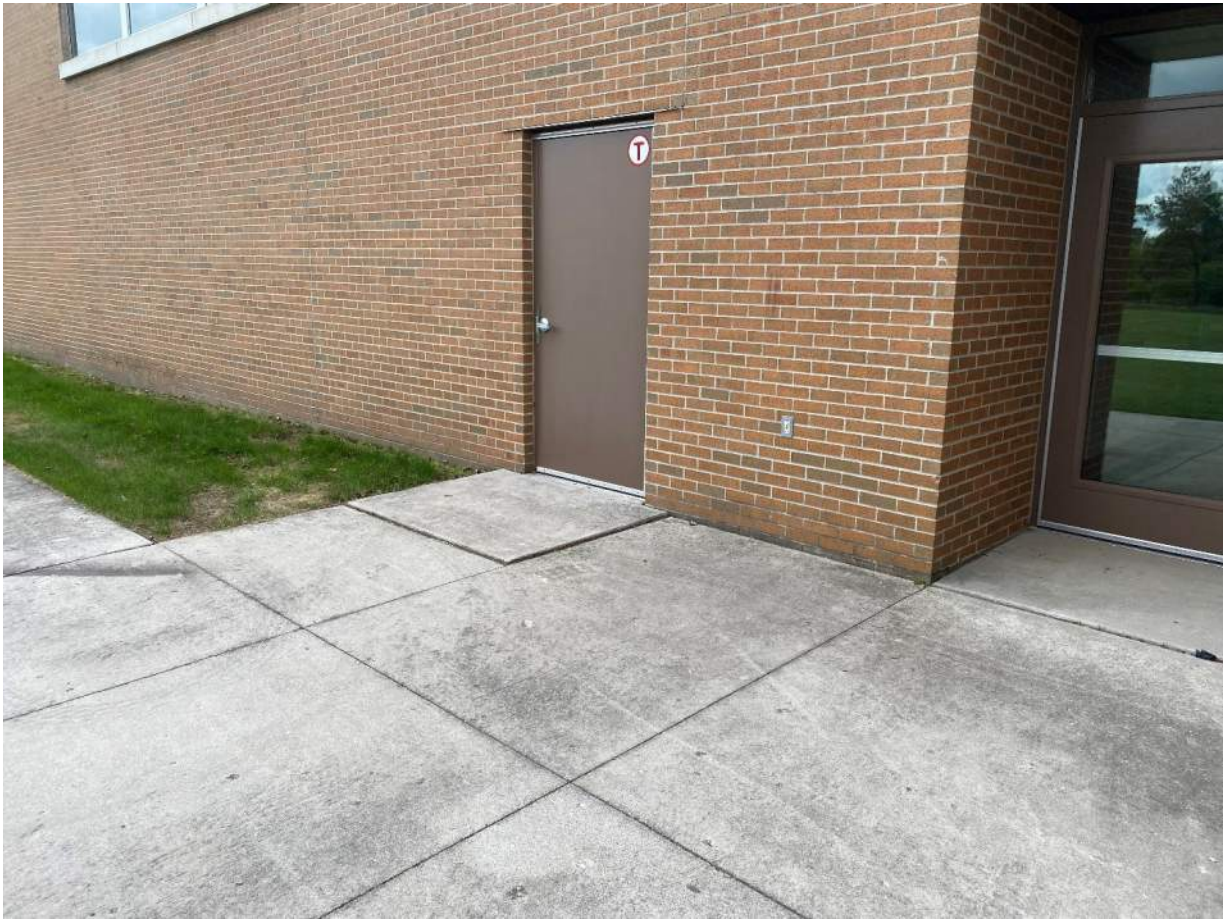
Figure 20: Worn sidewalk and stoop height higher than surrounding pavement on north side of school

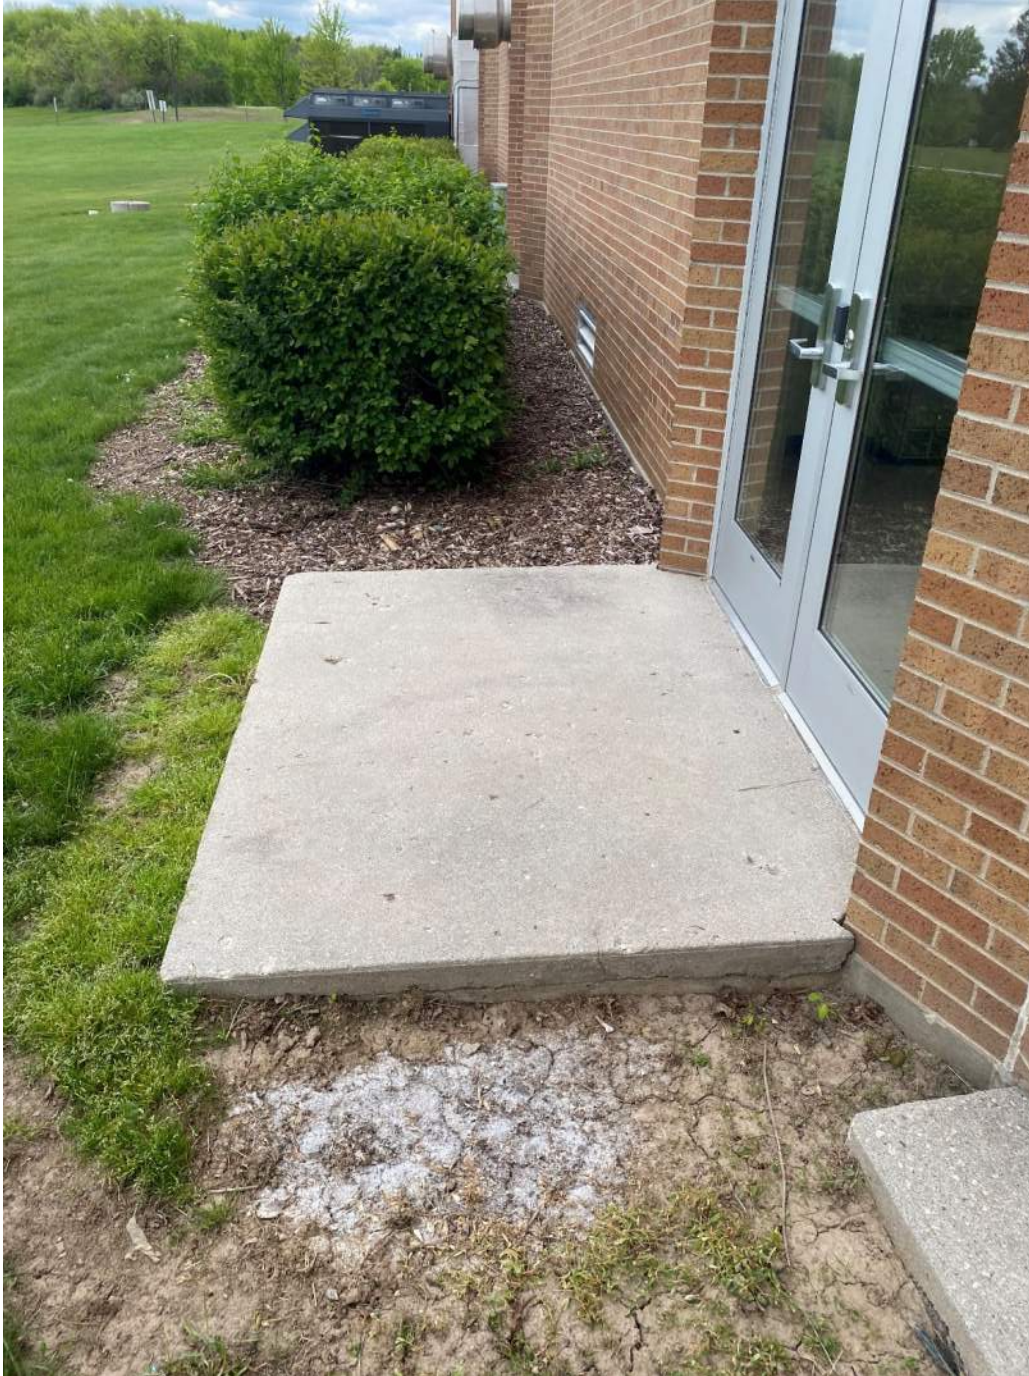
Figure 21: Door landings on east side of building

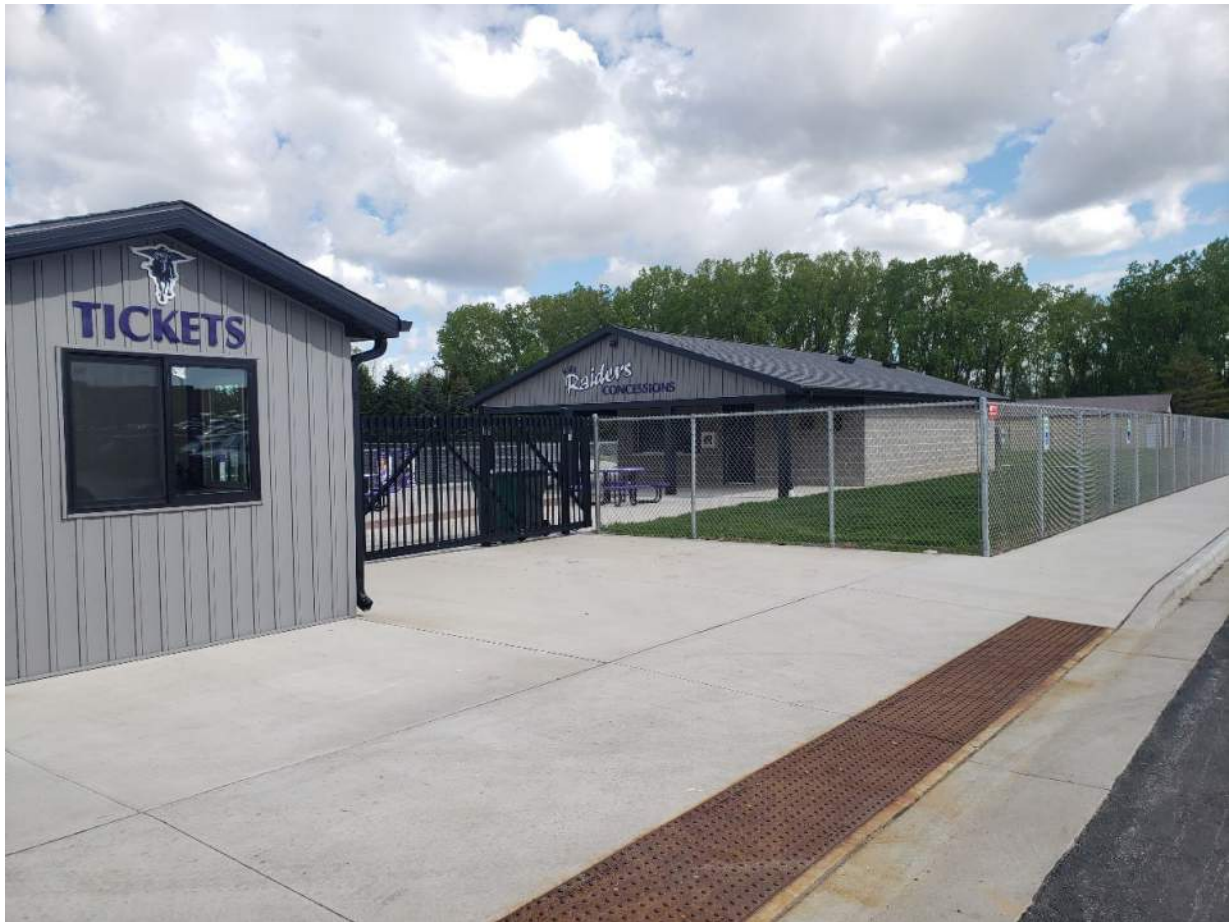
The running track, football field, adjoining fencing, bleachers and concrete sidewalk areas are in excellent condition due to being built in 2019 (Figure 23 & 24). The truncated dome near the entrance is rusted (Figure 22).

Figure 22: Rusted truncated dome in entrance to running track.

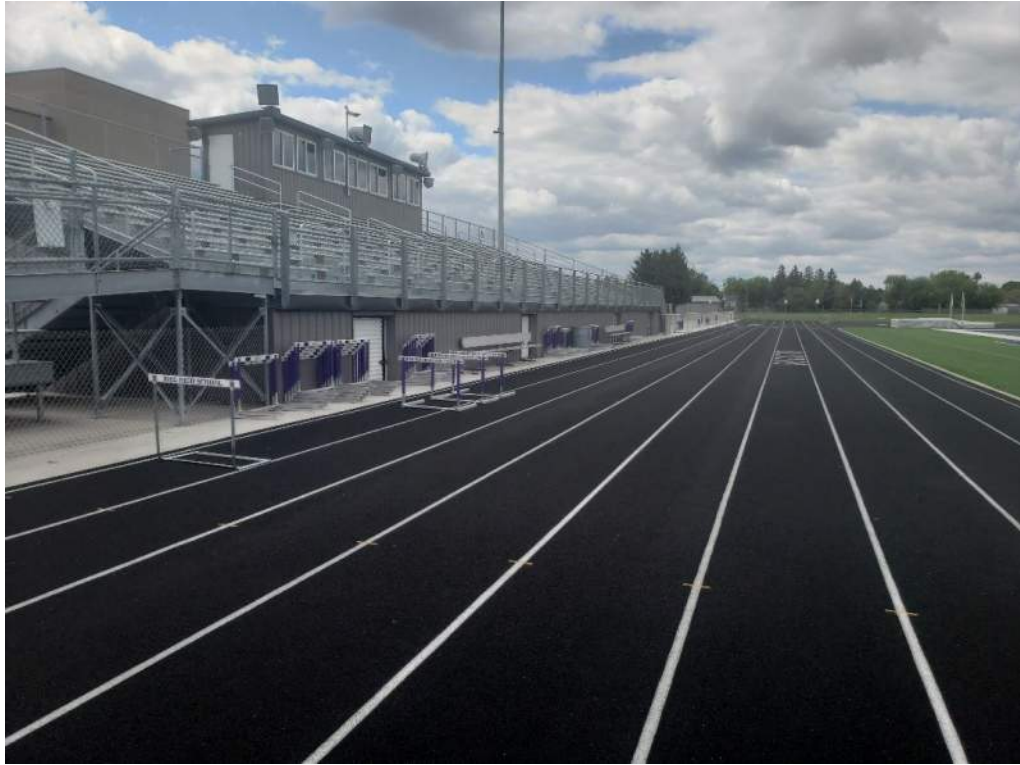
Figure 23: Running track in excellent condition.

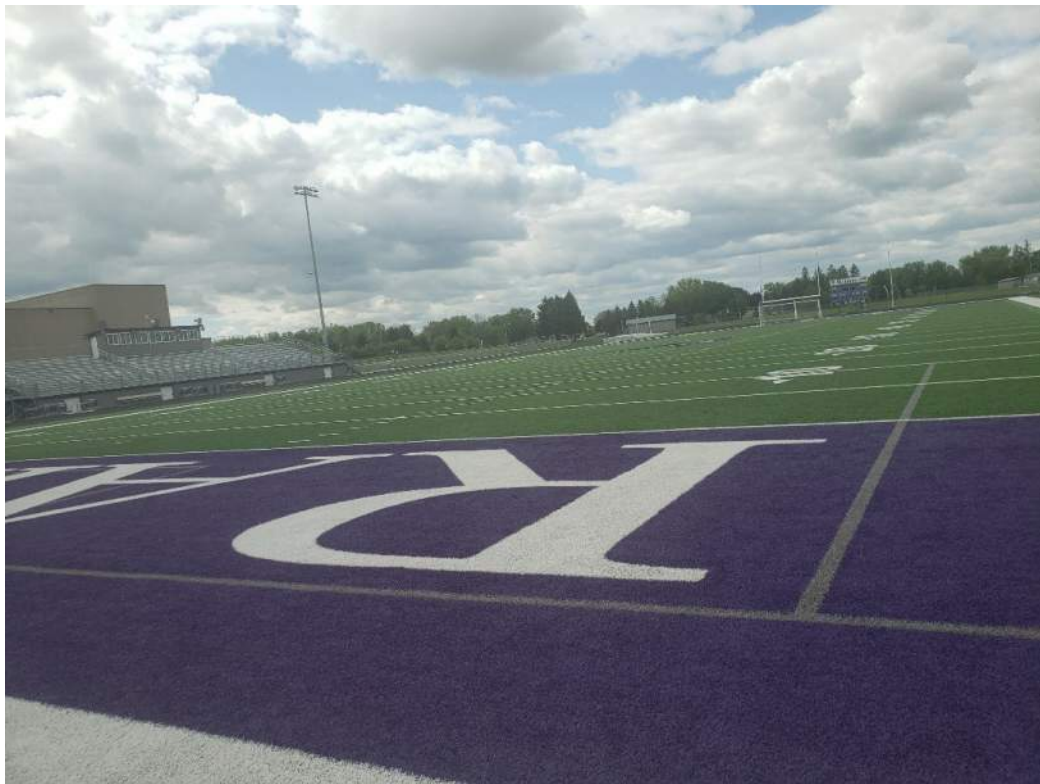
Figure 24: Artificial turf football field in excellent condition.
