Facilities Study Document | Kiel School District, Zielanis Elementary School

Building Systems Summary Checklist

Completed by: Alex Feudner and Ben Nerat, MSA Professional Services

Date of Walk-through: 05/18/2022

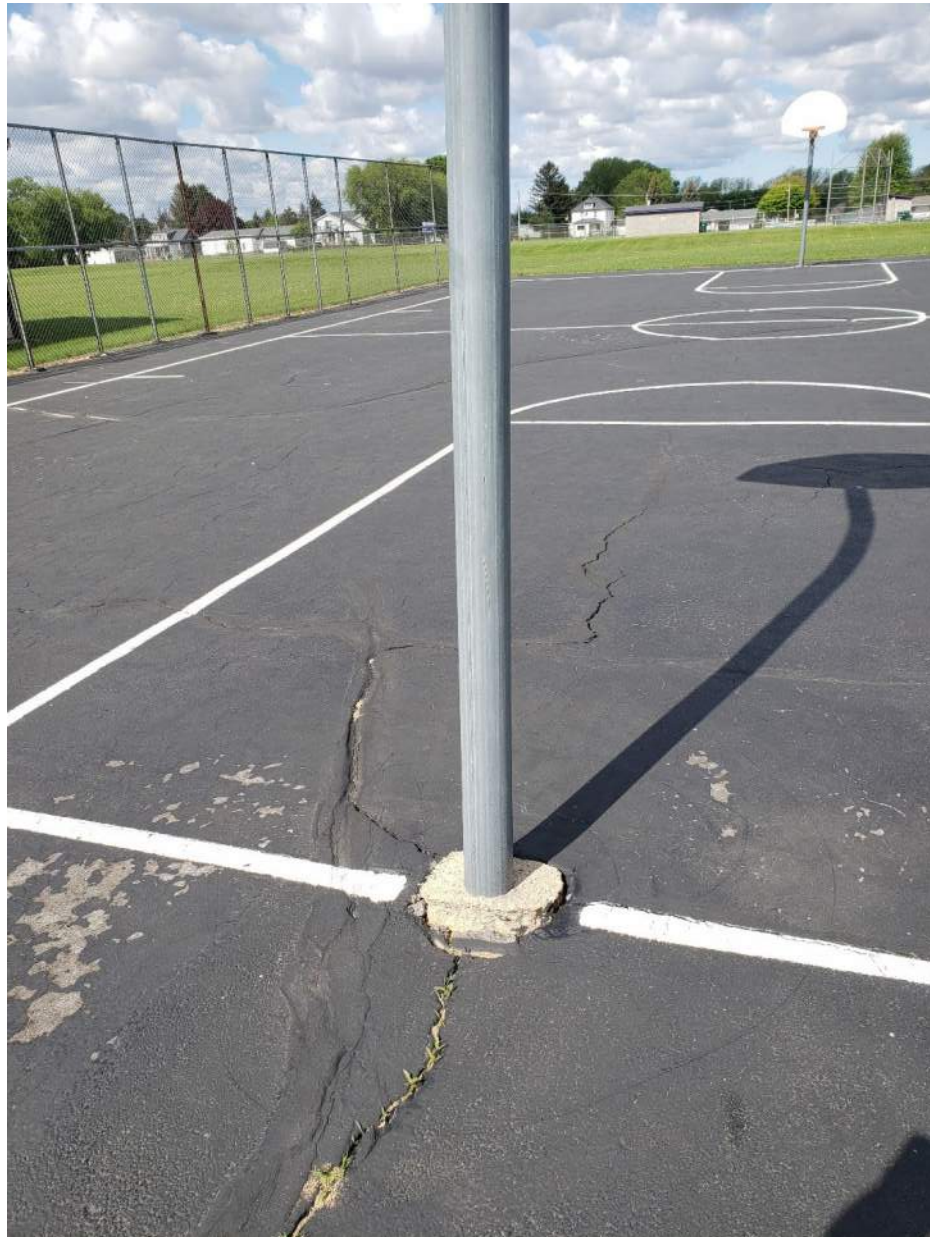
The two asphalt basketball courts are in fair condition. The pavement has large transverse and longitudinal cracking. Some of those cracks have been filled with crack sealant. The whole court is seal coated, but there are areas where the sealant is missing and cracking (Figure 25). The base of all basketball hoop posts shows some cracking. The shed area is newer and in good condition. The pavement markings are in fair condition and have some flakes of paint missing. However, the paint that is there is not very faded (Figure 25).

Figure 25: Basketball court with alligator and transverse cracking

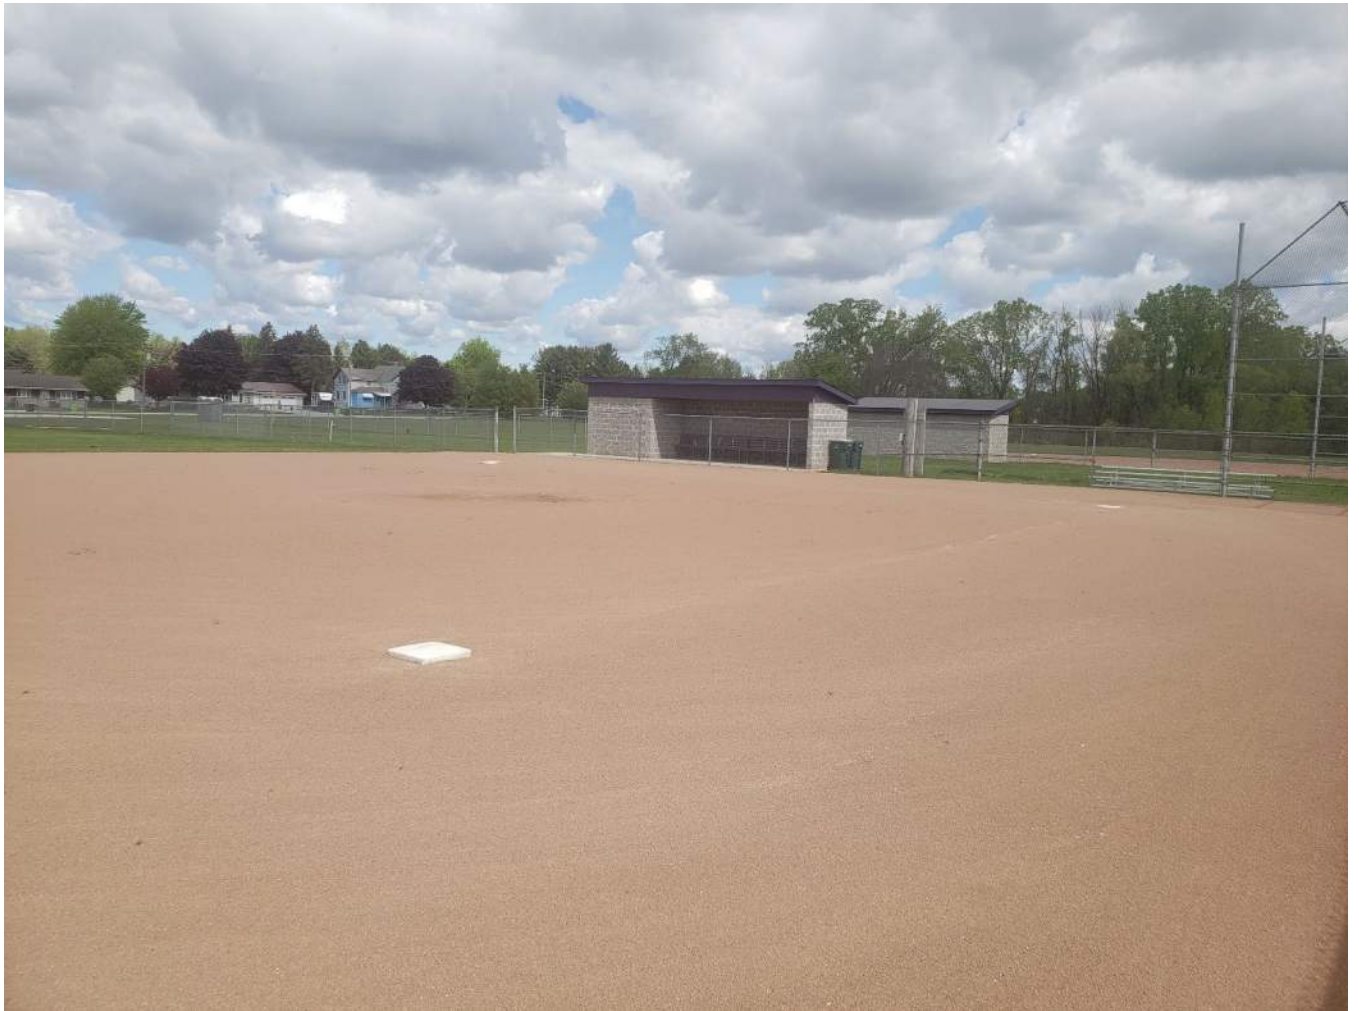
The two practice baseball fields consist of fields, fencing, dugouts and standalone metal bleachers. The fields are in good condition and appear well groomed (Figure 26). The dugouts appear to be newer, and the concrete pads are in good condition. There is a water fountain between the two fields that is in poor condition, due to it being anchored to a tilted board (Figure 27). The fencing requires some maintenance due to rusting posts, unravelling at the bottom, and tilting (Figure 28).

Figure 26: Practice baseball field in good condition.

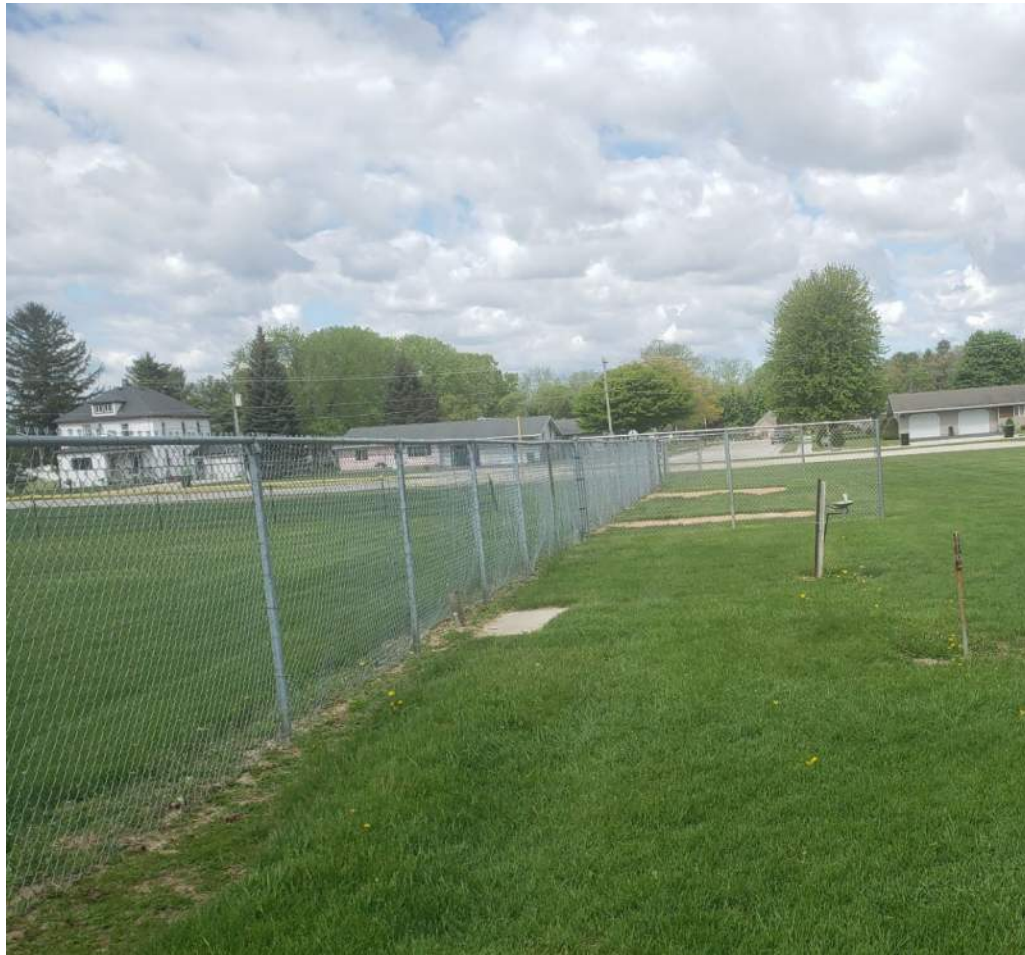
Figure 28: Fencing unraveling at bottom and unattached from posts.

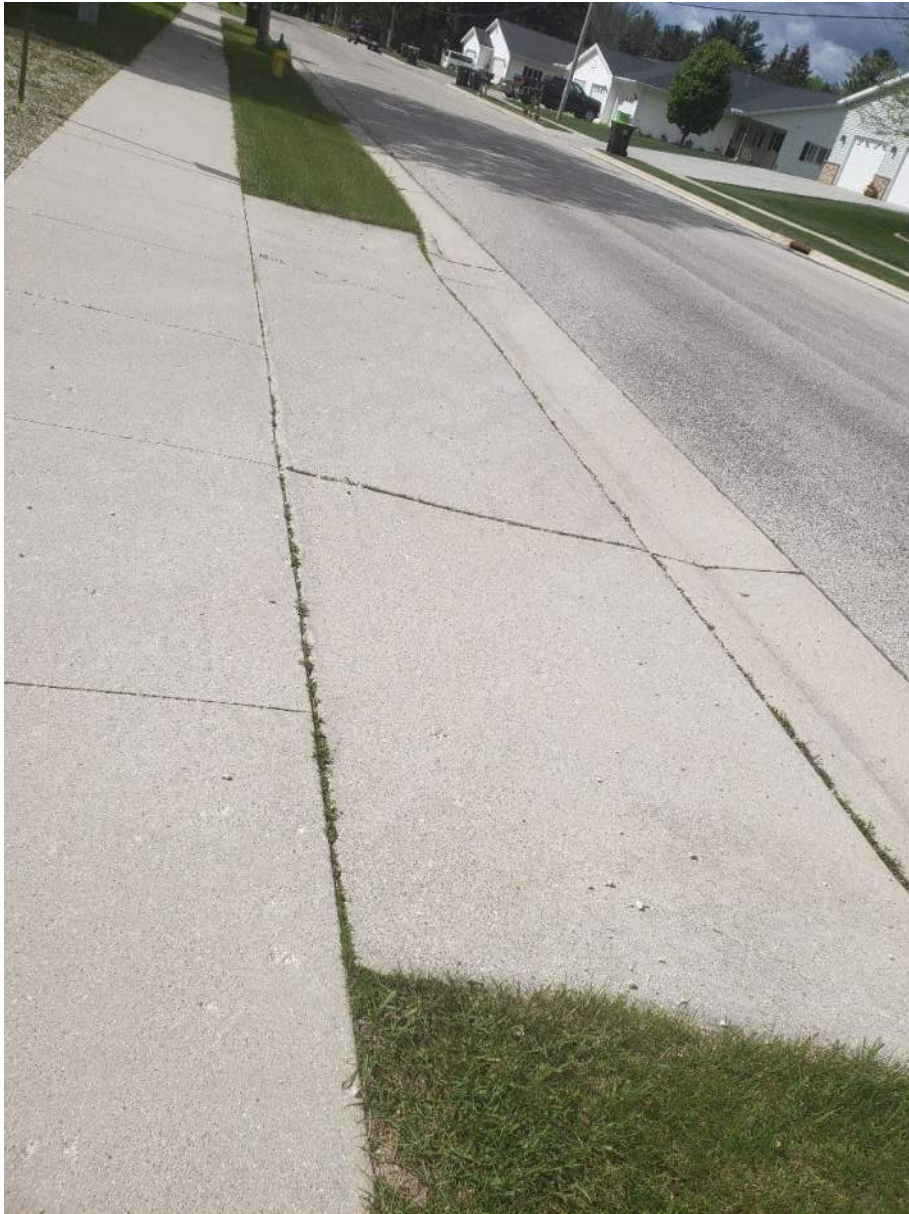
The gravel parking lot, sidewalks off 6th street and driveway apron are in good condition. There does not appear to be any rutting or depressions in the gravel lot (Figure 30). However, there is some green growth creeping into the lot. The concrete driveway and sidewalk are in good condition with some small pieces chipped off on the surface (Figure 29). There are no cracks.

Figure 29: Driveway apron in good condition.

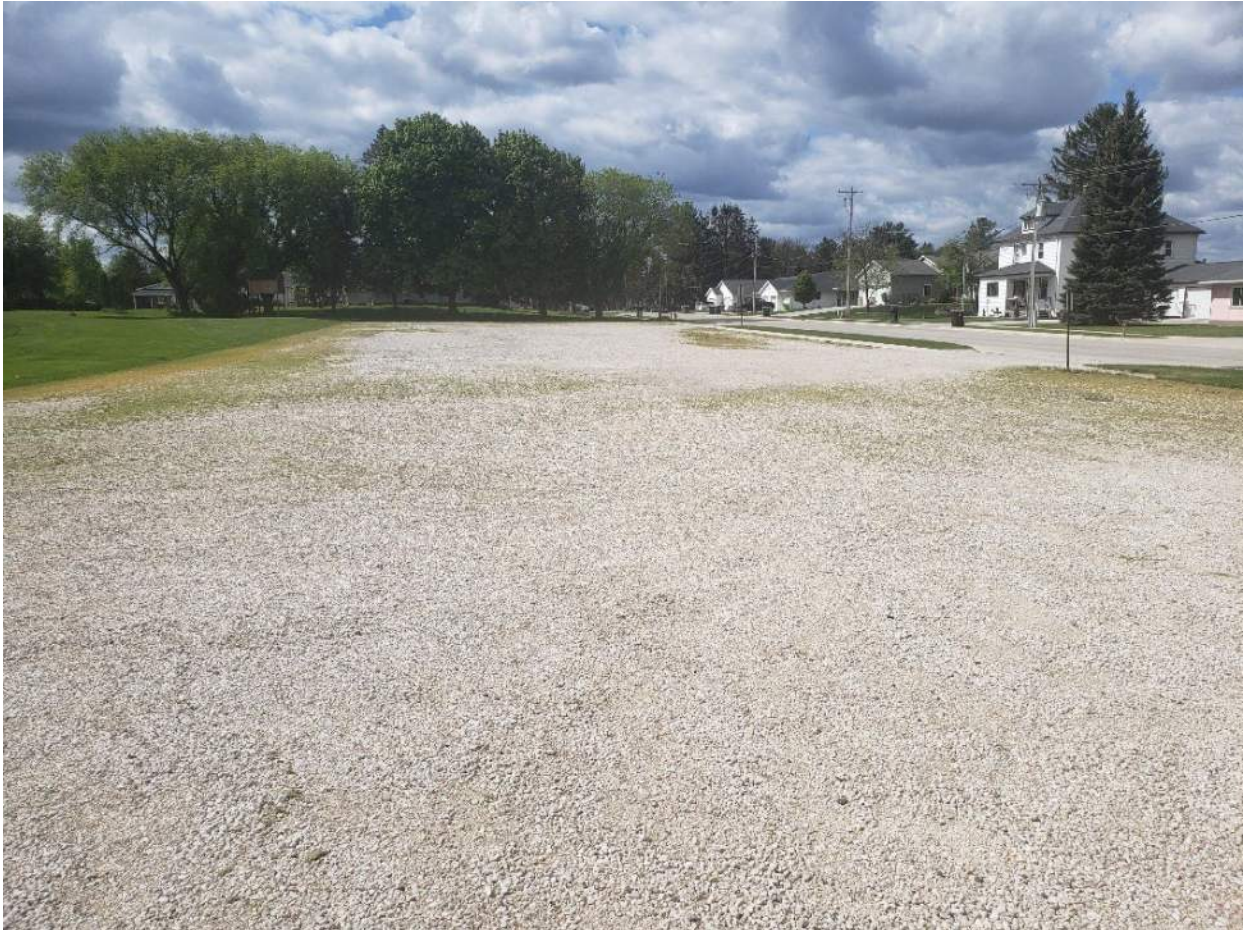
Figure 30: Gravel parking lot on South in good condition despite green growth.

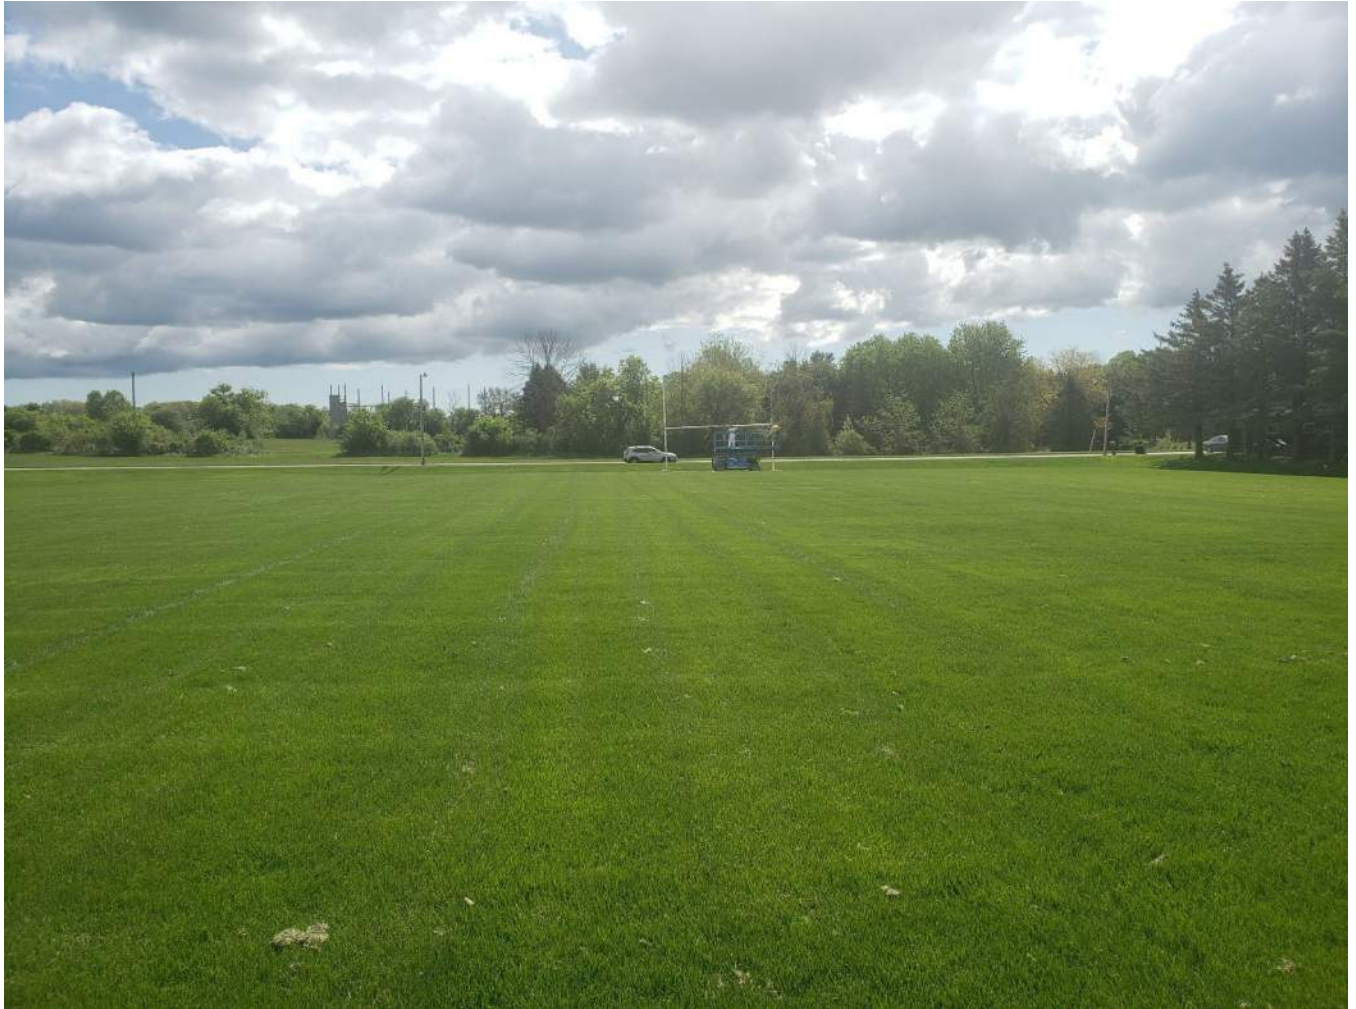
The grass football field is in excellent condition. The grass is well maintained and there were no dead areas (Figure 35). The field appeared flat with no bumps or ruts. The goal posts looked older and had some paint missing, but there was maintenance work being completed on them the day of the site visit.

Figure 35: Practice Football Field in good condition

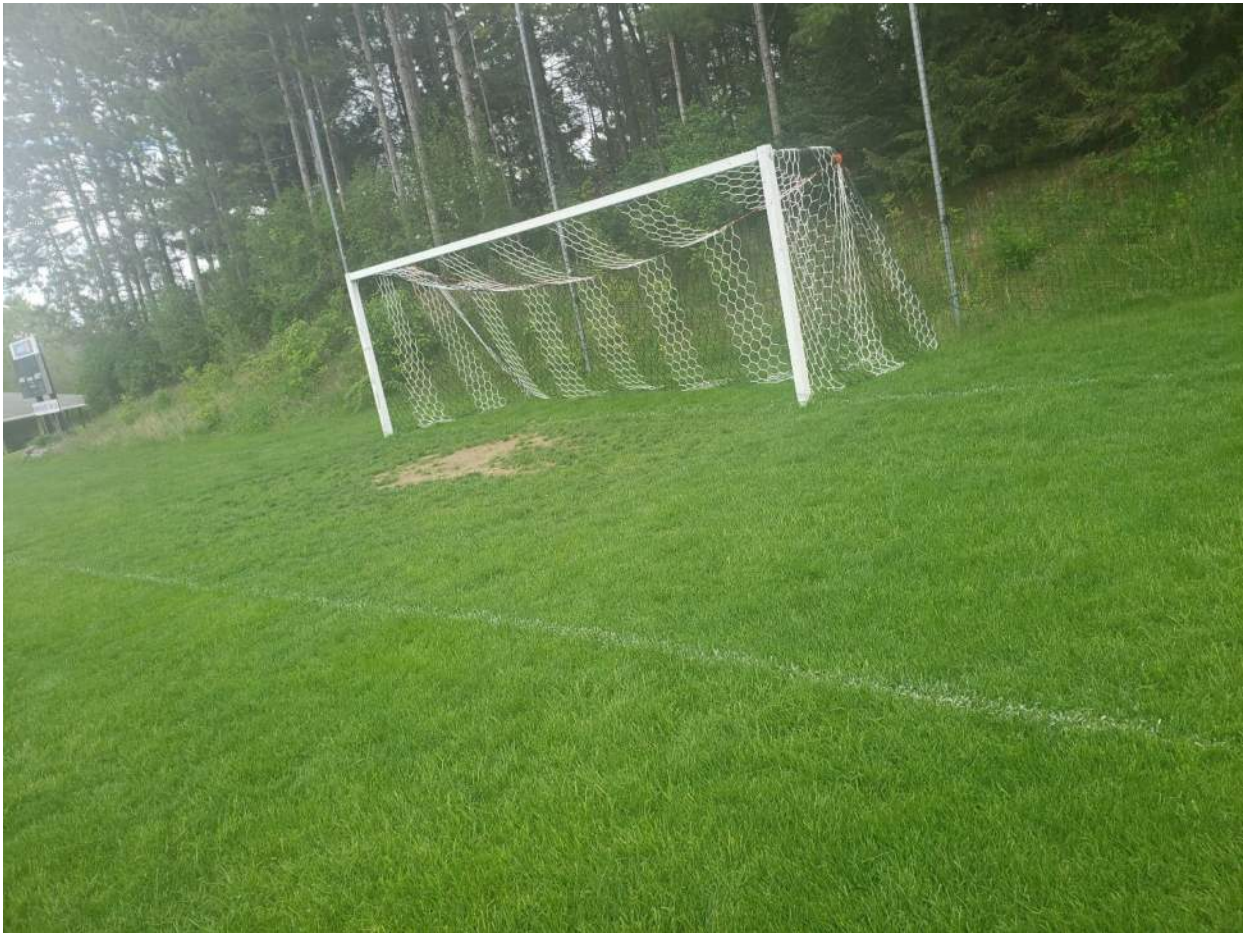
The Soccer Field consists of the field, three covered bleacher areas for players and a bleacher area for spectators. The field was in good to fair condition due to some dead patches of grass (Figure 36). The field appeared flat with no uneven areas. The bleachers were in good condition.

Figure 36: Dead grass in soccer field

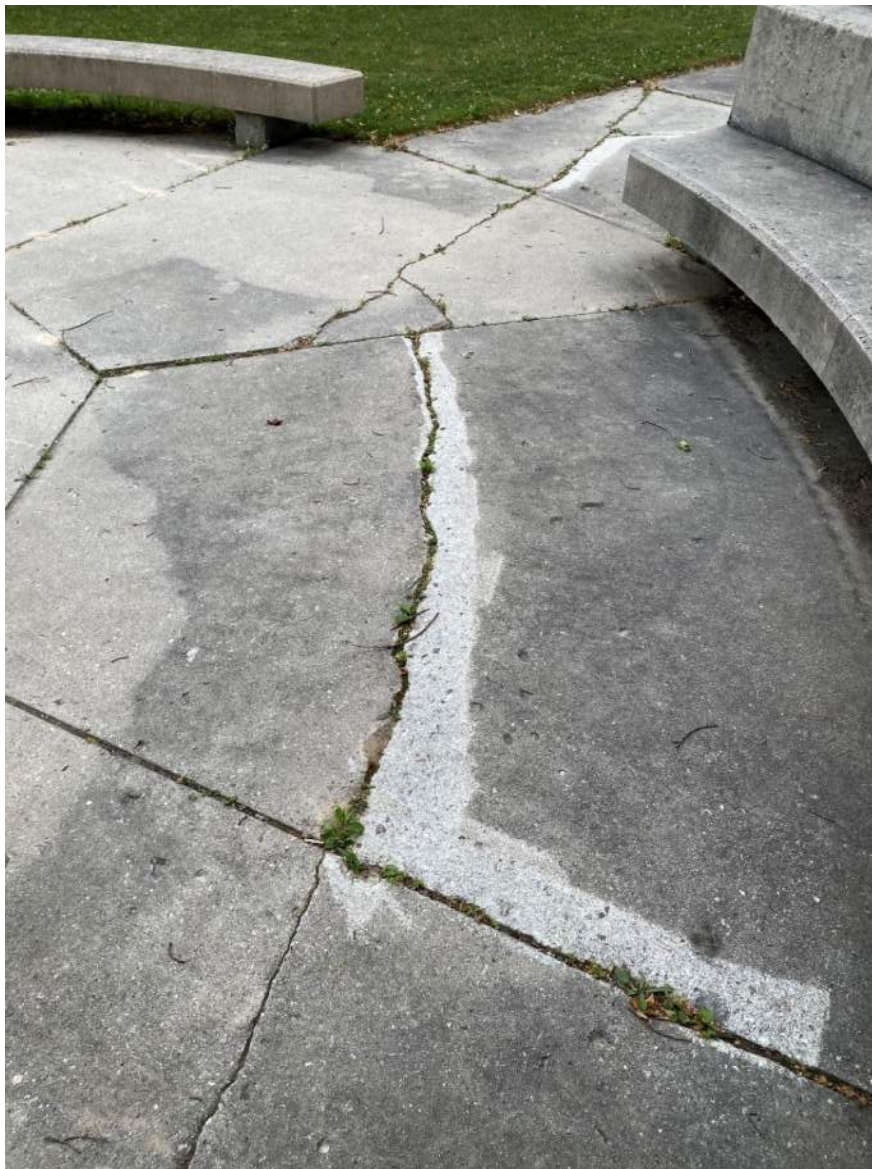
Figure 39: Cracking and settling concrete in courtyard.

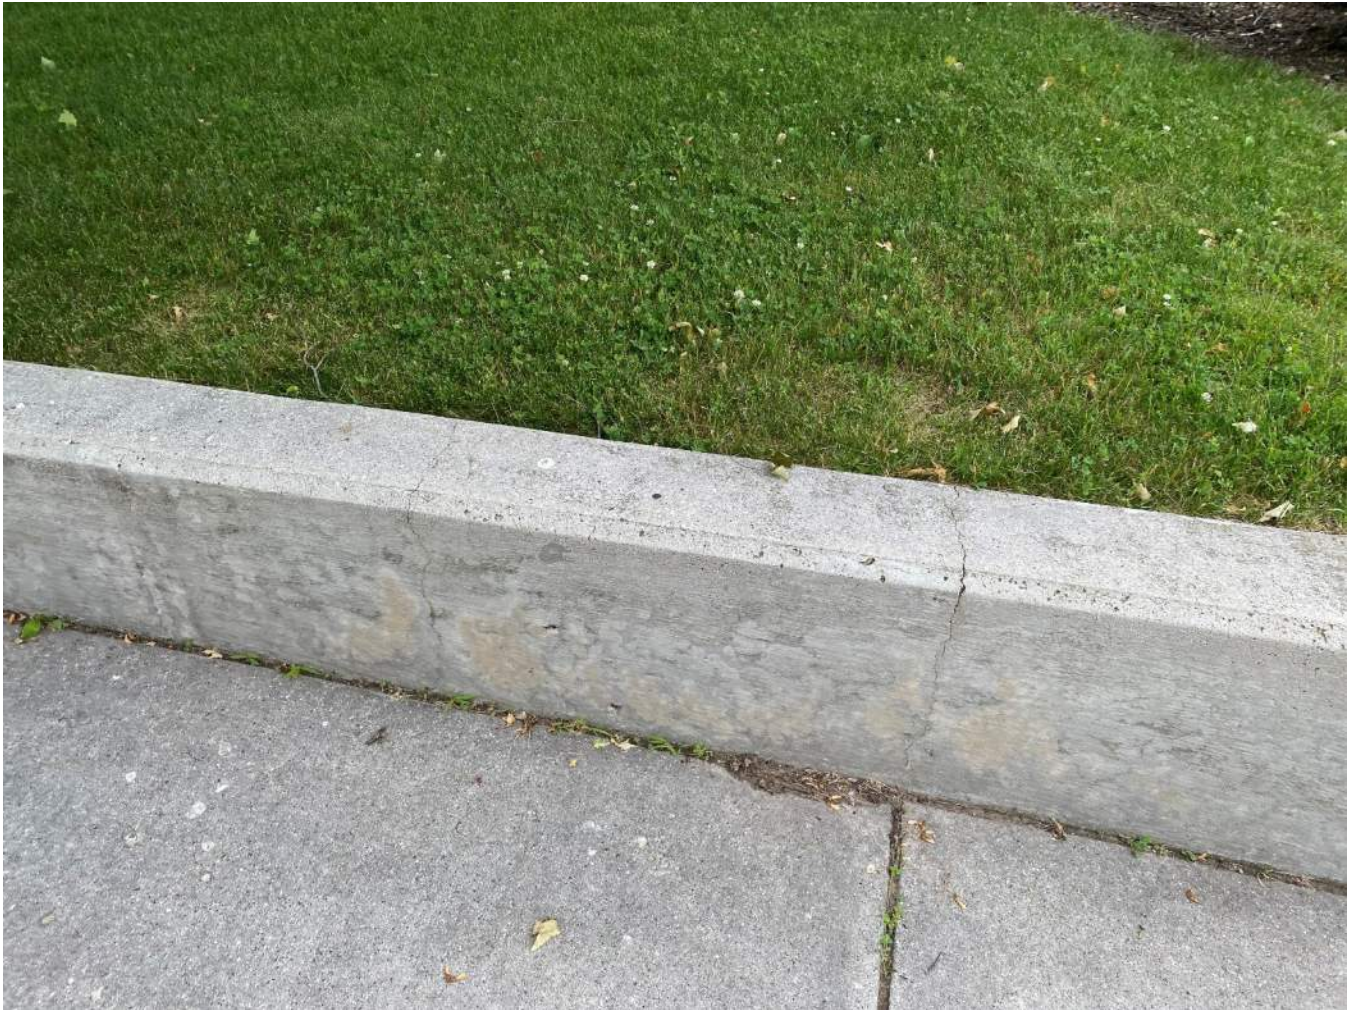
Figure 40: Cracking in concrete retaining wall in courtyard.

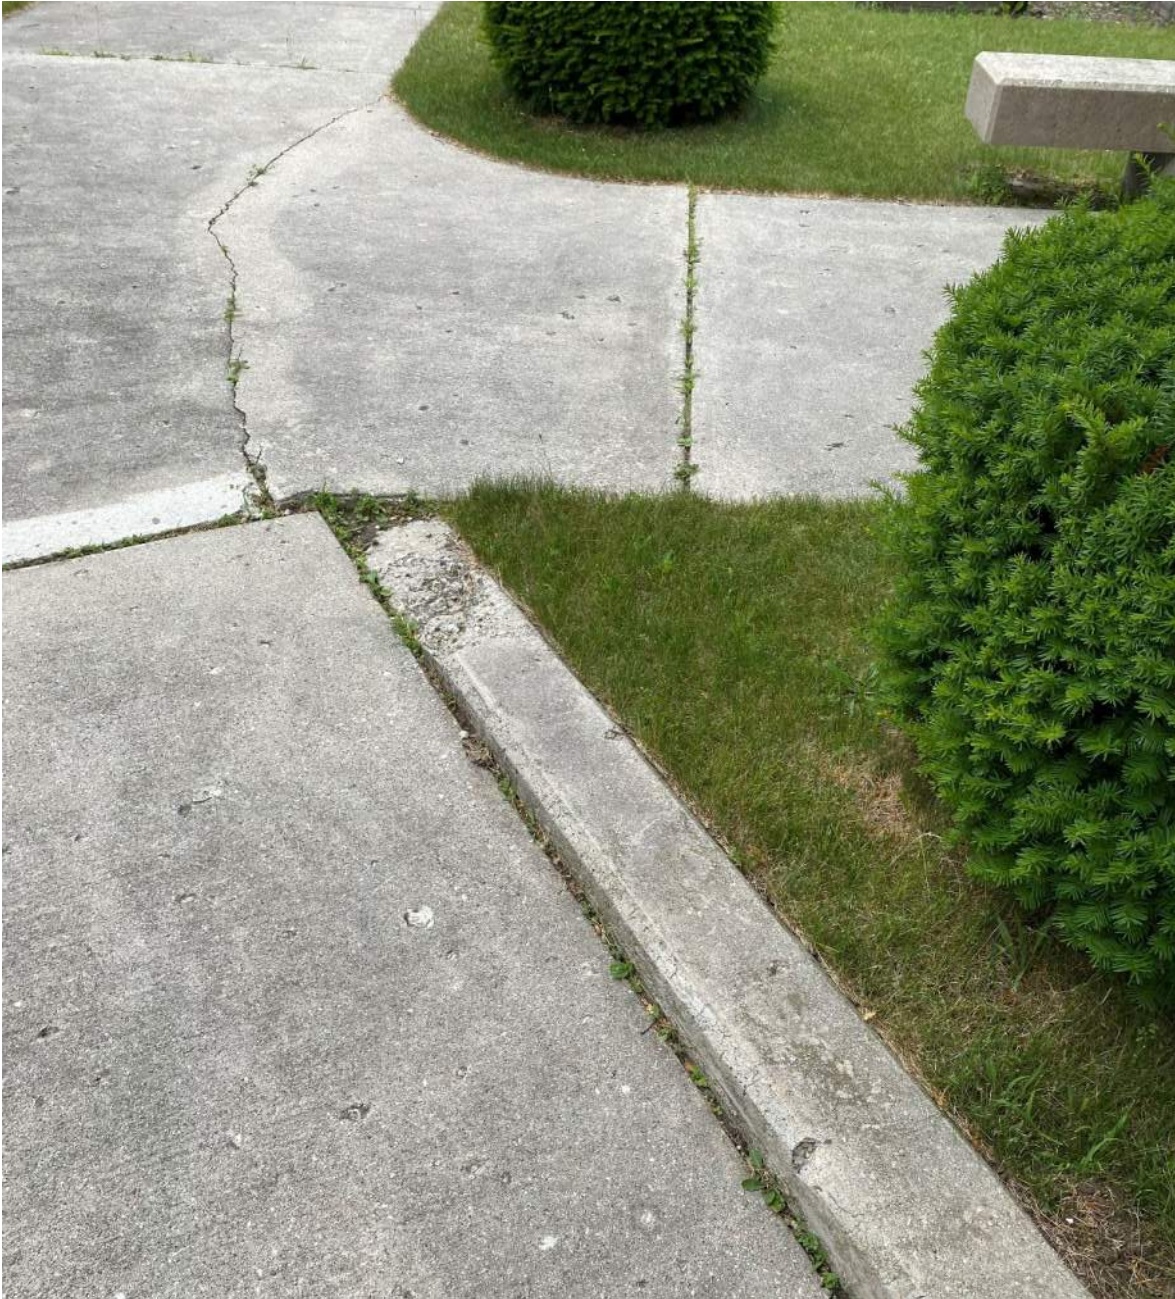
Figure 41: Cracking in sidewalk and deteriorating concrete retaining wall in courtyard.

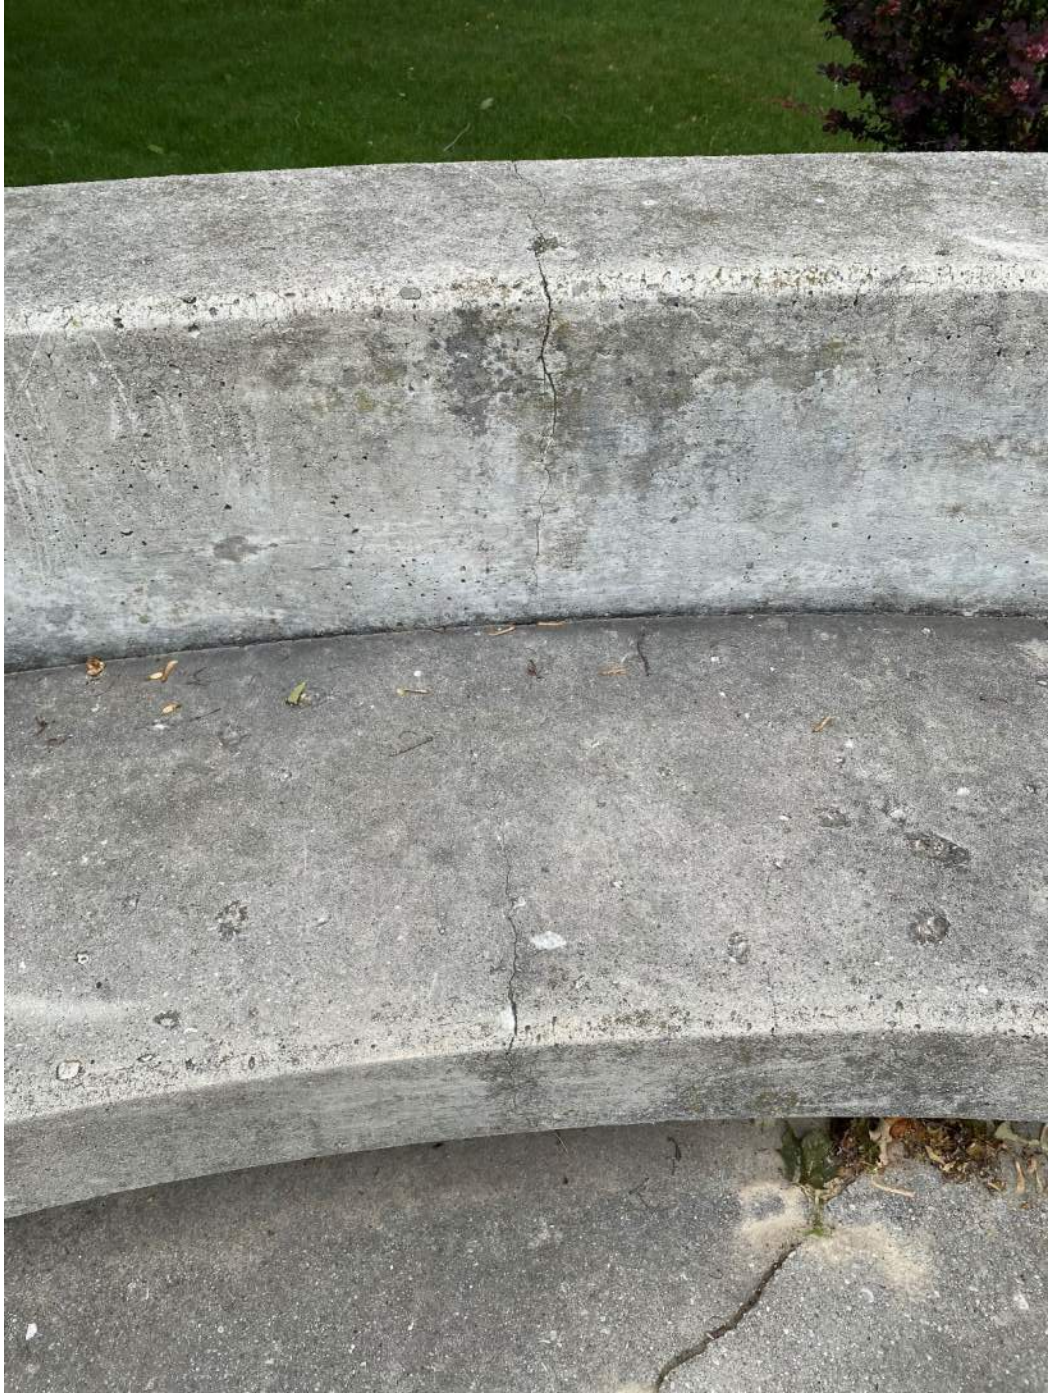
Figure 42: Cracking in circular concrete bench in center of courtyard.

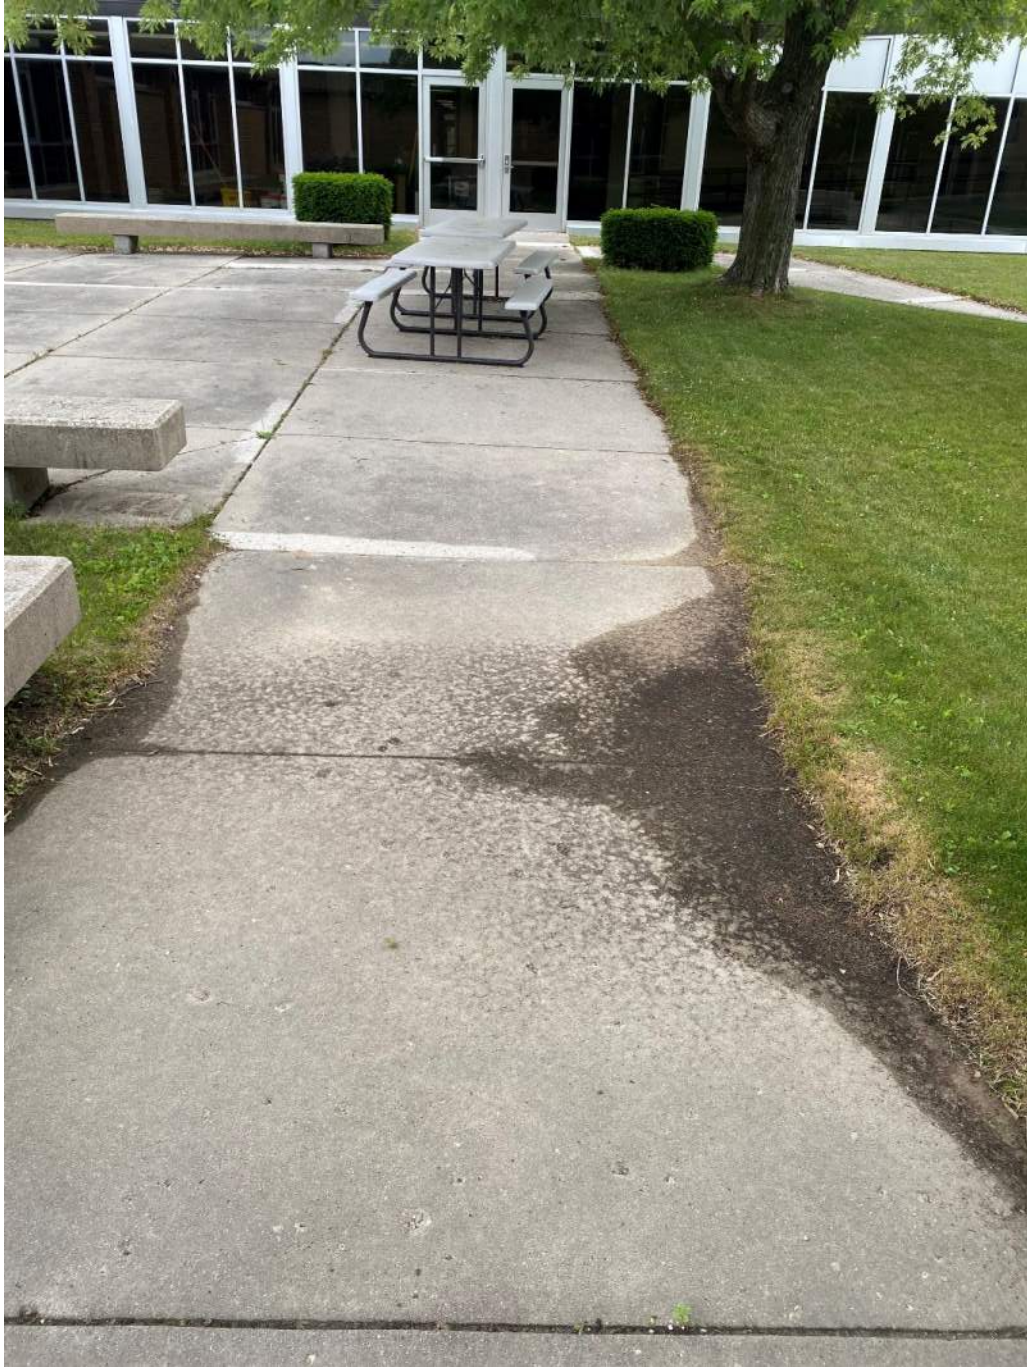
Figure 43: Accumulation of soil due to settling pavement in courtyard.
