Facilities Study Document | Kiel School District, Zielanis Elementary School

Building Systems Summary Checklist

Completed by: Alex Feudner and Ben Nerat, MSA Professional Services

Date of Walk-through: 05/18/2022

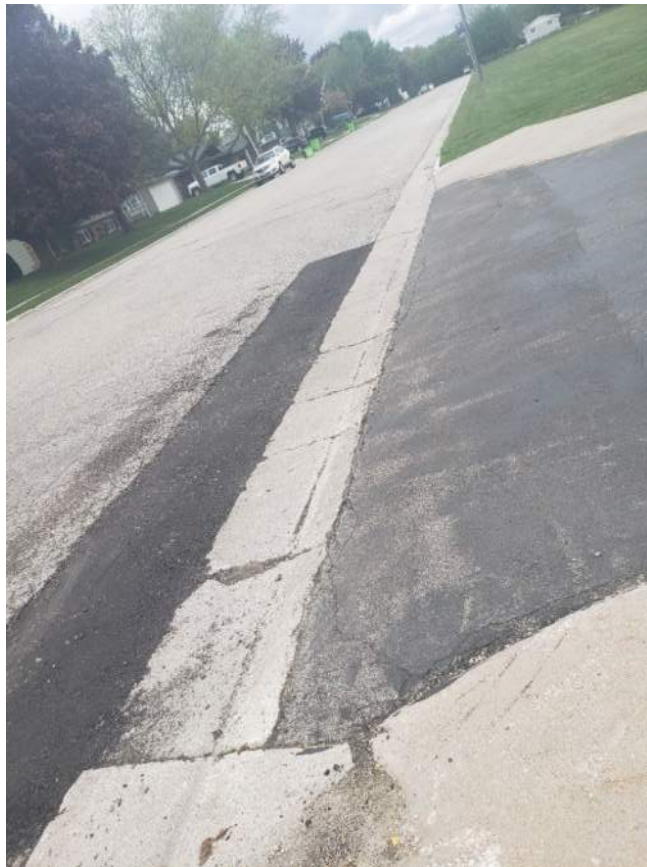
The West Parking Lot consists of two asphalt driveways, an asphalt parking lot and concrete sidewalk. The asphalt is in poor condition. Both asphalt driveway aprons have edge cracking on all edges (*Figure 2*), as well as cracking in the concrete gutter. The north end of the parking lot has an area that is settling causing alligator and block cracking (*Figure 3*). The pavement has longitudinal and transverse cracking in several areas and some edge cracking. The surface has large areas covered in crack sealant, and many of the sealed cracks are expanding (*Figure 4*). The sidewalk is severely cracked and uneven in multiple areas and is in poor condition (*Figure 5*). The concrete curb and gutter throughout the lot is extremely worn and many pieces of concrete are breaking off (*Figure 6*). It is in poor condition. The pavement markings are also in poor condition and are chipped and fading.

Figure 2: NW Driveway apron in fair condition.

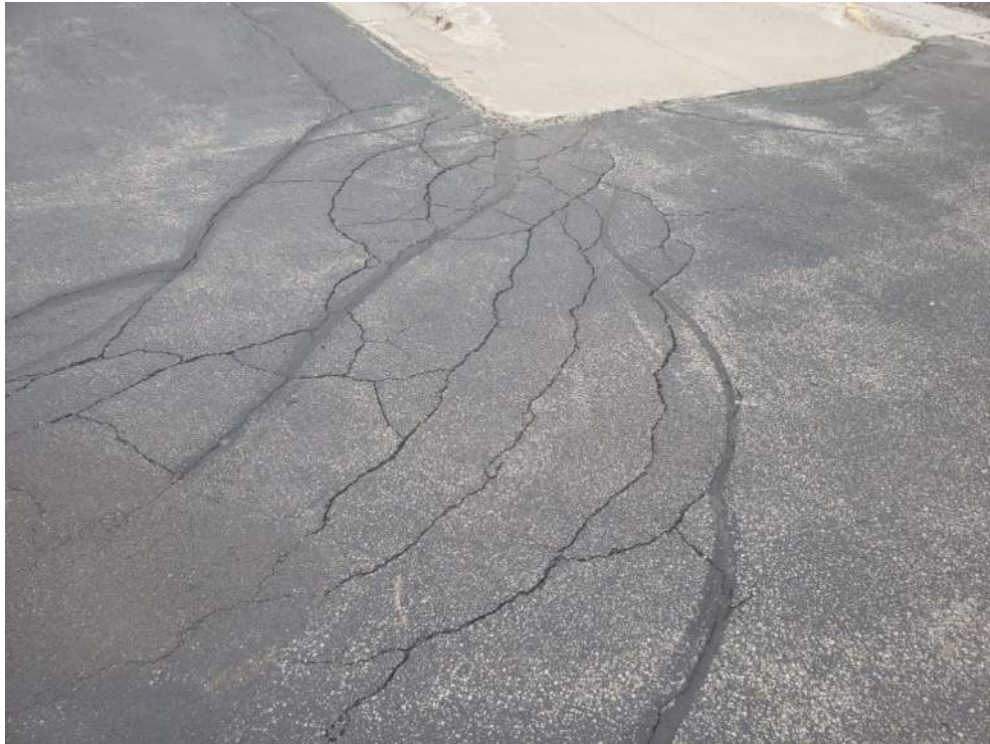
Figure 3: Cracked pavement on the North portion of West parking lot.

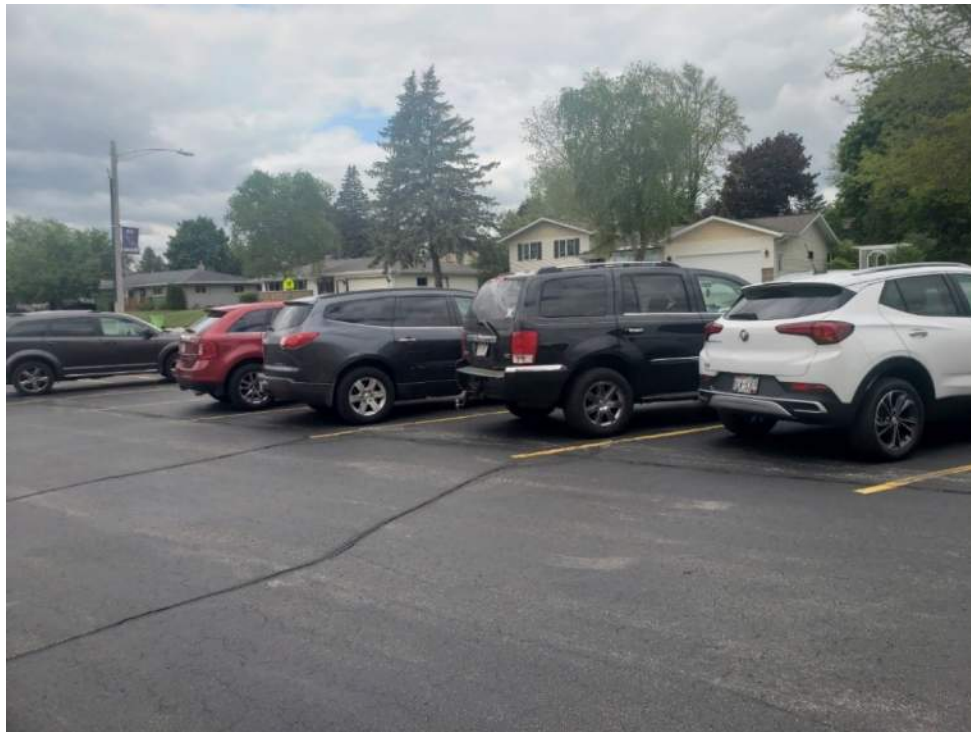
Figure 4: Transverse crack in West parking lot.

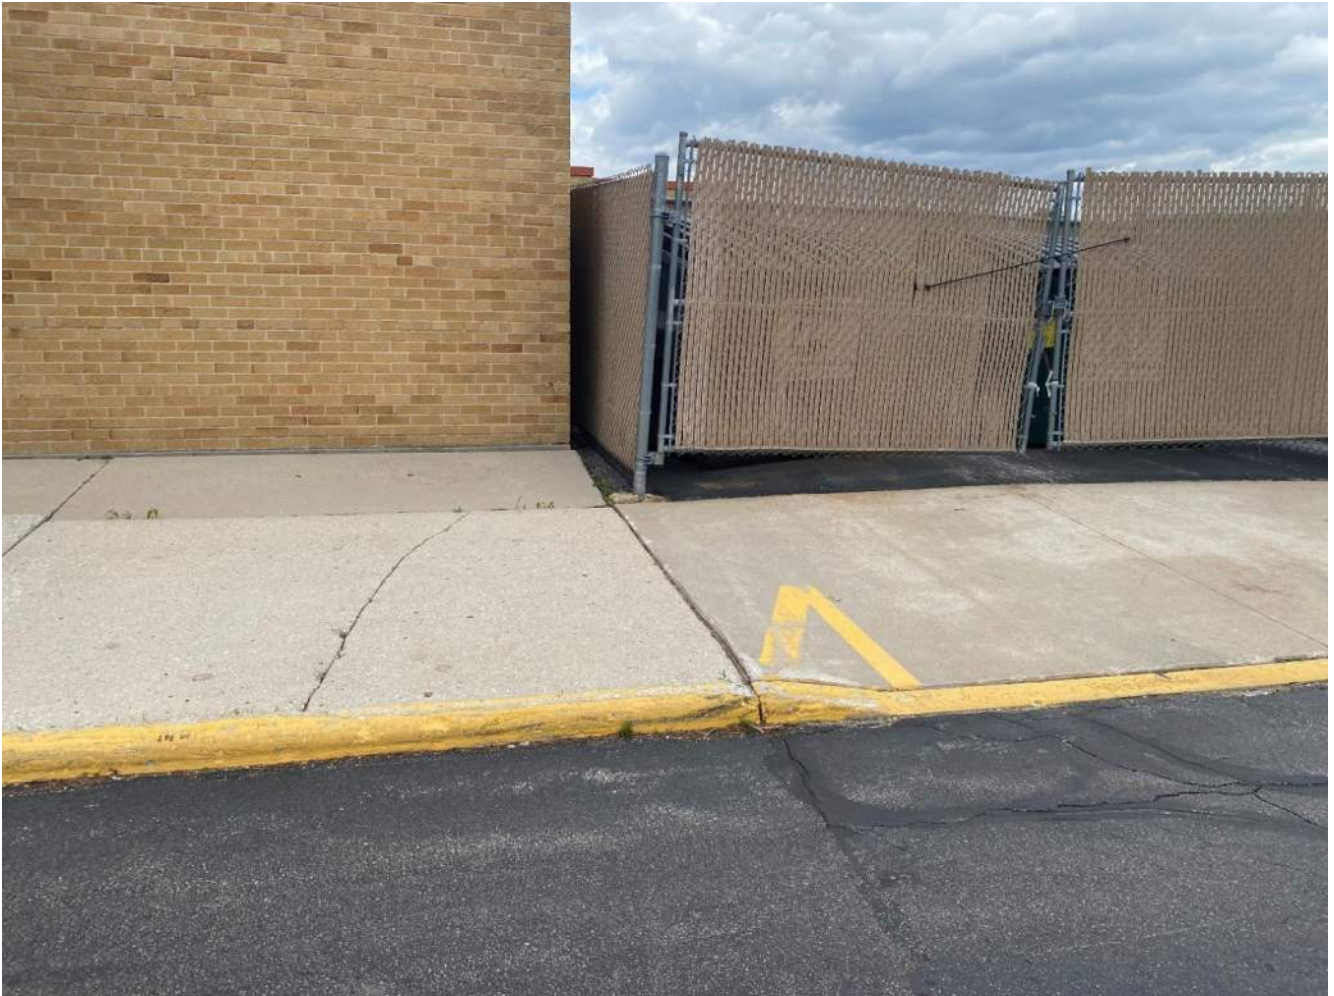
The South Parking Lot consists of an asphalt parking lot and drive loop, and sidewalk on the north, east and west sides. The asphalt driveway aprons at entry and exit, and the concrete driveway gutters are in poor condition (*Figure 7*). There are several areas of severe alligator cracking throughout the lot (*Figure 8*). There appears to be settlement in many areas causing additional cracking such as longitudinal, transverse and block (*Figure 9*). The sidewalks appear very worn but are in fair condition with some areas of cracking concrete (*Figure 10*). The concrete curb is in poor condition throughout due to gaps between sections and pieces of concrete broken off (*Figure 11*). The trash enclosure gate on the north-east portion of the south parking lot is uneven (*Figure 12*).

Figure 12: Trash enclosure near north-east corner of south parking lot

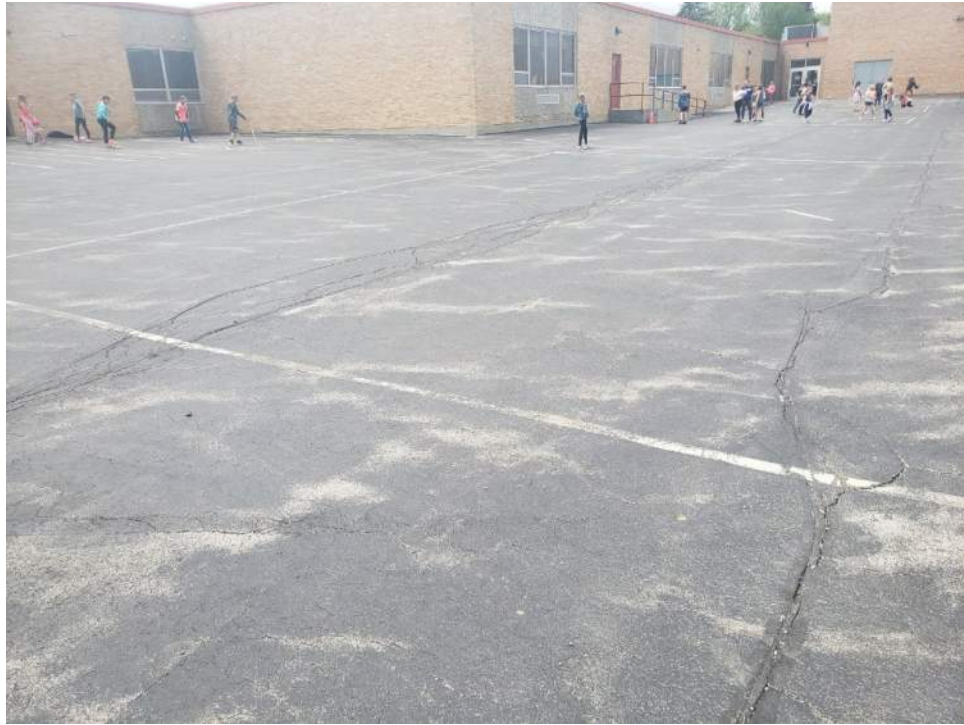
Figure 18: Longitudinal cracking and settling in the north play area

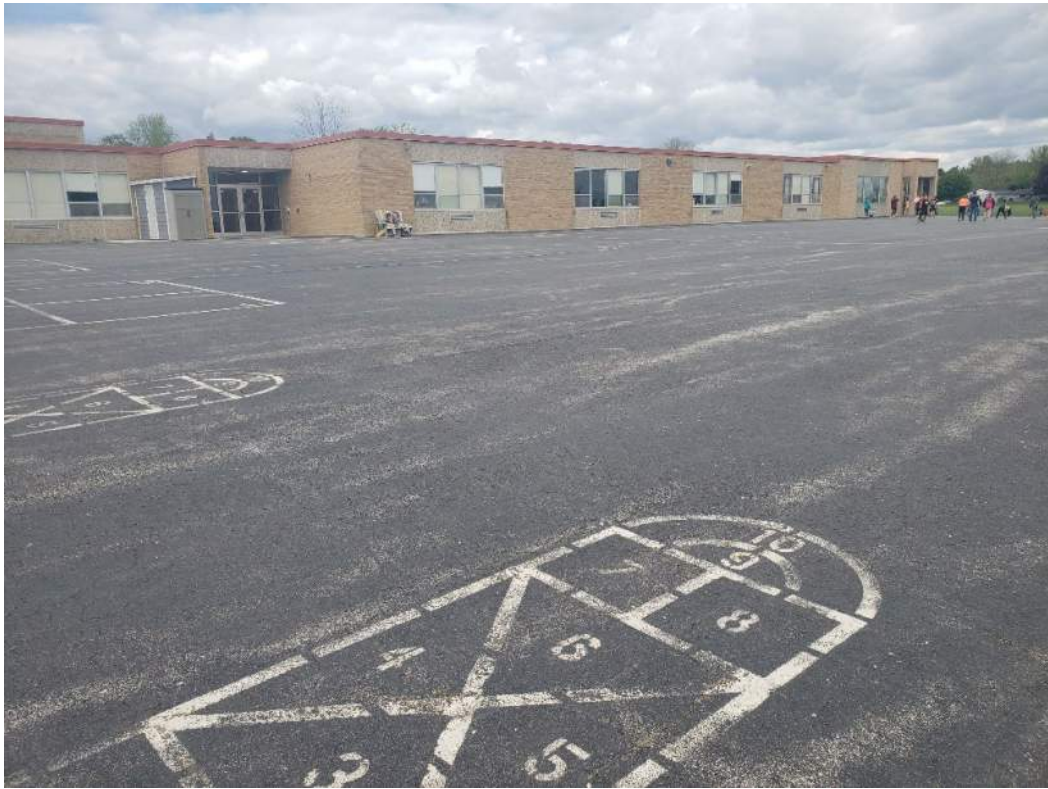
Figure 19: Fading play area markings

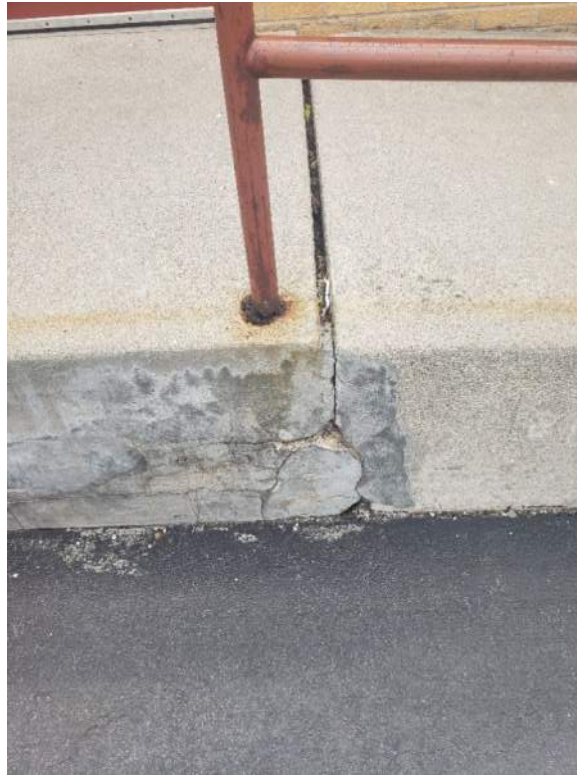
Figure 20: Severe cracking in several areas on the north ramps for existing building doors

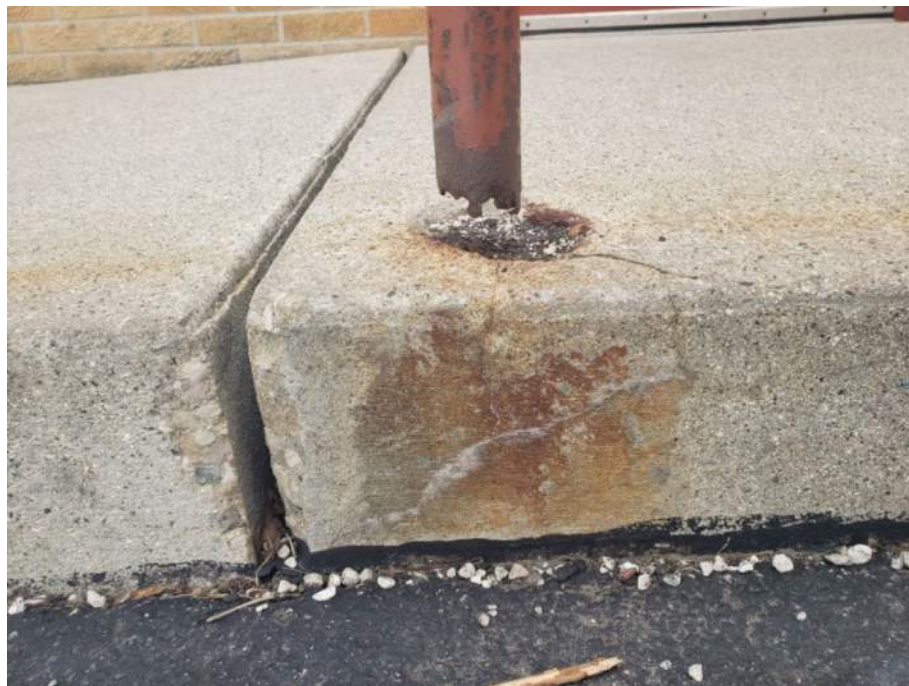
The North Play Yard consists of an asphalt play area, ball field with fencing and a covered picnic table pad. The concrete seating area extending off the north-west corner of the building has some chipped edges (*Figure 13*). The ball field is poorly maintained and covered with weeds (*Figure 14*). The ball field fencing needs to be repaired/replaced due to a wire hanging off the bottom (*Figure 15*). The existing asphalt swale on the north-east portion of the yard is deteriorated and in very poor condition (*Figure 16*). The picnic table pad is in good condition with no cracking present (*Figure 17*). The north portion of the asphalt play yard is in poor condition with longitudinal cracking and settling towards the middle (*Figure 18*). The pavement markings are fading in the asphalt play yard (*Figure 19*). The concrete ramps on the north portion of the building are in very poor condition with severe cracking (*Figure 20*). The metal railings on the ramp are rusting and becoming completely separated from the concrete ramp. This is causing sharp edges to be exposed near the base (*Figure 21*).

Figure 21: Rusted railing with exposed sharp base on ramps

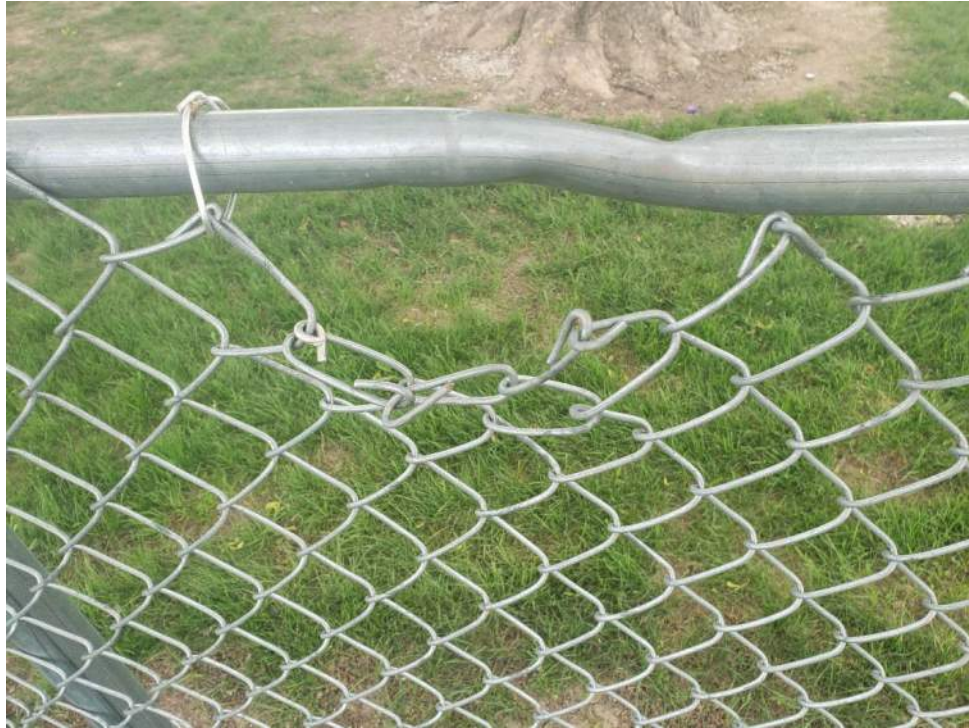
Figure 23: Broken links in the fencing that must be repaired/replaced

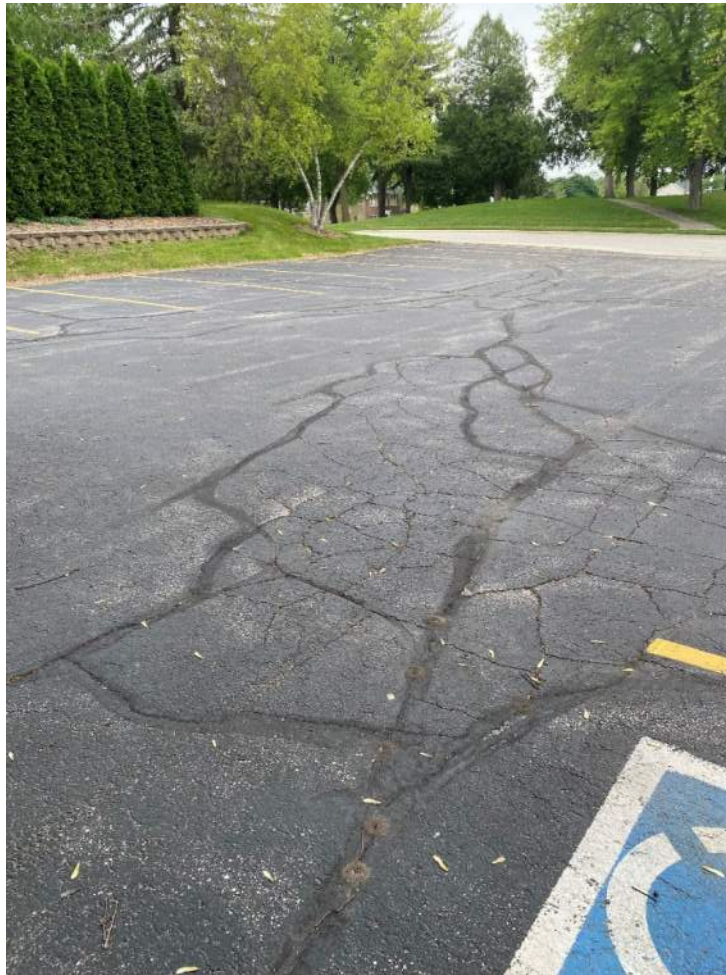
The southeast parking lot includes 17 regular stalls and 1 ADA stall. The stalls are all marked with pavement markings and the accessible stall also has a sign denoting it. There are transverse and longitudinal cracks in the parking lot. While many have been sealed some of the sealed cracks are expanding. There are also areas of block cracking that have not been sealed (Figure 2). These could turn into alligator cracking or potholes if left untreated. There is some settling occurring throughout the lot too, as there are discolored circles which indicate sitting water (Figure 3). The pavement markings are beginning to rub off in certain areas but are still visible. Overall, the condition of the southeast parking lot is fair to poor.

Figure 2: Block, transverse, and longitudinal cracks in southeast parking lot.

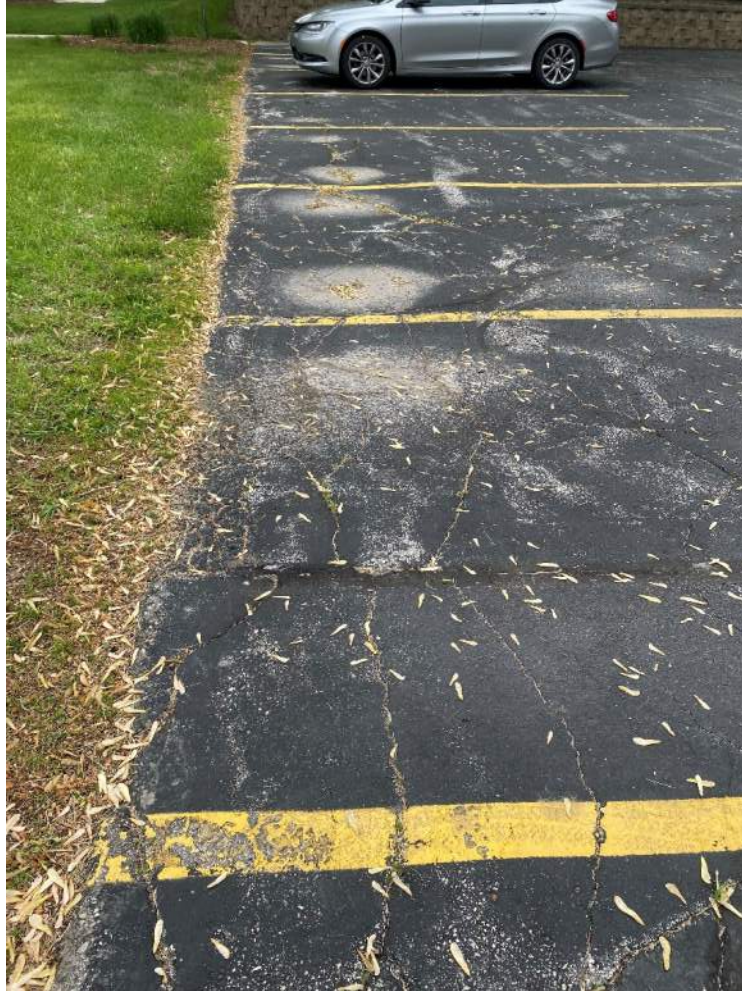
Figure 3: Pavement settling occurring in southeast parking lot.

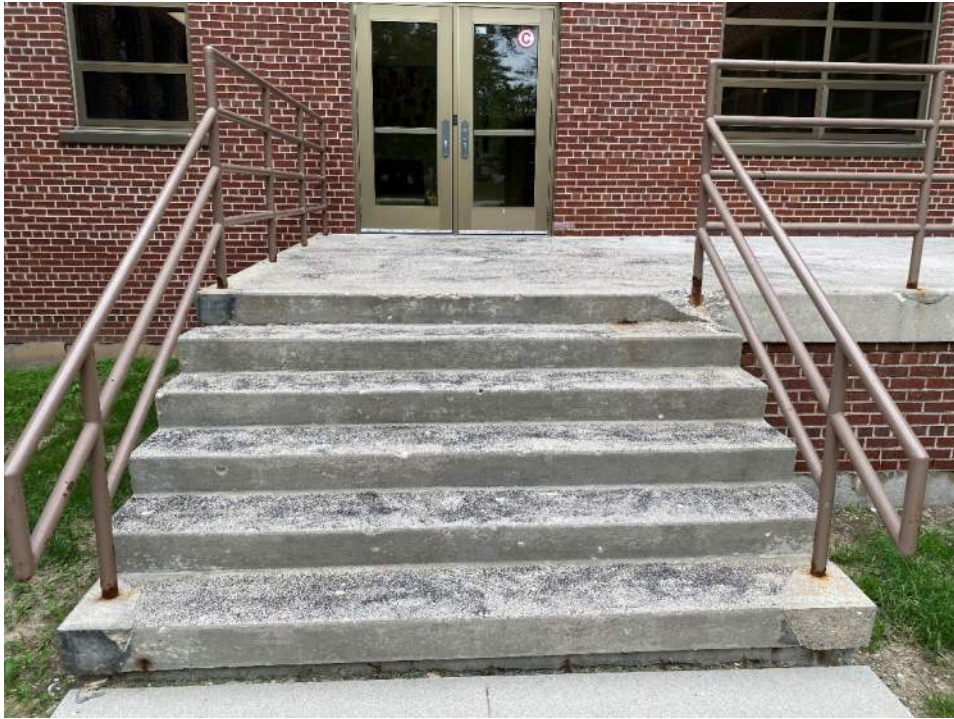
The concrete sidewalk from the bottom of the staircase to Paine Street appears to be in good condition with few cracks. Many of the slabs appear new. The concrete staircase and landing are extremely worn and in poor condition (Figure 4). There is a lot of chipped concrete, and the railings are rusted (Figure 5). The grass in this area has areas of exposed soil where no grass is growing.

Figure 4: Front east stairs in poor condition.

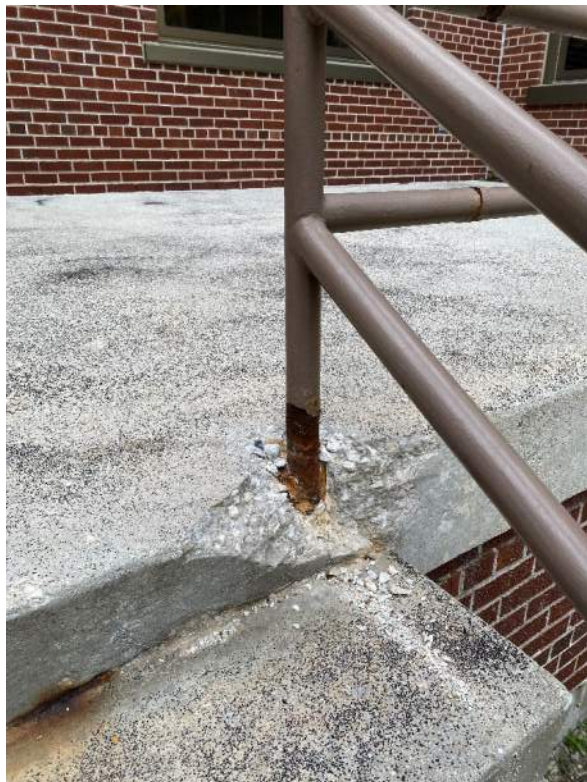
Figure 5: Concrete deterioration at railing post on Front East Stairs.

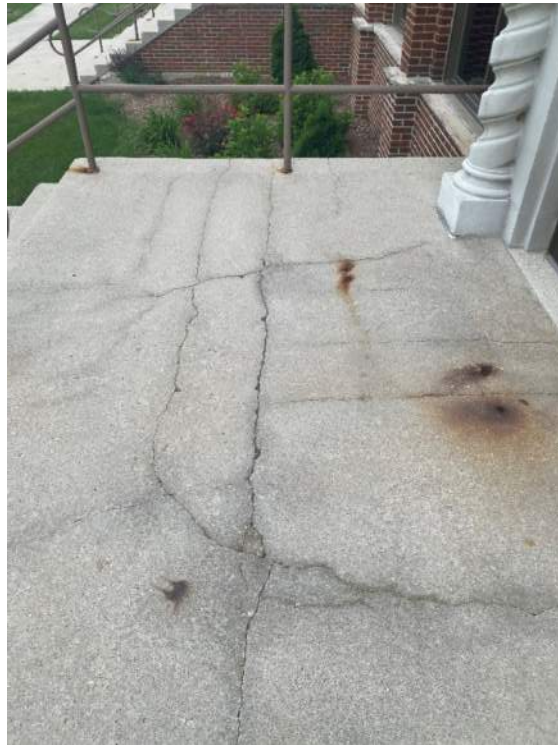
The center east concrete staircase is in poor condition. There are many cracks on the concrete slab, as well as cracking and missing concrete on the stair's foundation (Figures 7&8). The bottom of the railings are rusting. The large slab at the base of the center east stairway also has a large vertical crack running through it (Figure 9). The center east sidewalk from the school to Paine Street is in fair to poor condition. Two slabs on the north end have large horizontal cracks all the way through them (Figure 10). The farthest south slab near the city sidewalk has a large corner completely cracked off (Figure 11). Overall, the concrete sidewalk is in fair condition, except for the four cracked slabs which are in poor condition.

Figure 9: Top of center east concrete stairs in poor condition.

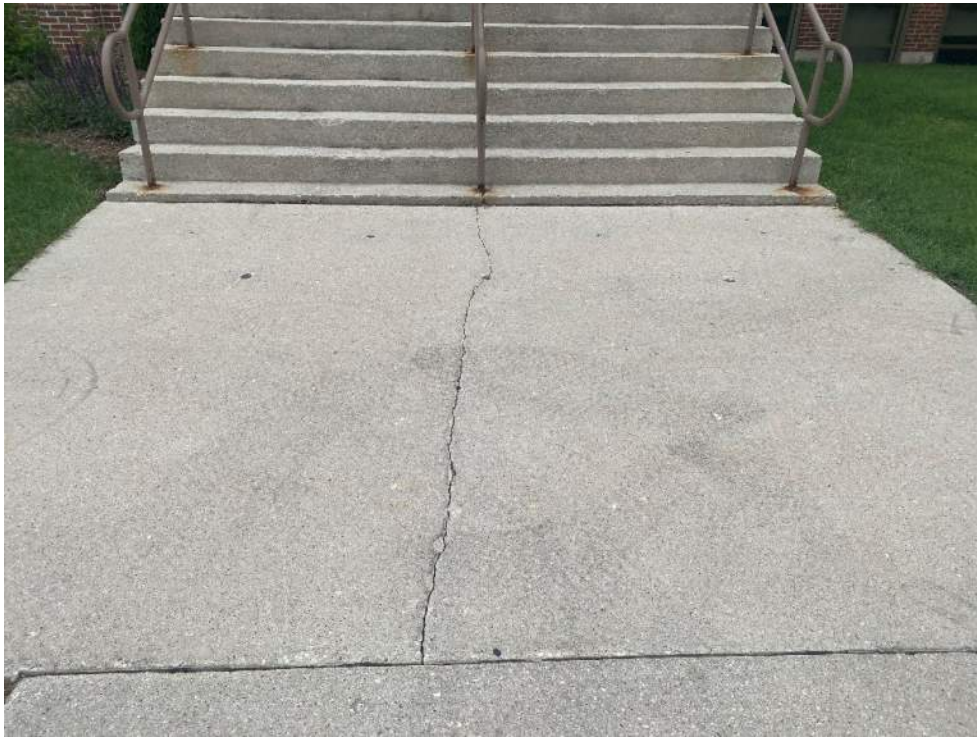
Figure 9: Vertical crack in concrete slab at bottom of front center east stairs.

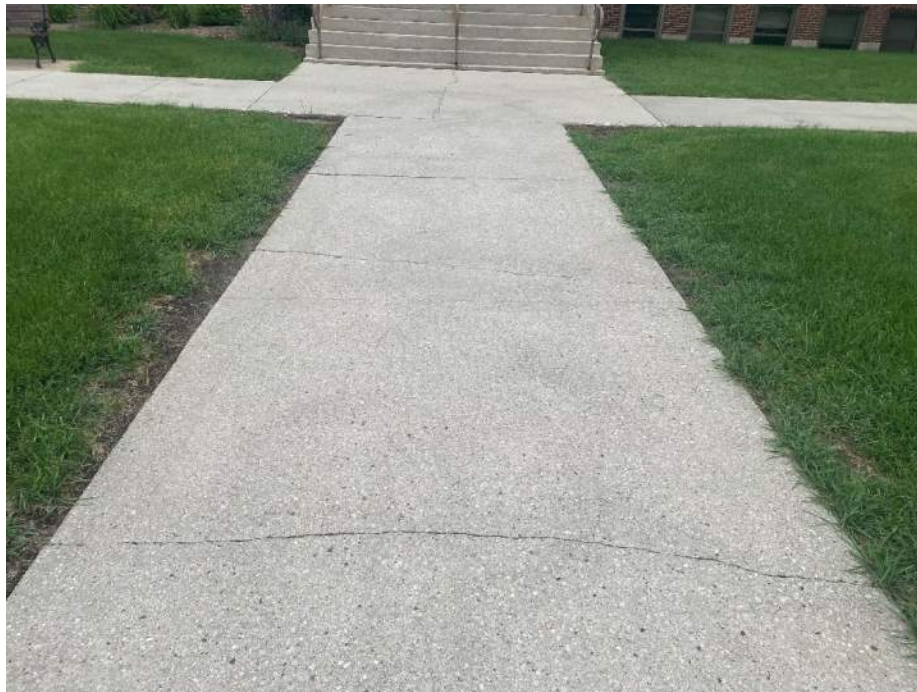
Figure 10: Horizontal cracking in front center east Sidewalk.

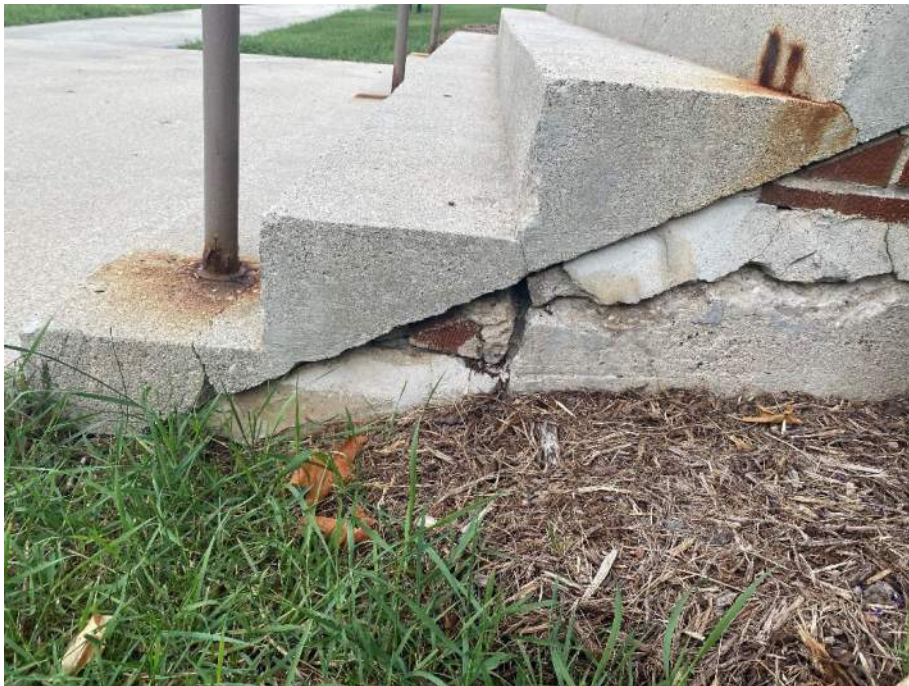
The center west sidewalk concrete staircase is in poor condition (Figure 12). There are many cracks on the concrete slab (Figure 14), as well as cracking and missing concrete on the stair's foundation (Figure 13). The bottoms of the railings are rusting. The concrete sidewalk that connects the stairs to Paine Street has some slabs that have large cracks in it. There is one slab towards the north end that has a large horizontal crack all the way across it (Figure 15). The same slab also has an angled crack further north (Figure 16). This area of concrete appears older than the concrete on the south half of the sidewalk. There are two slabs in the newer portion that have the corners completely broken off from the slab (Figure 17). All these cracked slabs could be replaced while keeping the other slabs that have no cracking.

Figure 13: Foundation deterioration of front center west concrete stair.

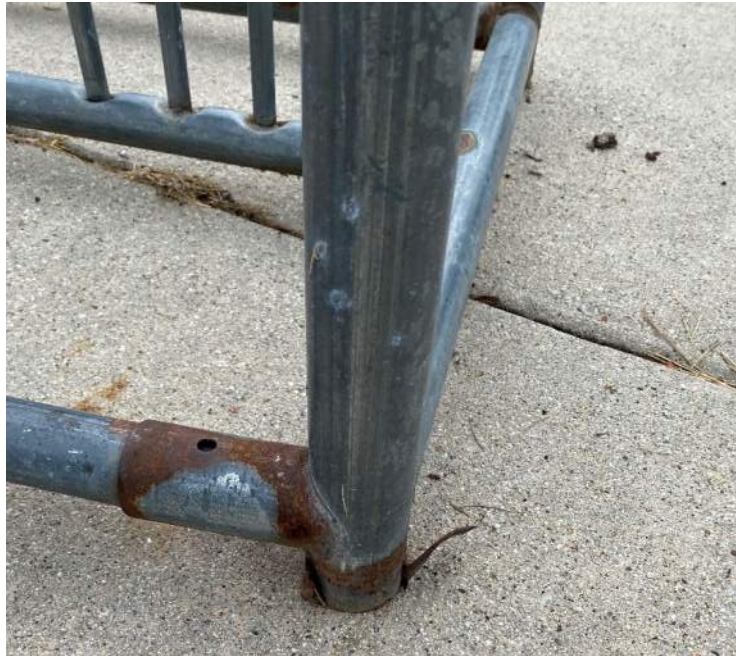
The concrete plaza area on the front of the school is in very good condition. The concrete appears to be very new. There are no major cracks in this area. The benches are also in very good condition. The metal bike racks are in fair to poor condition. There are sharp metal pieces hanging off the bottoms of the racks, which could be dangerous (Figure 21&22). The concrete stairway is in fair condition. The foundation has a large vertical crack in nearly the same area on each side (Figure 23&24). The concrete stairs are in good condition besides a thin crack going right up the middle (Figure 25). The metal railing is in good condition with no rusting.

Figure 21: Sharp edges exposed on metal bike rack.

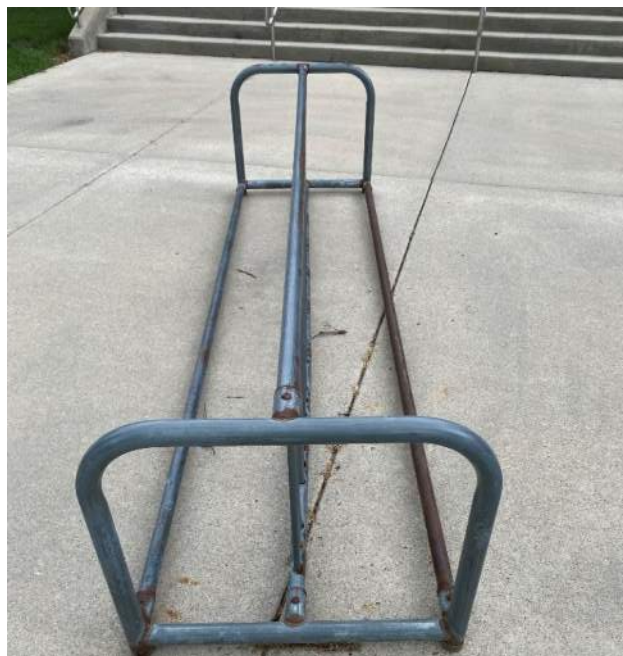
Figure 22: Metal bike racks in fair to poor condition.

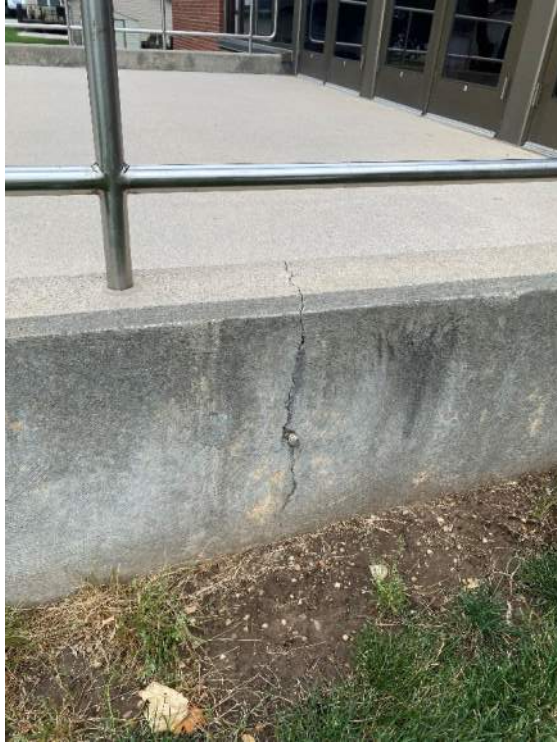
Figure 23: Crack in foundation of front west stairway.

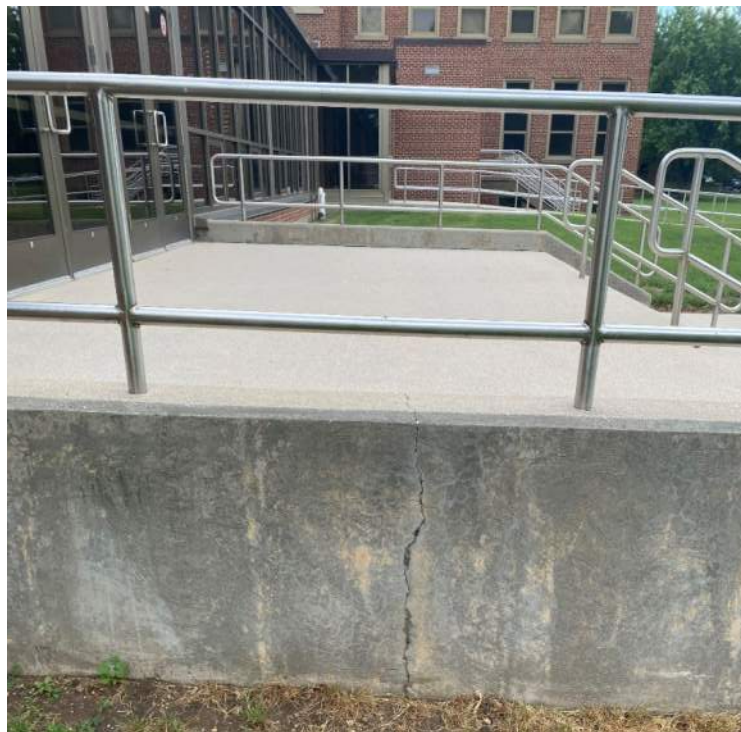
Figure 24: Another foundation crack on front west stairs.

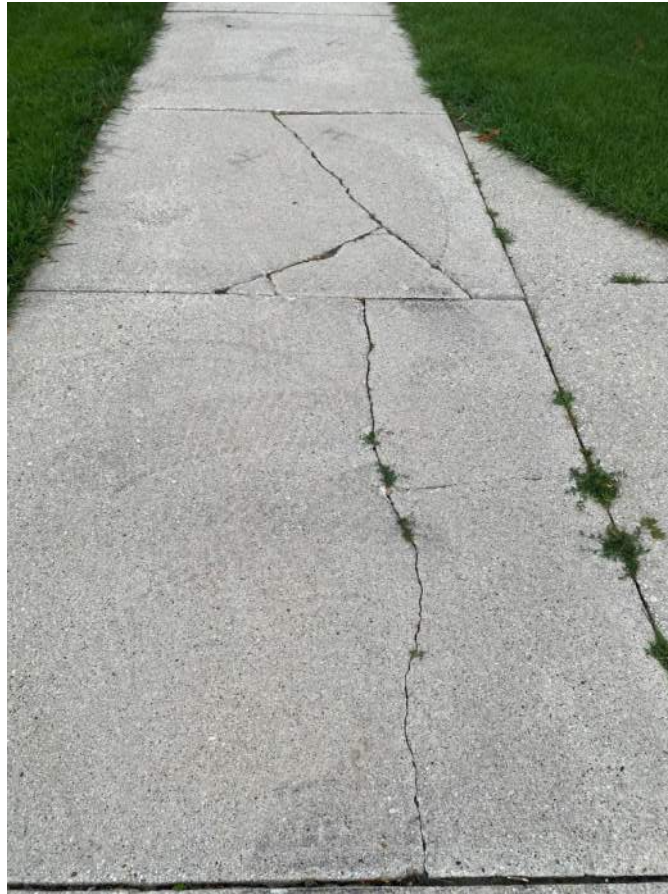
The front west sidewalk connects the west side of the school to Paine Street. The two legs of the west sidewalk are in poor condition, with exception to the few slabs that appear newer. Majority of this sidewalk appears old and worn with cracks throughout (Figure 29). Some slabs are broken into multiple pieces (Figure 26,27&28).

Figure 26: Severe cracking in front west sidewalk.

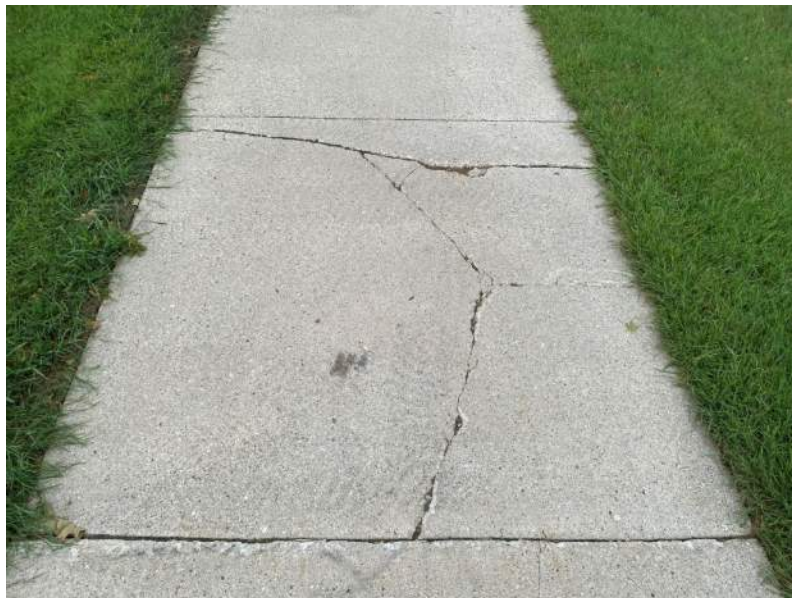
Figure 27: Additional cracking in front west sidewalk.

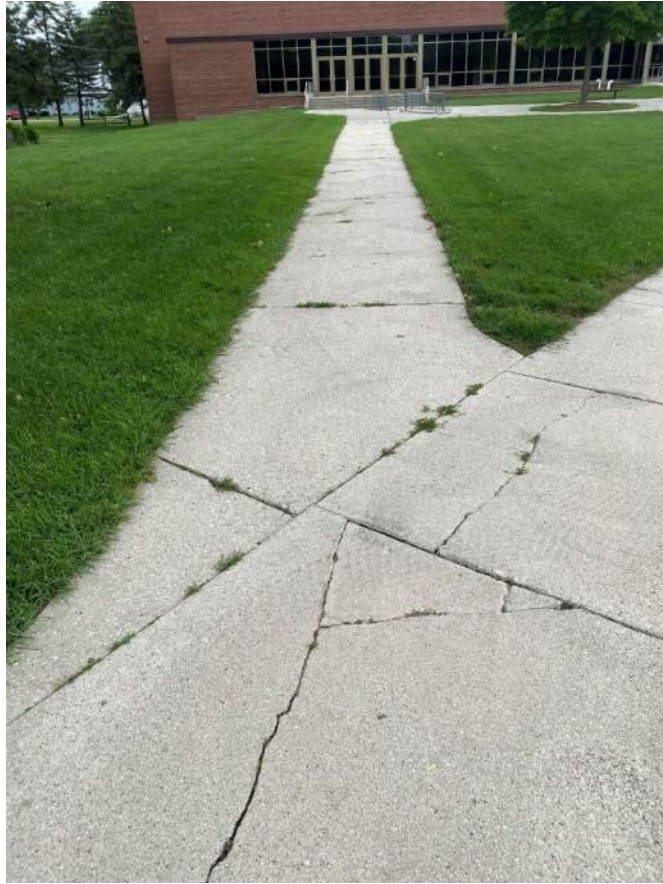
Figure 28: Cracking in front west sidewalk.

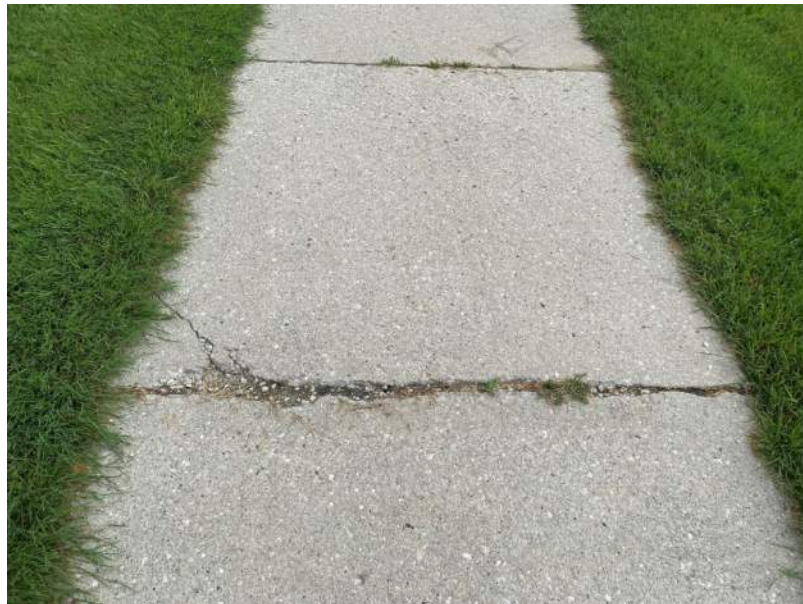
Figure 29: Deteriorating concrete on front west sidewalk.

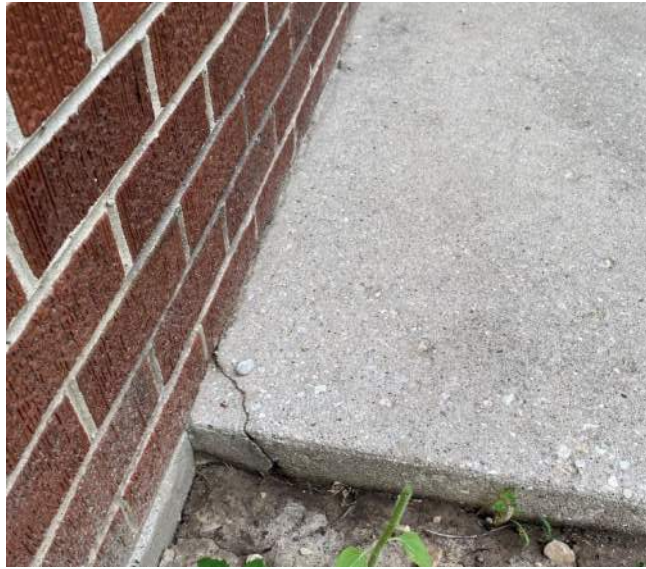
The door on the west side of the school has a large concrete landing that is in fair condition. The landing appears worn and one corner has corner broken off it (Figure 30). The surrounding grass is not growing well, and soil is exposed (Figure 31).

Figure 30: Corner cracked off concrete slab at door on west side of school.

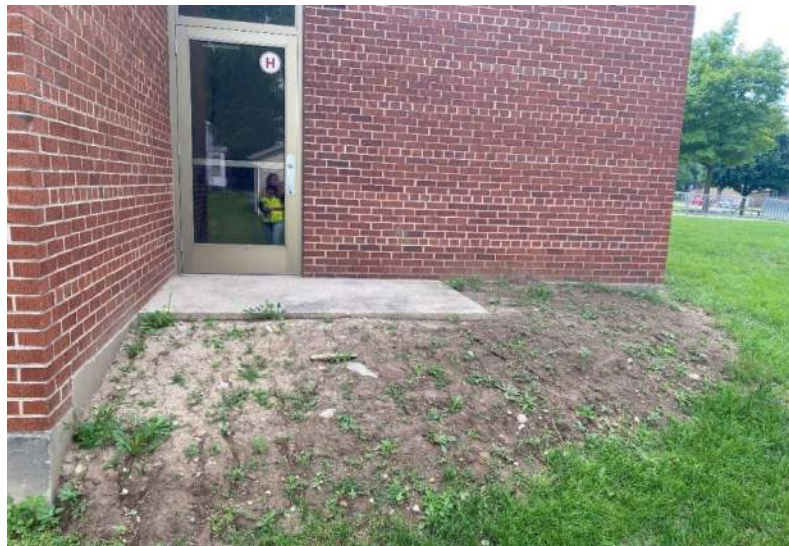
Figure 31: Concrete slab and surrounding grass in good to fair condition on west side of school.

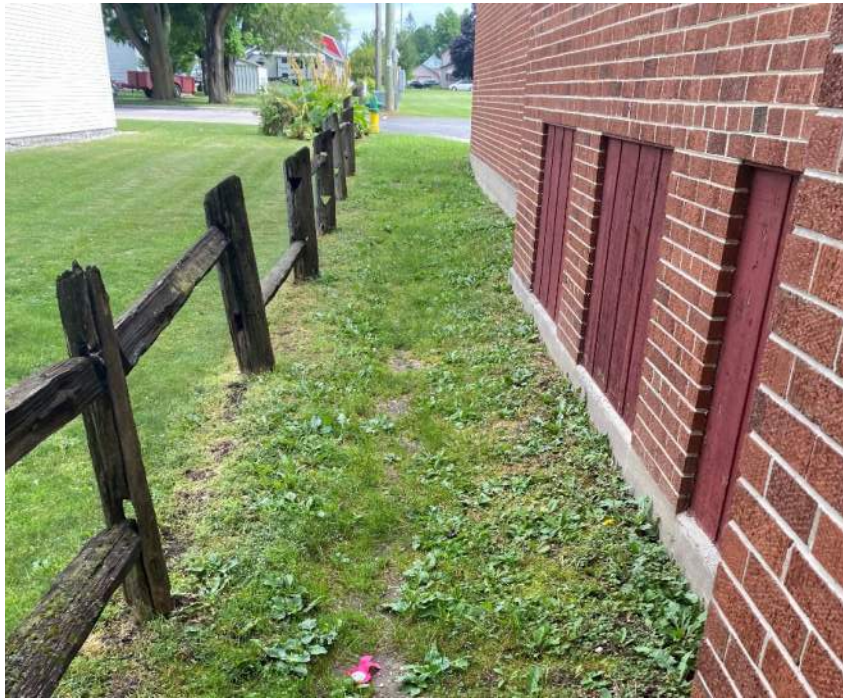
The wooden fence on the property line on the west side of the school is in poor condition. Many of the pieces are missing and the wood appears rotted and tipsy (Figure 32).

Figure 32: Wood fence on west side of school in poor condition.

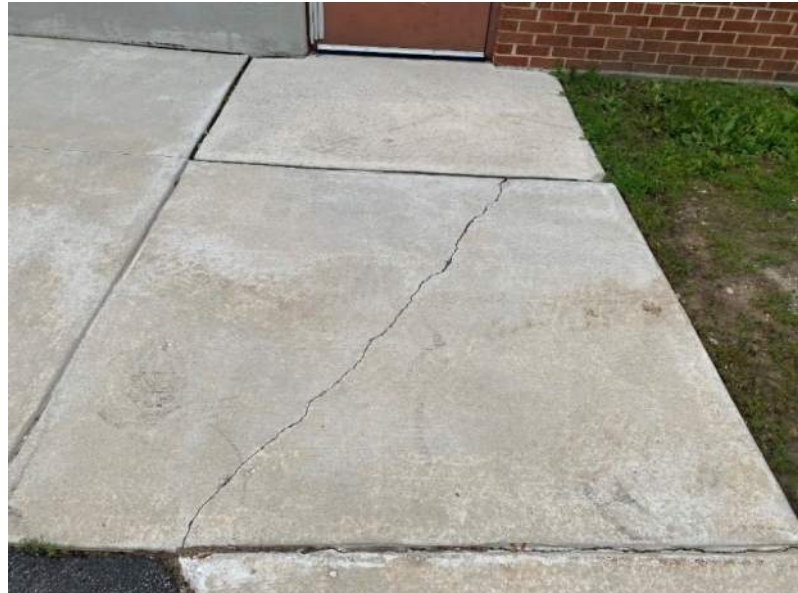
The sidewalk along the back of the building on the west side is in good condition, except for one slab with a large crack through it (Figure 33). The northwest parking lot is in fair to poor condition. There are significant longitudinal and transverse cracks throughout (Figure 34). The worst cracking is in the two bays of parking stalls (Figure 35,36, &37). There also appears to be some settling near the catch basins. The drive lane between the two bays of parking stalls appears to be in fair condition with less cracking (Figure 38). The pavement markings are beginning to wear off.

Figure 33: Cracked concrete slab at west door on back side of school.

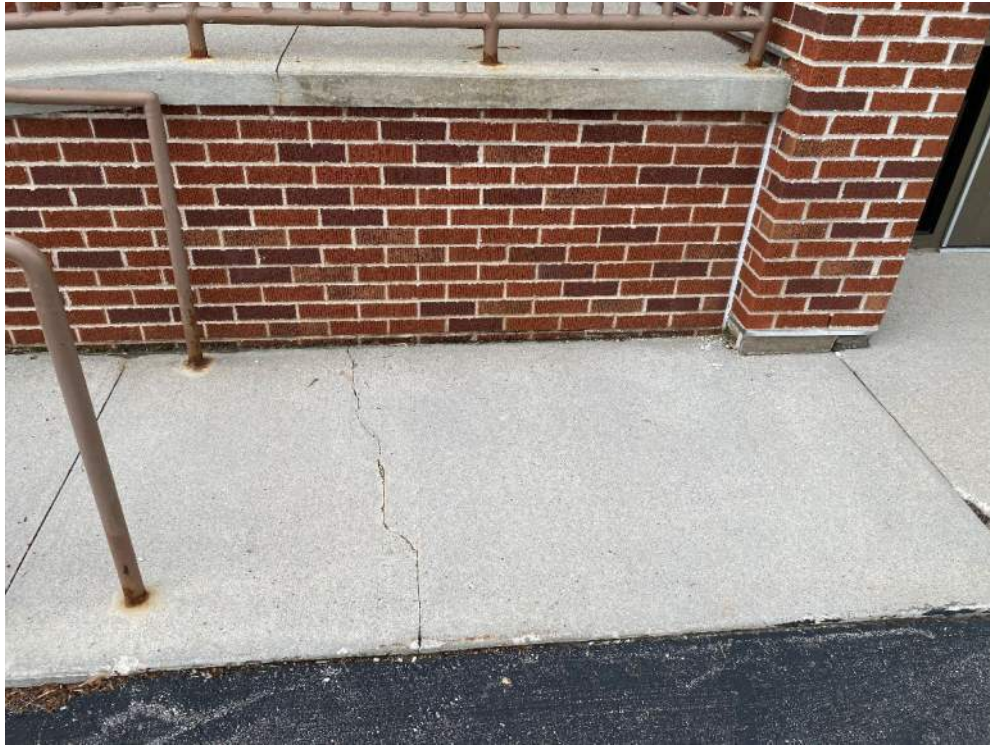
Overall, the back concrete ramp is in fair condition. The brick base has minimal cracking (Figure 39). There are two cracks in the concrete pavement, but majority of the concrete is not cracked or chipped (Figure 40). The railing is rusted especially at the base.

Figure 40: Cracked slab at landing of back concrete ramp.

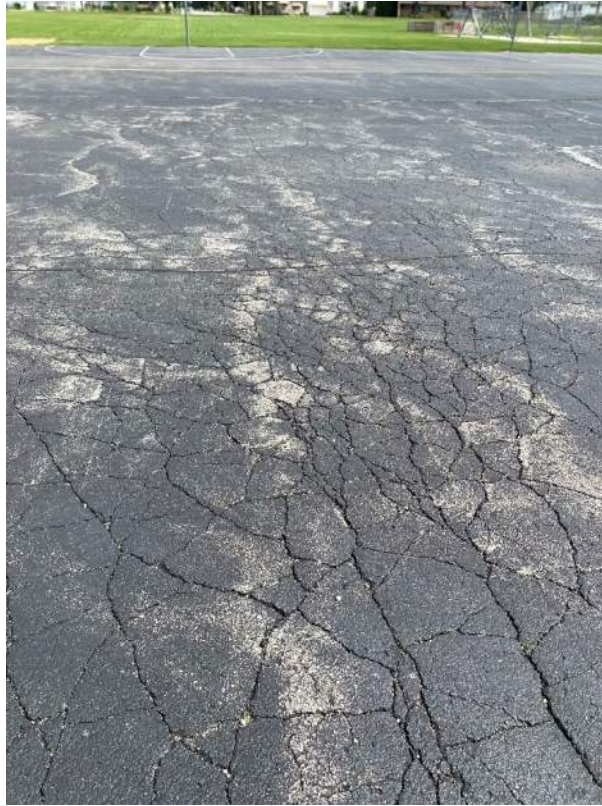
The asphalt in the back of the school used for a play yard and loading area is in very poor condition. Majority of the pavement has alligator cracking, as well as longitudinal, transverse and block cracks (Figure 41&42). The concrete stoop near the shed and the shed are in poor condition (Figure 43&44). The concrete stoop is chipped away on one corner and the shed is rotting at the bottom. The pavement markings in the play yard are worn and faded. The basketball hoop backboards and metal netting are rusting and are in poor condition (Figure 45). The poles are in fair condition.

Figure 41: Severe alligator cracking in back play yard.

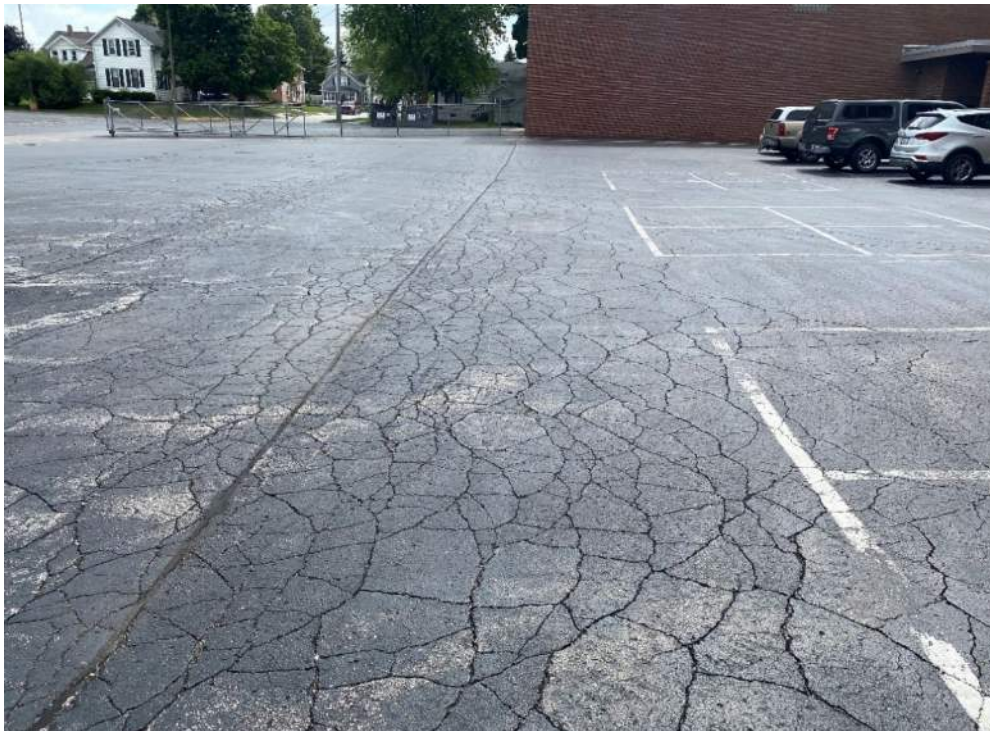
Figure 42: Alligator cracking throughout back play yard.

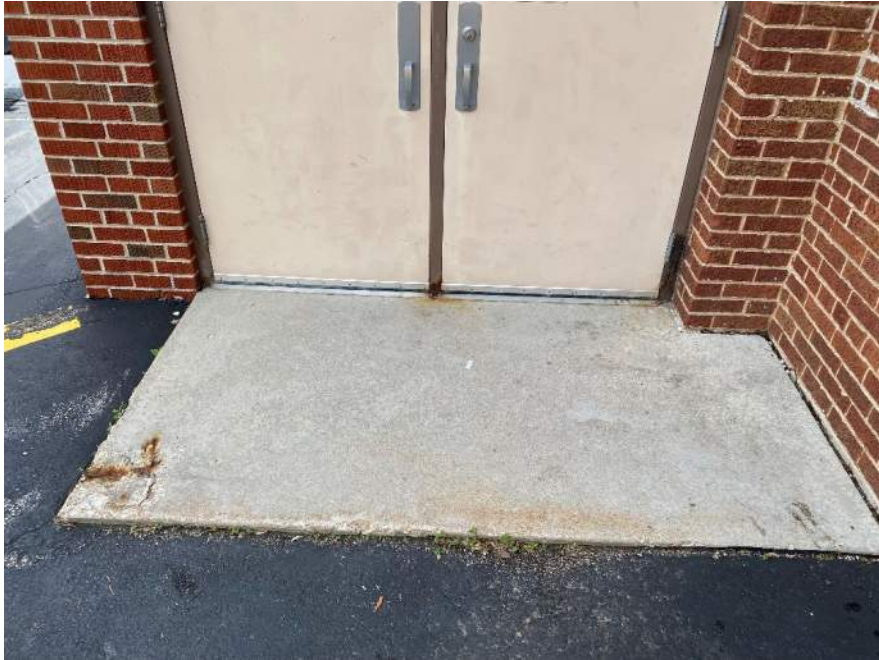
Figure 43: Deteriorating concrete stoop in back play yard.
