Facilities Study Document | Kiel School District, Zielanis Elementary School

Building Systems Summary Checklist

Completed by: Alex Feudner and Ben Nerat, MSA Professional Services

Date of Walk-through: 05/18/2022

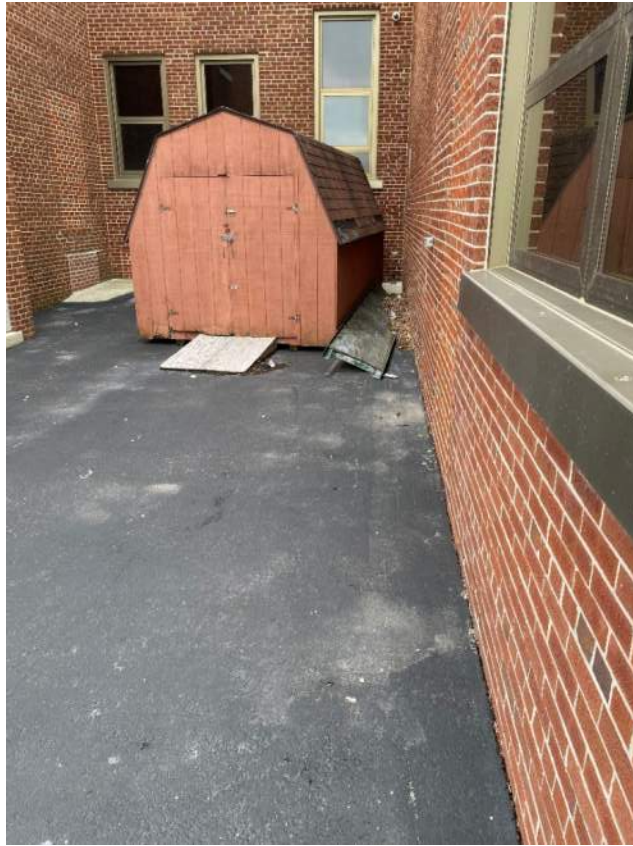
Figure 44: Deteriorating shed in back play yard.

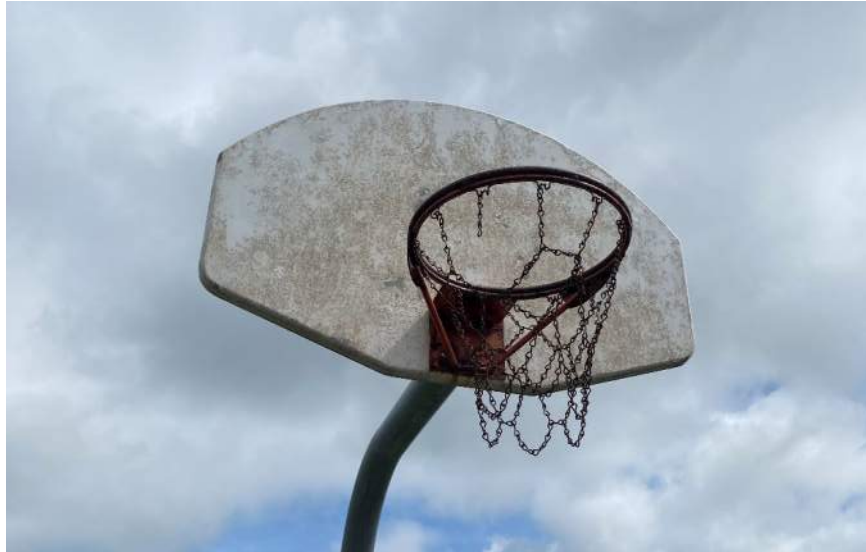
Figure 45: Basketball hoops in poor condition in back play yard.

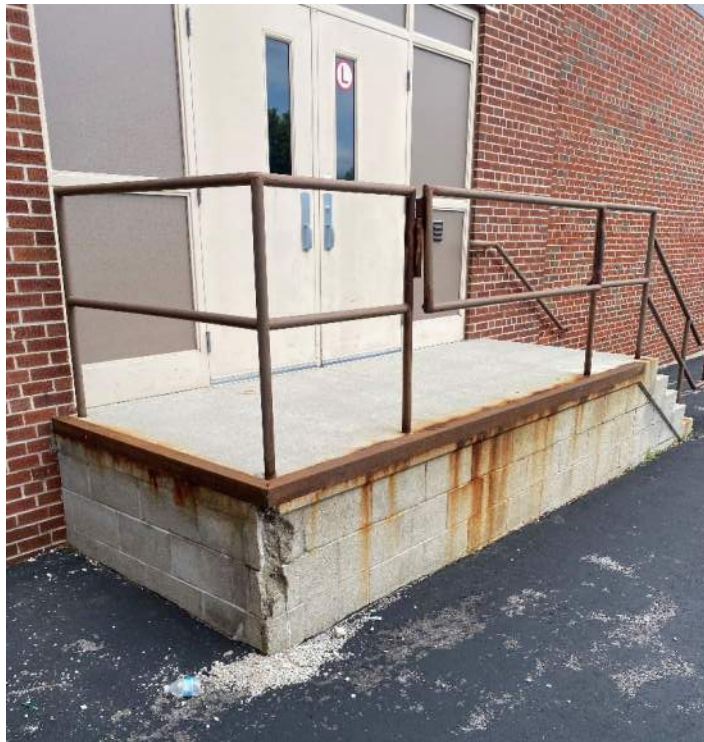
The back concrete stairway is in poor condition. The cinderblock base is disintegrating in areas and the concrete steps are cracking and chipping (Figure 46). The metal railing is very rusted and deteriorated as well.

Figure 46: Concrete stair in back play yard in poor condition.

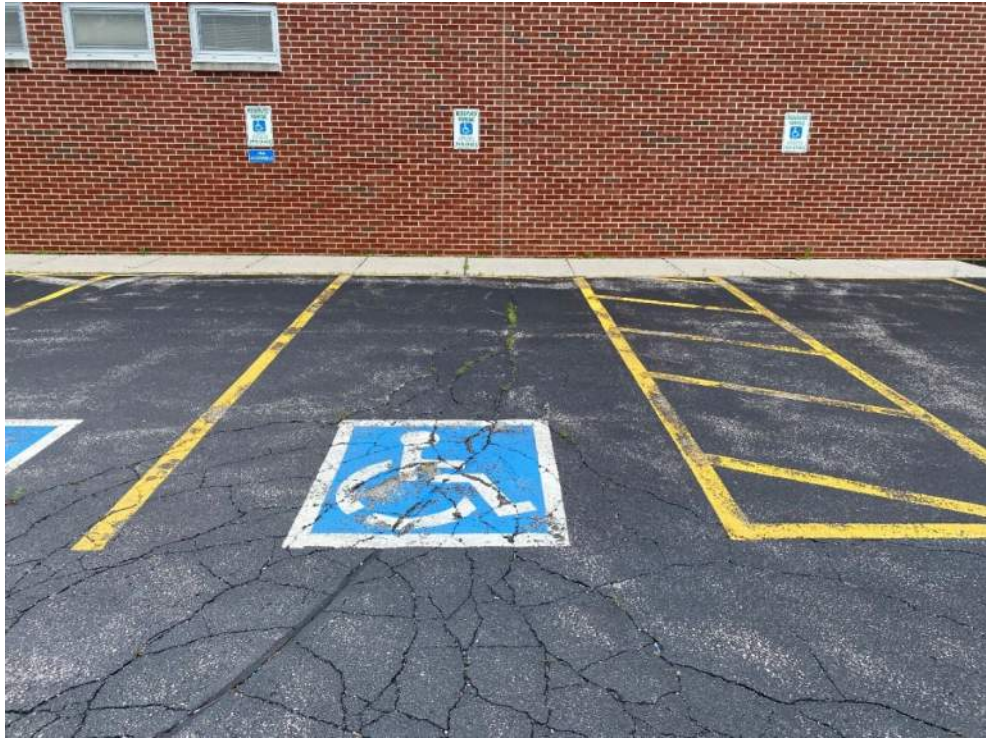
The back ADA asphalt parking area is in poor condition. Majority of the pavement is covered in alligator cracking (Figure 48,49&50). The pavement marking is also wearing off. The concrete sidewalk south of the ADA stalls is in fair condition. The pavement appears old and chipped, but there is minimal cracking (Figure 51). There is some newer pavement north of the accessible stalls that is part of the drive lane that is in fair condition. There are longitudinal cracks in that pavement, but there is no alligator cracking.

Figure 49: Alligator cracking in ADA stalls on east side of back of school.

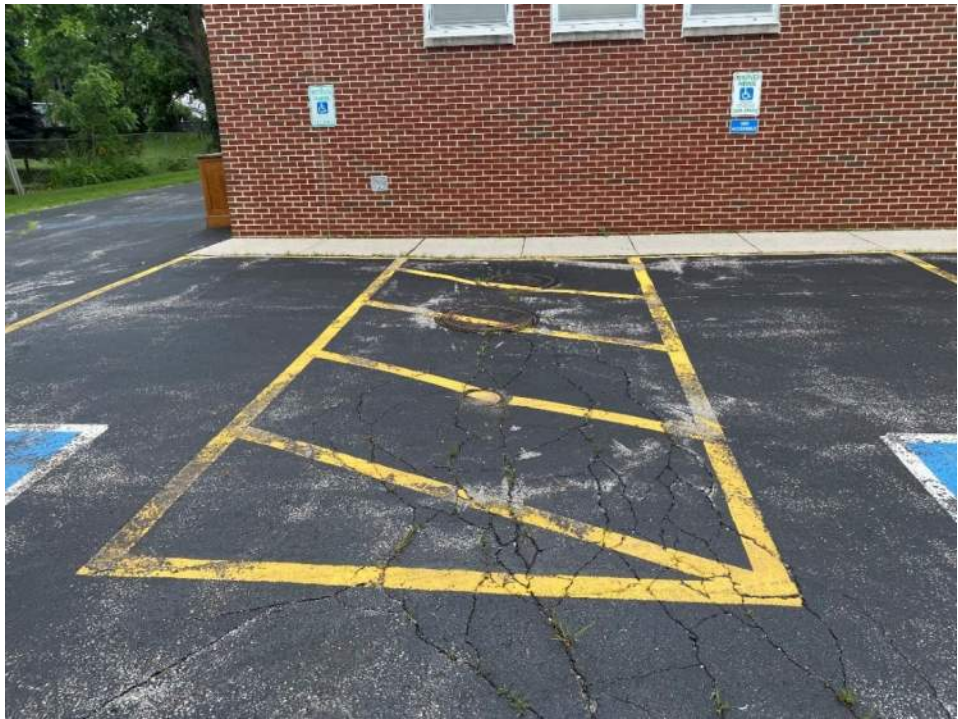
Figure 50: Alligator cracking and worn pavement markings in back east ADA stalls.

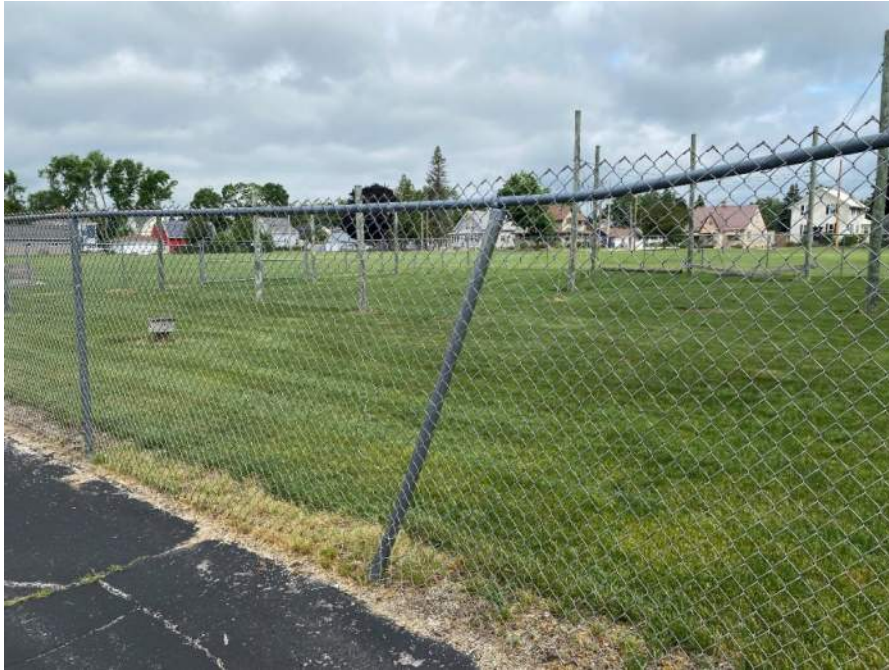
The fencing surrounding the climbing area is in fair condition. It is tipping over in some areas and the bottom is coming unraveled causing sharp wires to stick out (Figure 54&55).

Figure 54: Fence surrounding climbing area falling over.

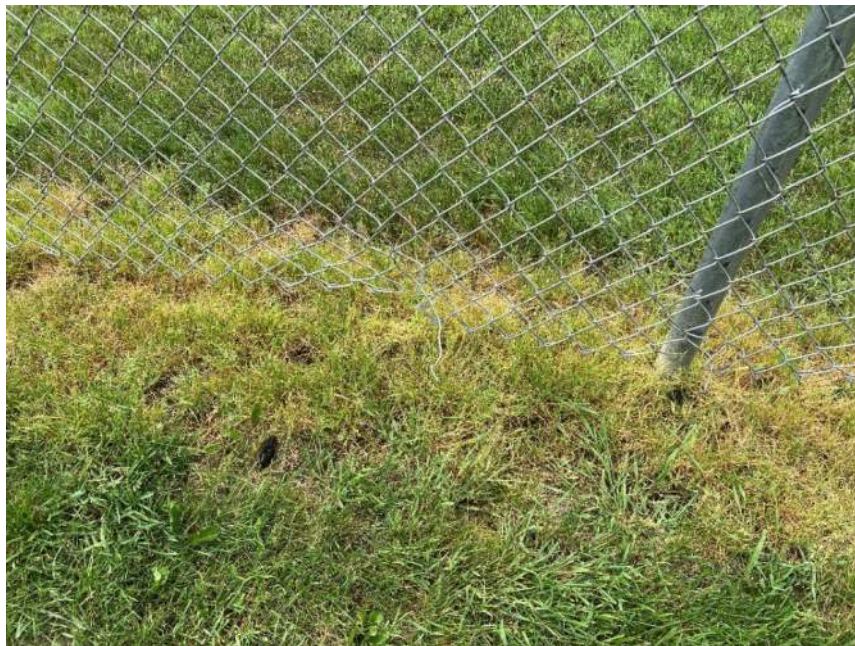
Figure 55: Exposed wire on bottom of fence surrounding climbing equipment.

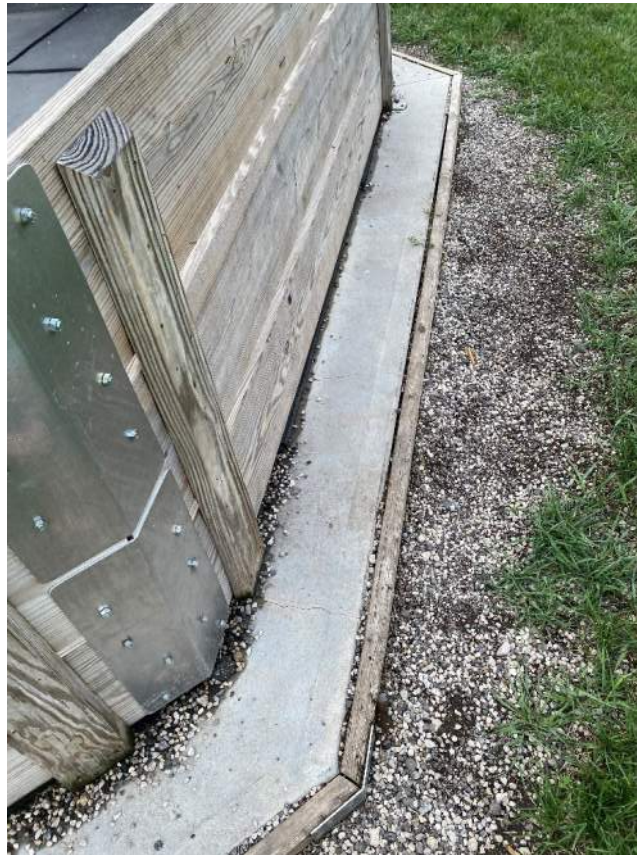
The wooden octagon is in good to fair condition. There was water sitting on the rubber pads inside the enclosure. Some of the gravel base is missing under the concrete pad (Figure 56). There are also some cracks radiating out of the concrete pad (Figure 57). The climbing net is in good condition and looks very new. The swing set is in fair to poor condition due to some of the swings breaking apart (Figure 58).

Figure 57: Cracks in concrete base for wooden octagon.

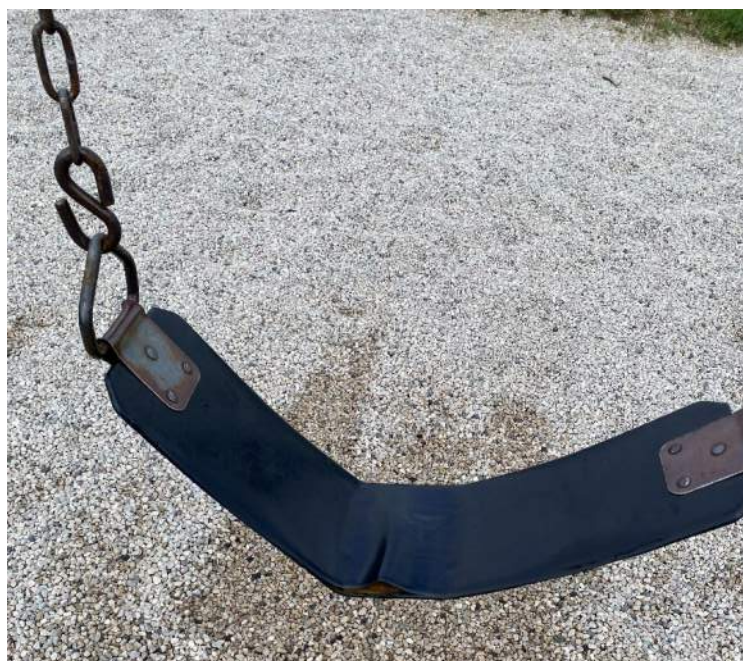
Figure 58: Broken swing seats on back swing set.

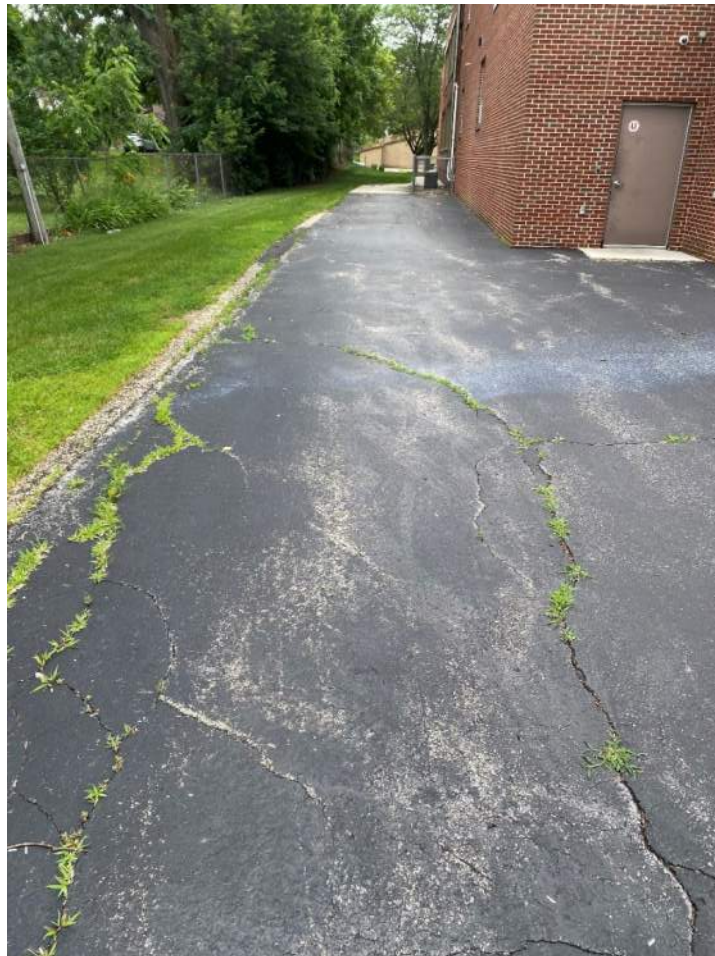
The asphalt on the east side of the school is in poor condition. There are many longitudinal and transverse cracks with weeds growing up through them (Figure 59). The older concrete sidewalk near the fenced in mechanical equipment is in poor condition. There are cracks in the pavement and some settlement causing standing water (Figure 60). There is also newer concrete sidewalk to the south of the mechanical equipment that is in good condition with minimal cracking. The grass on the east side of the school is patchy and having trouble growing in the shade. The metal fencing enclosing the mechanical equipment is in good condition. The metal fence on the property line is in poor condition (Figure 61). It is overgrown with trees and tipping over in areas.

Figure 59: Longitudinal, transverse and block cracking in asphalt on east side of school.

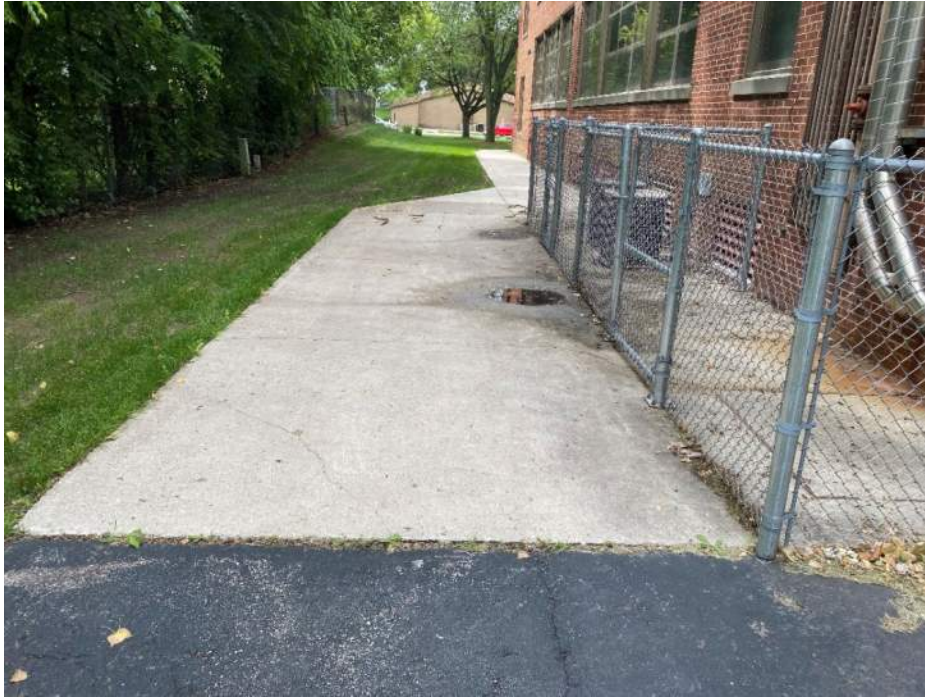
Figure 60: Cracking and settling in concrete slab on east side of school causing water to pool.

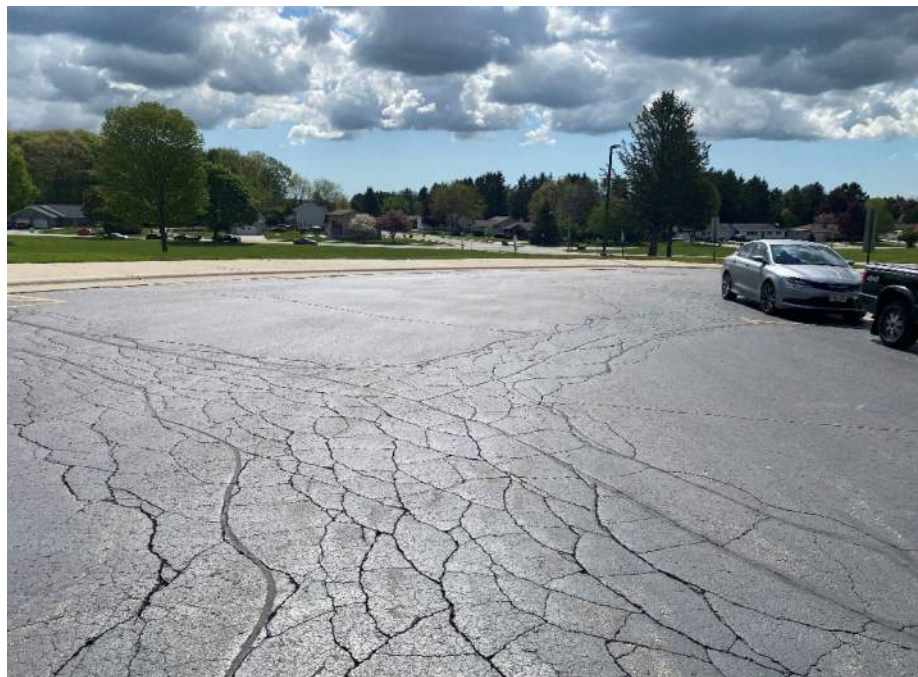
Figure 2: Alligator and block cracking in asphalt pavement in Bus/Visitor Parking Loop.

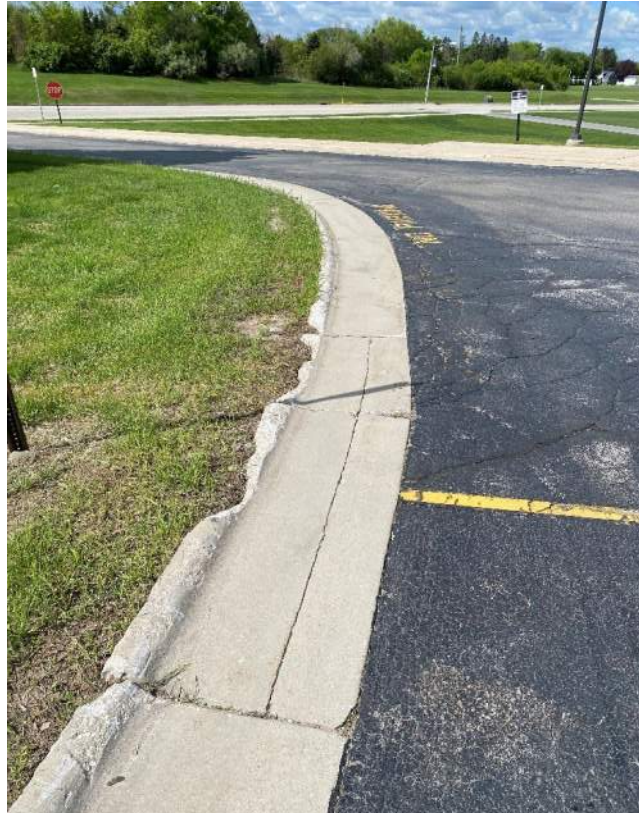
Figure 4: Curb head broken off in Bus/Visitor Parking Loop.

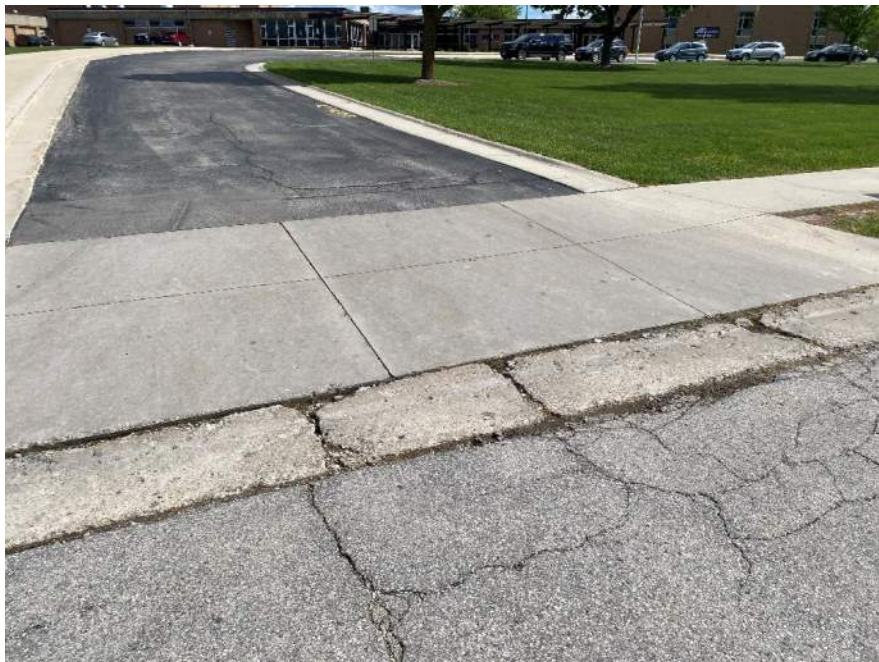
Figure 5: Cracked curb and gutter at exit driveway in Bus/Visitor Parking Loop.

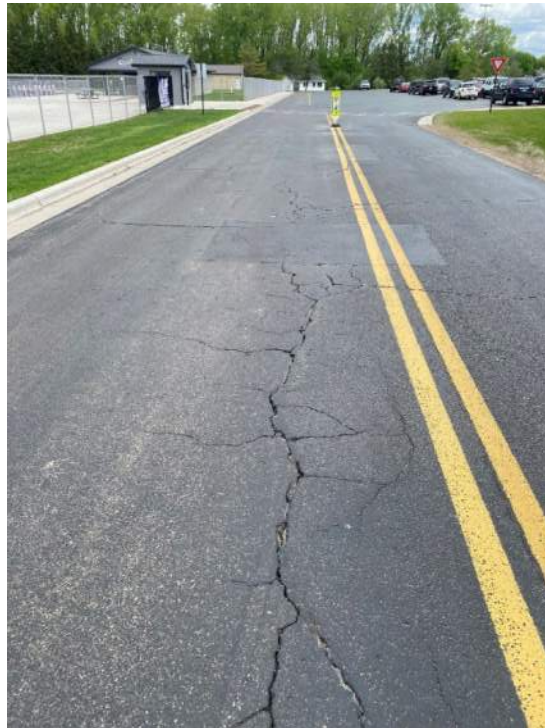
building and extends north. The condition of the asphalt drive is fair from the southwest corner of the school building to the south (Figure 11). The portion of the roadway that borders the west side of the school is in poor condition due to block and alligator cracking (Figure 12). There are many longitudinal and transverse cracks throughout the entire drive (Figure 13). There are multiple patches on the roadway, but some of the patches are cracking. There is edge cracking along the edges of the drive where there is no curb and gutter. The concrete driveway is in good to fair condition. It shows signs of typical wear and tear, but few cracks in the concrete except for the curb and gutter portion and flares. Pavement markings are in good to fair condition with some fading beginning. The curb and gutter near the north portion of the roadway is in excellent condition, as it was recently installed.

Figure 13: Longitudinal and Transverse Cracking on north portion of Access Drive.

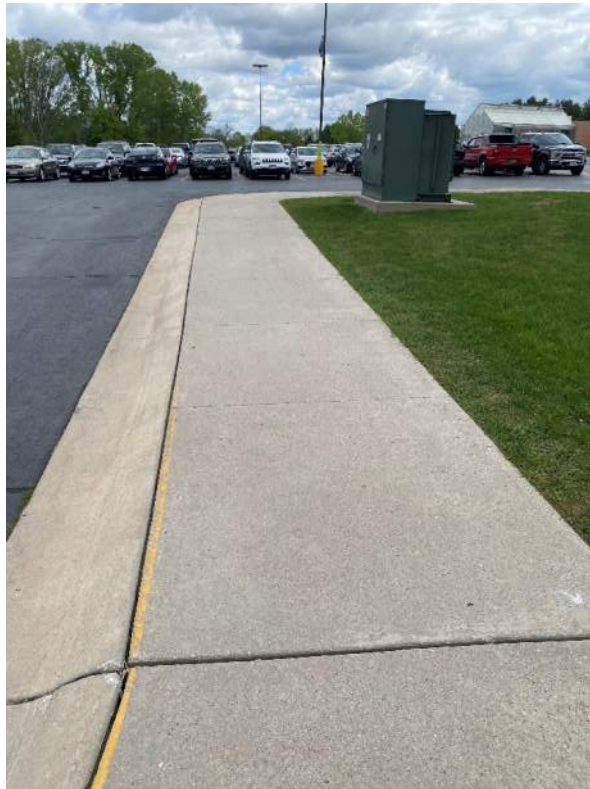
Figure 16: Sidewalk in Student Parking Lot

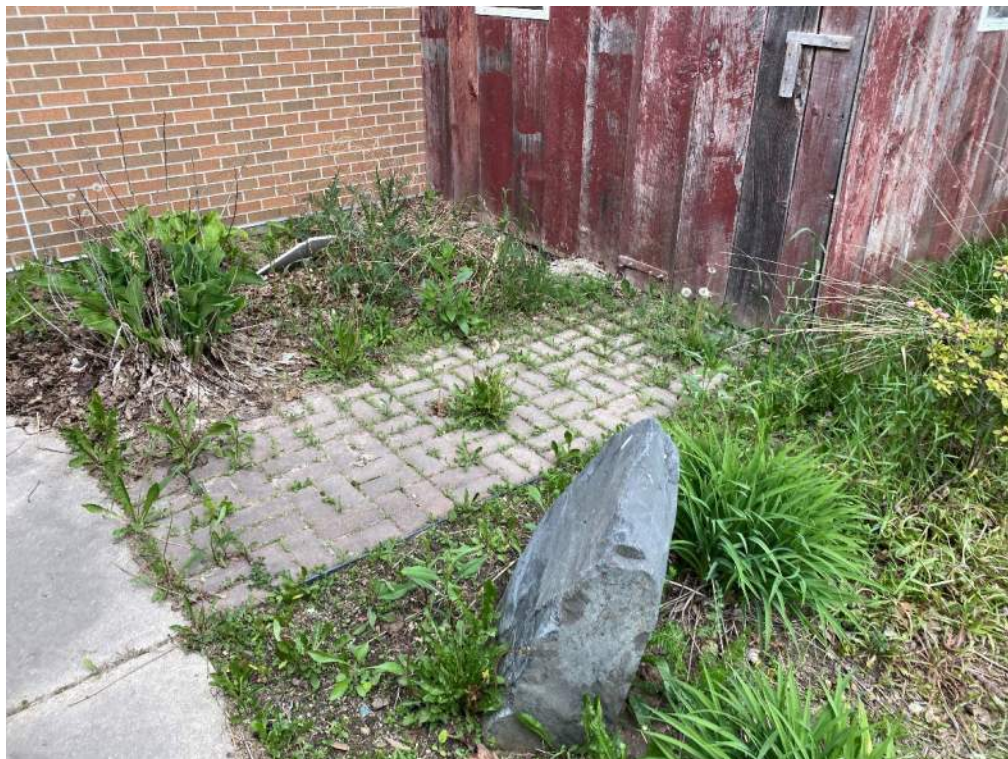
Figure 19: Overgrown pavers in front of small shed near goat pen on north side of school

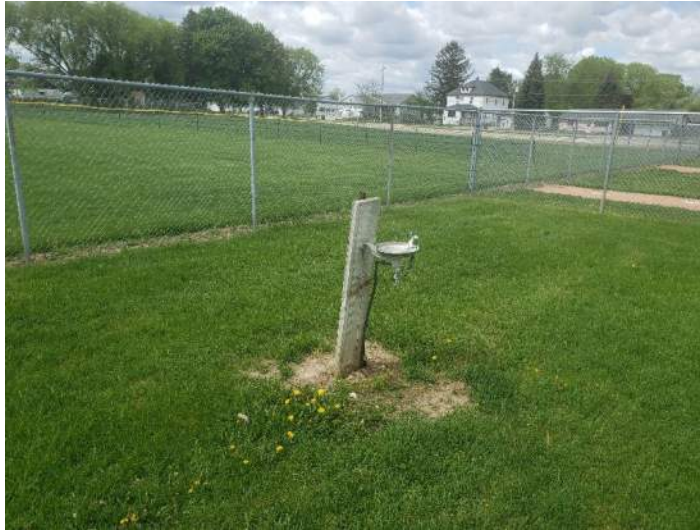
The two practice baseball fields consist of fields, fencing, dugouts and standalone metal bleachers. The fields are in good condition and appear well groomed (Figure 26). The dugouts appear to be newer, and the concrete pads are in good condition. There is a water fountain between the two fields that is in poor condition, due to it being anchored to a tilted board (Figure 27). The fencing requires some maintenance due to rusting posts, unravelling at the bottom, and tilting (Figure 28).

Figure 27: Water fountain in between practice baseball fields in poor condition

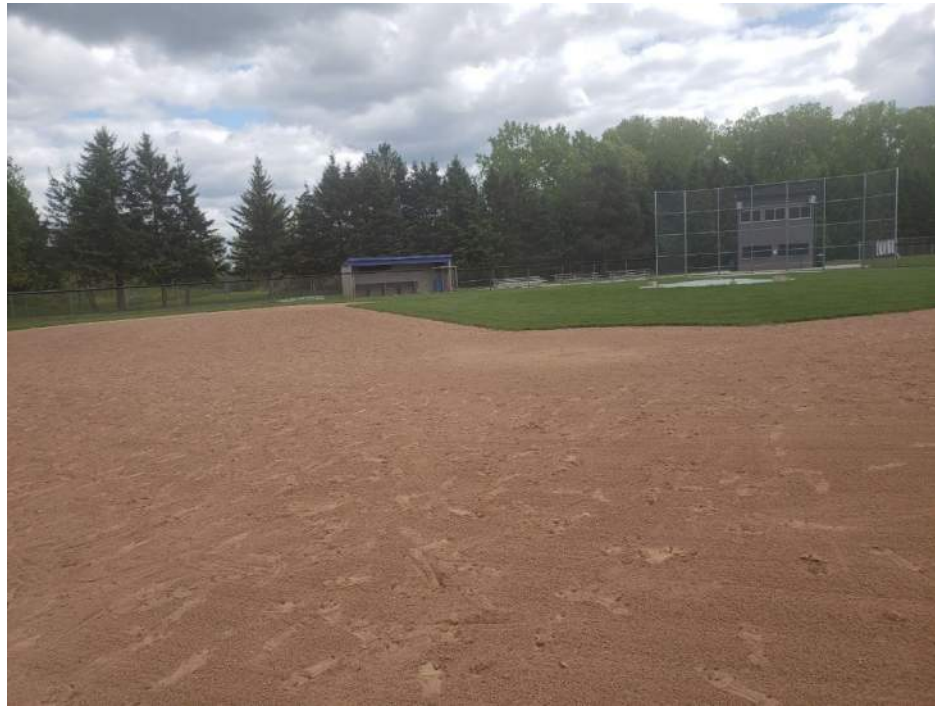
The Varsity Baseball Field consists of the field, dugouts, concession stand, bleachers, and fencing. The field is in good condition (Figure 31). Some areas outside of the fenced in field have no grass growing (Figure 34). The new concession stand, and pad are in good condition as well. One of the dugouts has concrete floors that are covered in rubber. The rubber is peeling away and ripping, and the condition of the concrete underneath was unknown due to being covered in rubber (Figure 32). The wood benches in the dugouts were old and have paint worn off them (Figure 33). The other dugout had no rubber on the floor, and the condition of the concrete pad was fair due to some large cracks. The wood benches were also old and worn. The metal bleachers are on gravel pads and were in good condition. The fencing around the field is in good condition.

Figure 31: Varsity baseball field

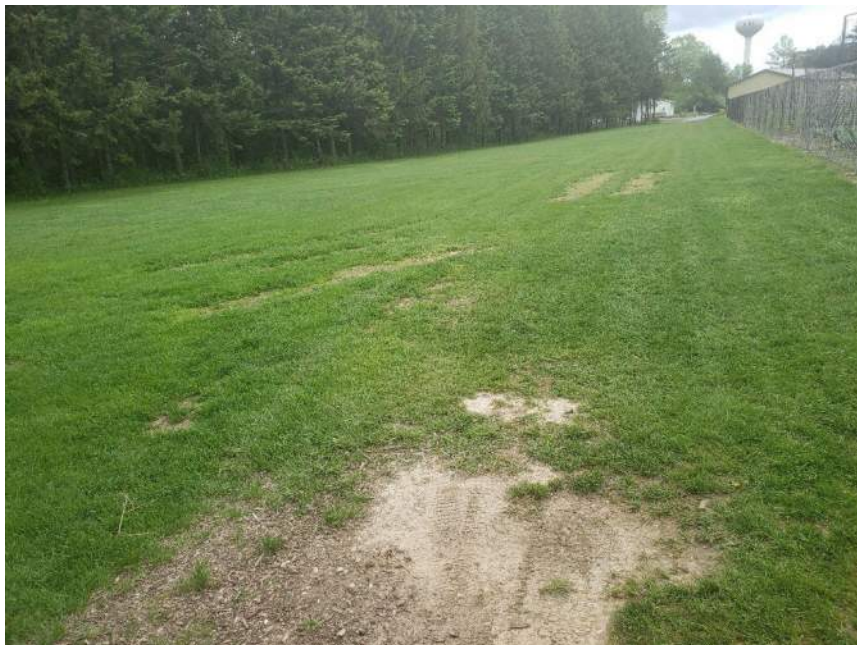
Figure 34: Dead and rutted grass northeast of Varsity Baseball Field

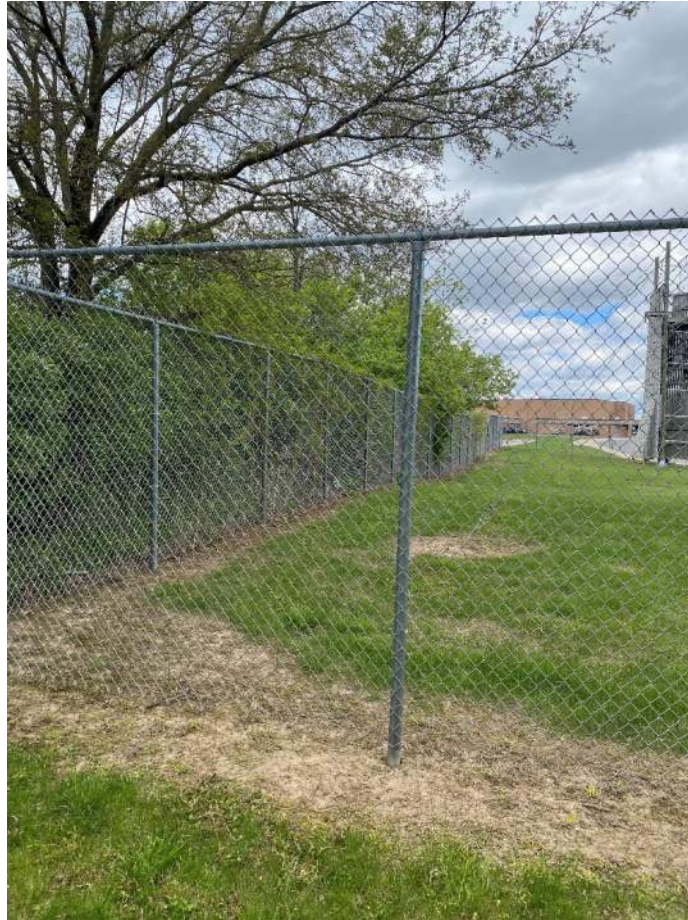
The Outdoor Climbing Area consists of a fenced in area with climbing walls and posts. The fence was in fair condition due to some unraveling at the bottom. There was some trees and brush growing into the west fence line (Figure 37). The grass area between the road and the north fence had a lot of patches of dead grass (Figure 38).

Figure 37: Trees and brush growing into fence on west side of climbing area

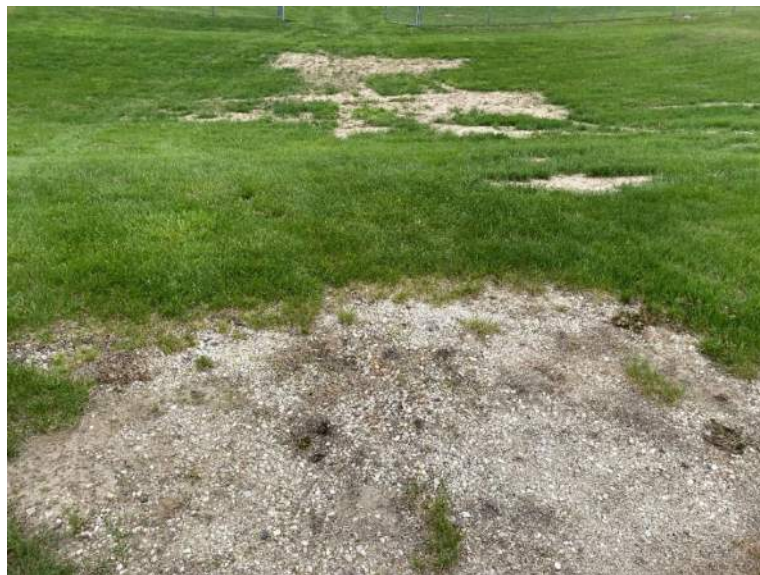
Figure 38: Dead grass on north side of climbing area

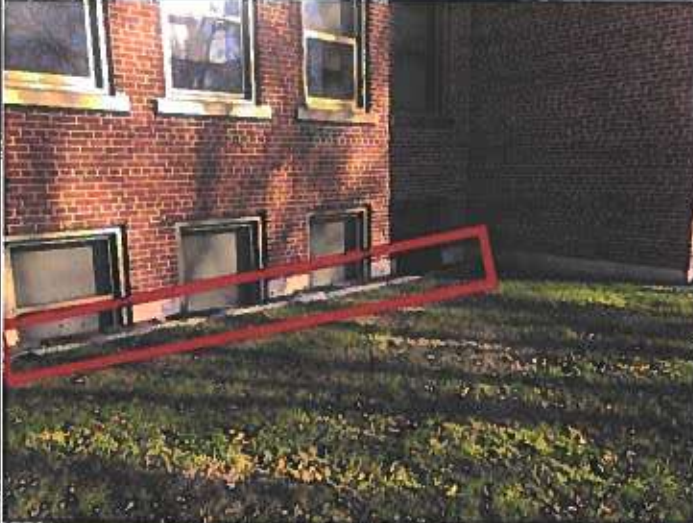
A photograph of the exterior wall of a brick building. The wall is made of red bricks and has several windows. A red rectangular box is drawn on the ground in front of the building, highlighting a specific area.	<p>2. This is the exterior wall of the home economics classroom. The picture shows how half of the home economics room is underground.</p>

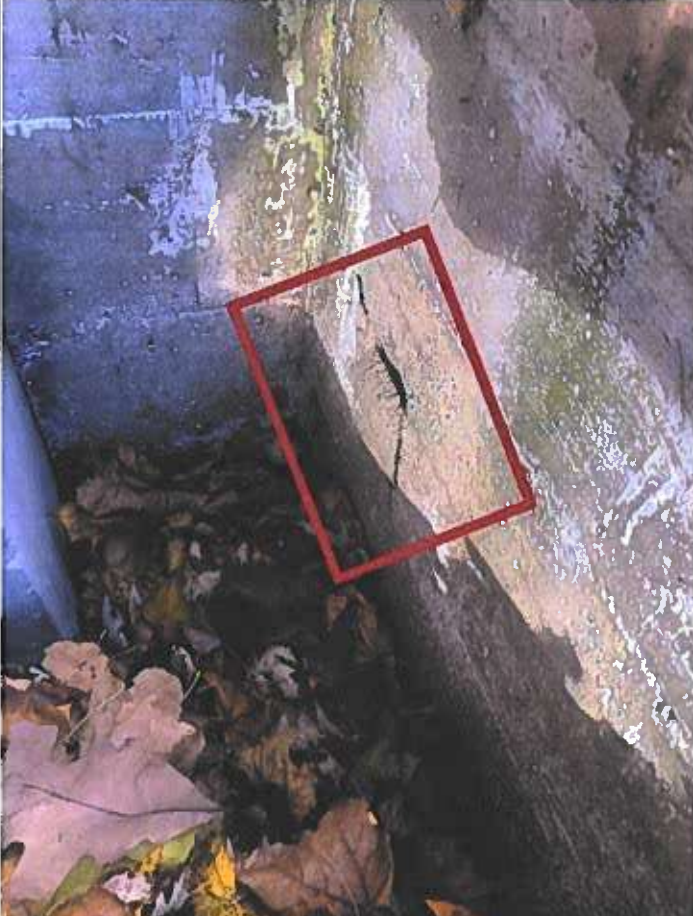
A close-up photograph of the foundation of a brick building. The foundation is made of concrete and shows a significant crack. A red rectangular box is drawn around the crack to highlight it. There are some leaves and debris in the foreground.	<p>3. A crack observed in the foundation underneath the window. This was located on the south side of the building.</p>

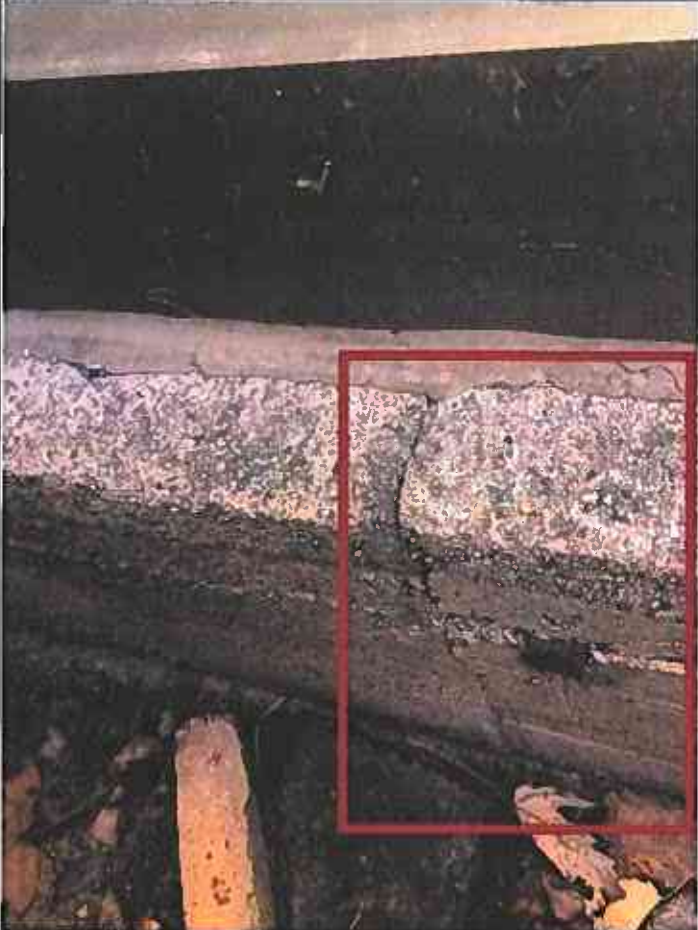
A photograph showing a cross-section of a foundation. The top part is a dark, possibly concrete or masonry surface. Below it is a lighter, textured layer, likely insulation or a different material. A vertical crack is visible in the lighter layer, highlighted by a red rectangular box. The bottom part of the image shows a dark, possibly excavated area with some debris and a wooden post.	<p>4. Another crack discovered in the foundation under a different home economic window. This is located on the south side of the building. We later target this crack getting it to leak within ten minutes.</p>

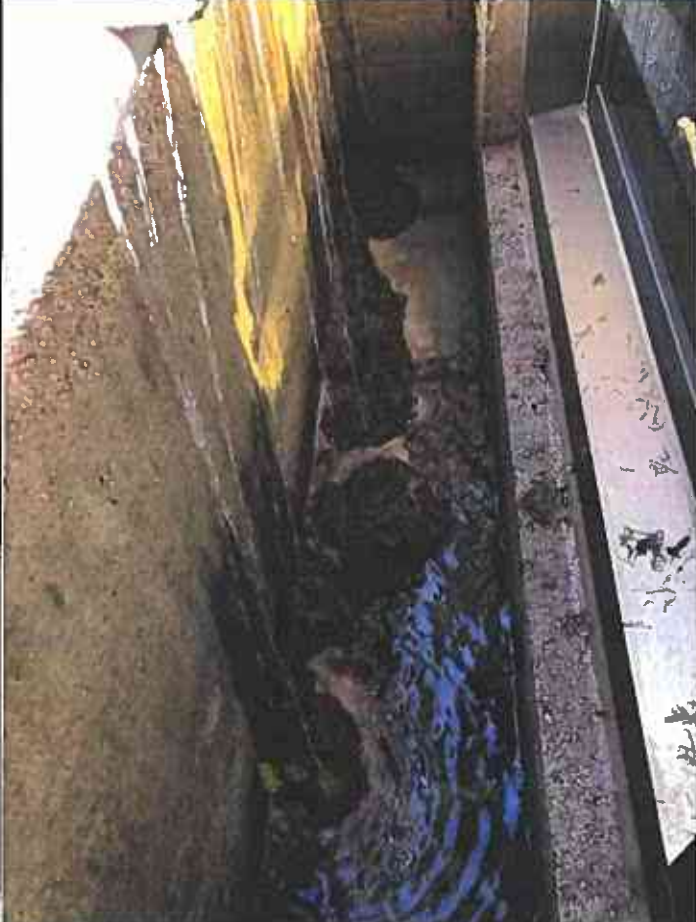
A photograph showing a close-up view of a light-well or drainage area. The surface is dark and appears to be made of concrete or a similar material. There is a significant amount of water accumulated in the well, with ripples visible on the surface. The lighting is somewhat dim, and the overall appearance is one of a neglected or poorly maintained drainage system.	<p>7. Water accumulation in the light-well. There was spacing between the building and the boxed concrete foundation. This lets the water weep between all light-wells. Every well started to fill up with water.</p>

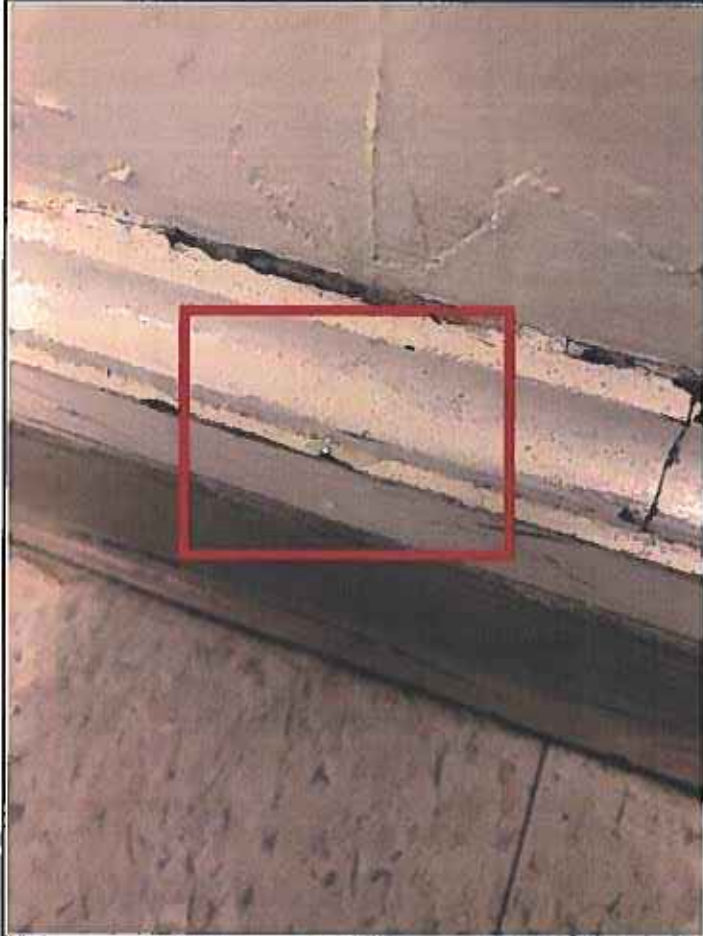
<p>9. Water was observed inside running down the wall and coming out of the trim. The water running down the wall from the inside matches up very well with the crack on the corner of the window sill outside. This took roughly 35 minutes to begin leaking.</p>

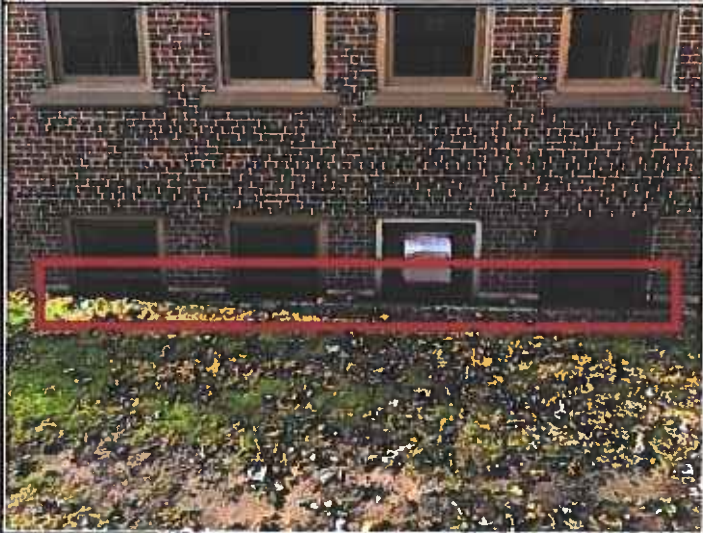
<p>10. The second home economics room has two exterior walls. The southern wall has no windows. It's a completely bricked side. The east side wall has the windows shown here.</p>

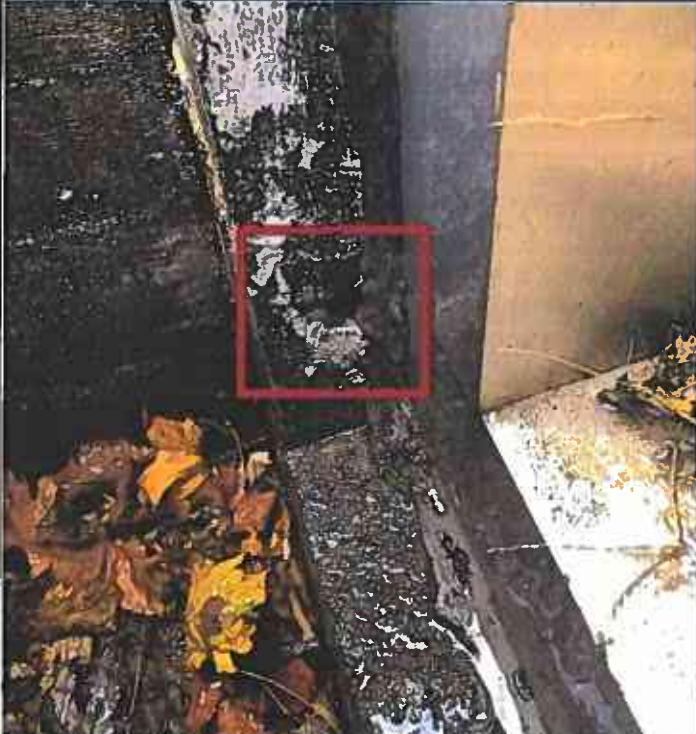
A photograph showing a close-up of a roof surface. A dark, irregular hole is visible in the roof material, highlighted by a red square. The hole appears to be a vent opening. The surrounding roof surface is dark and textured, possibly asphalt or a similar material. There are some yellow leaves and debris scattered around the hole. A window frame is visible on the right side of the image.	<p>11. A hole was discovered by the window that has the vent coming out of it. See photo 10.</p>

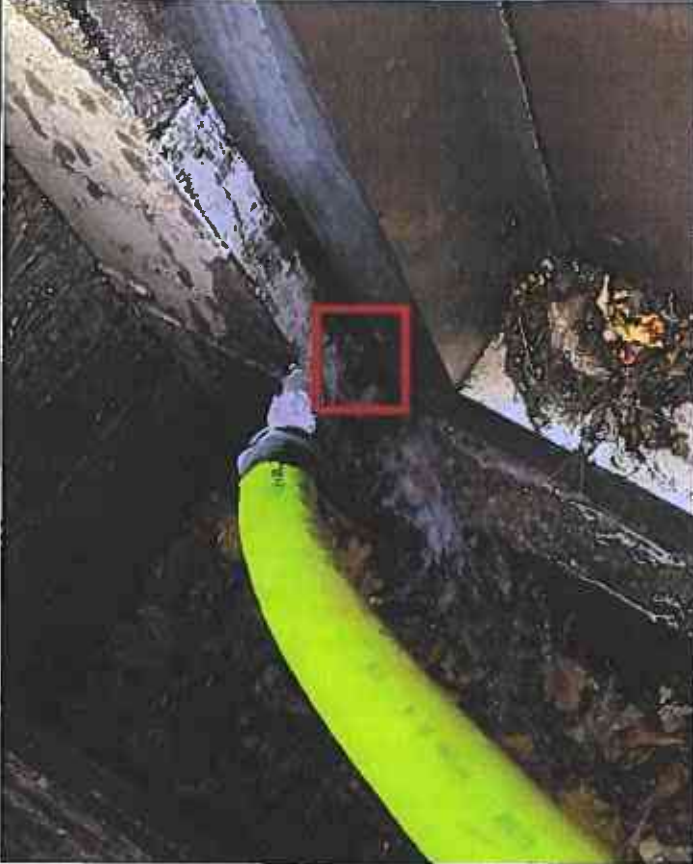
A photograph showing a close-up of a roof edge or gutter area. A bright yellow-green hose is positioned to spray water onto a dark, possibly damaged, surface. A red square highlights a specific area where the water is being applied. The surrounding area shows some debris and structural elements of the roof.	<p>12. Following the information from the first test we were able to single out what were the problematic areas. Once those defects were detected we took a more direct approach on our testing. As shown here we simulated the rain directly on the defect. Leak shows up after twenty minutes.</p>

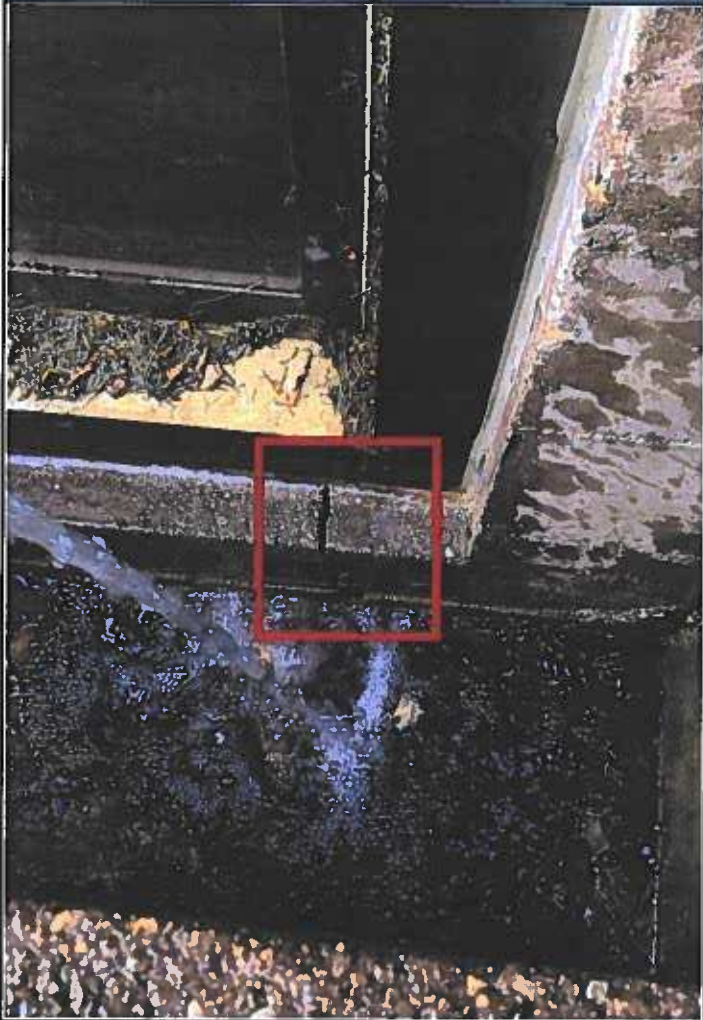
<p>13. This defect is in the most northern light-well on the east wall.</p>

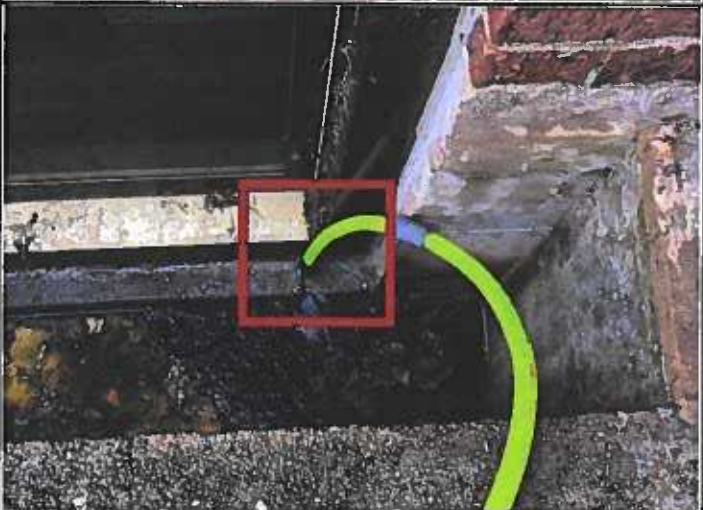
<p>14. We took a direct approach with this defect also. The leak shows up inside the building in under five minutes.</p>

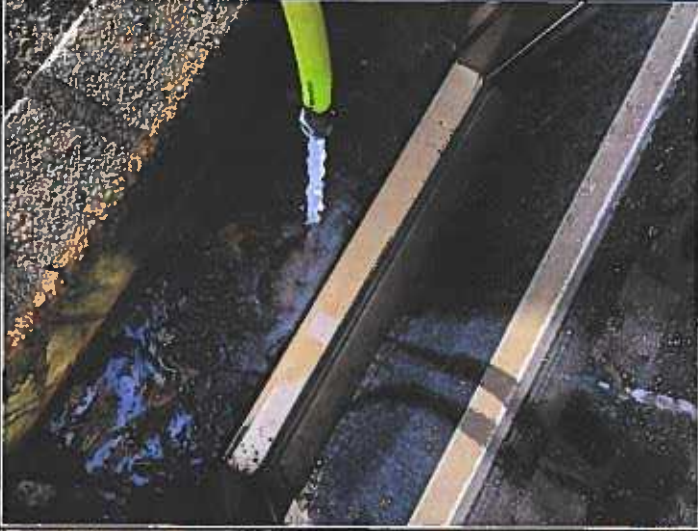
<p>18. We filled up the light-wells to simulate rain.</p>

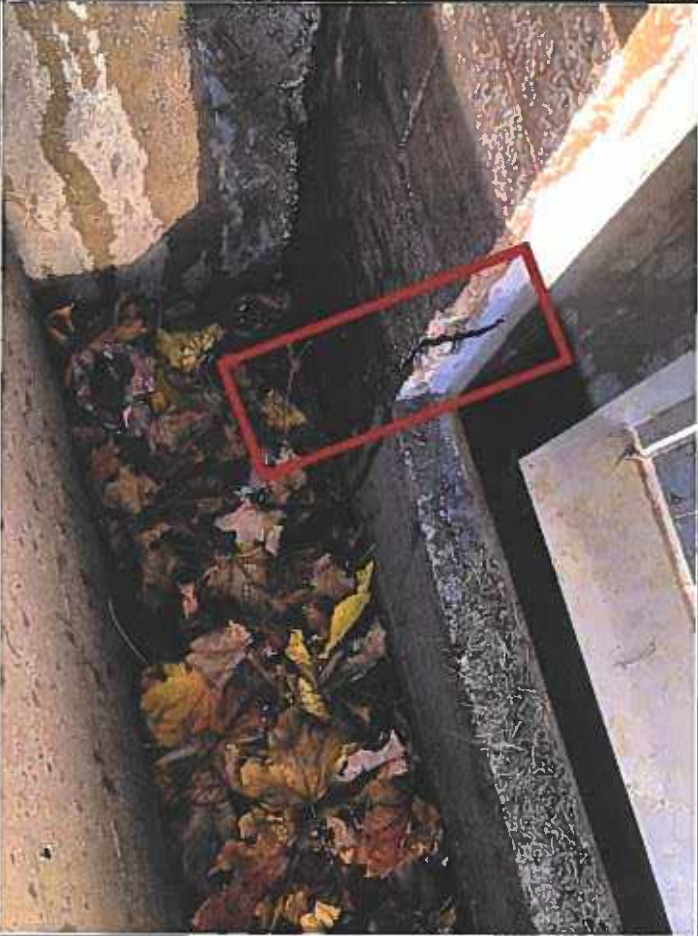
<p>19. This is a defect we observed. It's such a significant crack that we decided to do a direct simulator on it.</p>

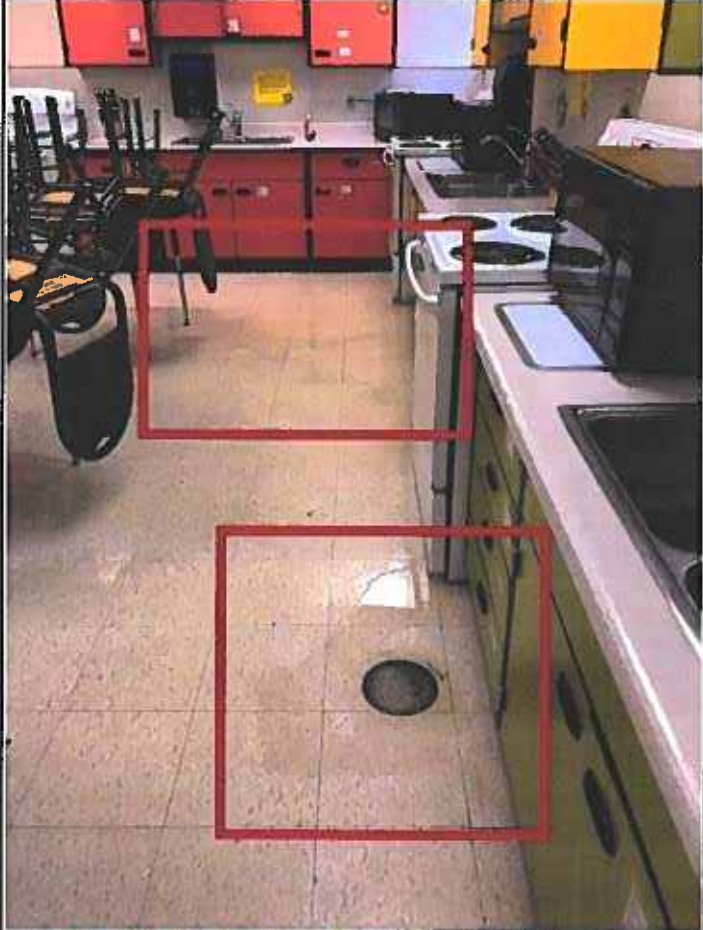
<p>16. This picture shows where both defects leak. The most northern pooling is from the defect in picture 15. The southern pooling is from picture 12.</p>

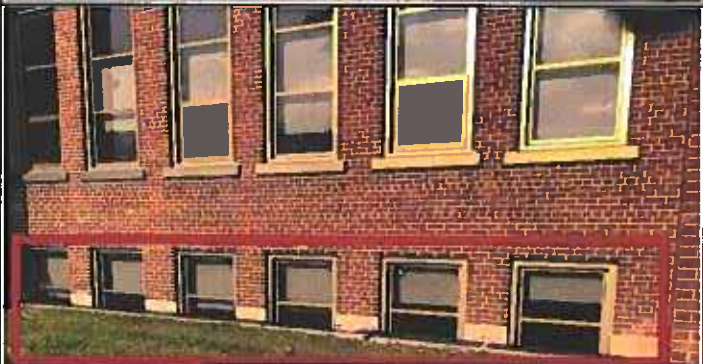
<p>17. This is an overview of the exterior wall for the art room. It was reported that water pools on the floor when it rains.</p>
