Facilities Study Document | Kiel School District, Zielanis Elementary School

Building Systems Summary Checklist

Completed by: Alex Feudner and Ben Nerat, MSA Professional Services

Date of Walk-through: 05/18/2022

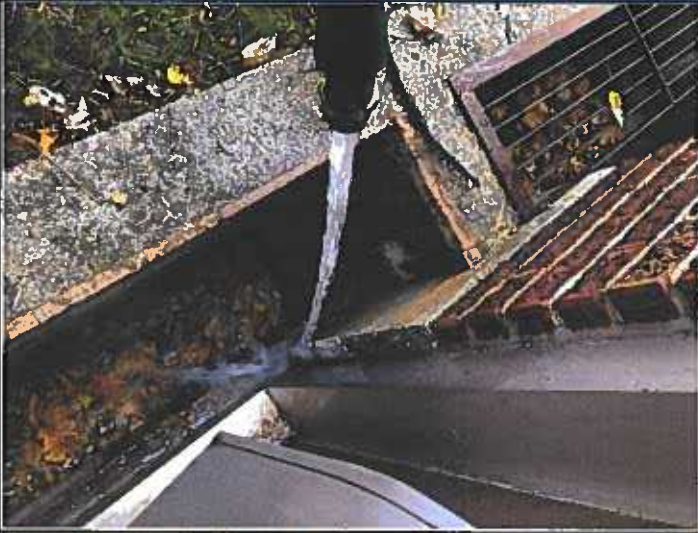
<p>20. This picture shows how we directly flooded the defect. This leak was present inside within a minute.</p>

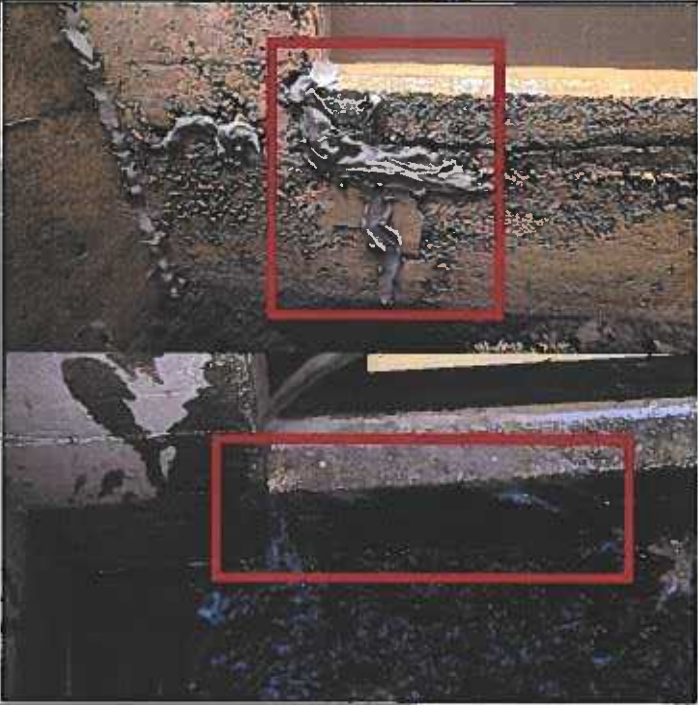
<p>21. The next day after we tested the art and home economics rooms we decided to try another test. We picked a defect we were able to test temporarily repair and retest. Most of the cracks found run deep into the soil. We chose one that didn't run underground. We caulked the defect and ran another simulation. We were able to stop that from leaking inside. Giving us further proof that those defects around the windows foundations are the source to the recurring water entry.</p>

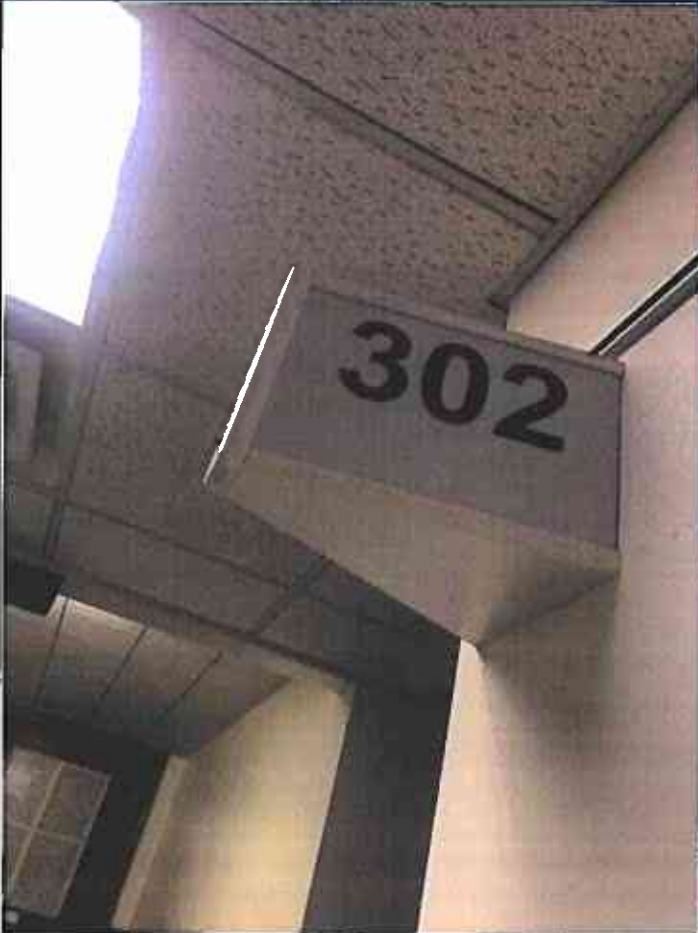
<p>1. Room 302 shows signs of moisture between the tiles and ceiling. The room is located on the north side of the building. It was reported that water hasn't accumulated. The custodian stated he had been there for five years and never witnessed it leaking.</p>

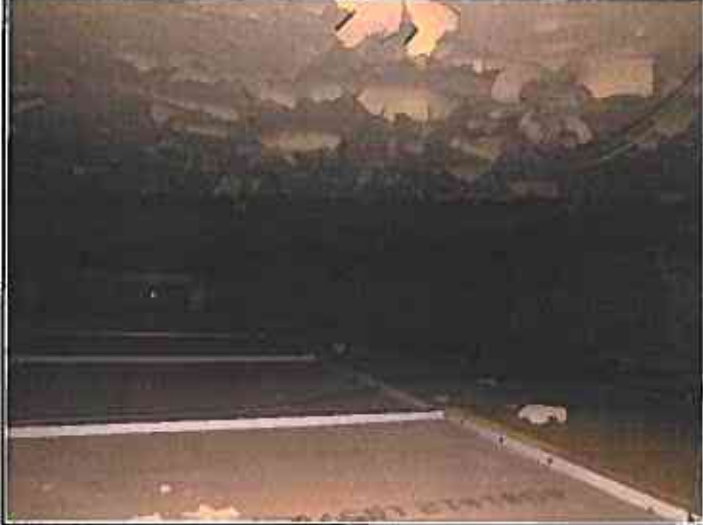
A close-up photograph of a ceiling surface. The paint is severely peeling and chipped away, revealing a dark, textured substrate underneath. The peeling is concentrated in the upper right portion of the frame.	<p>2. The paint is peeling from the ceiling above the ceiling tiles in room 302.</p>

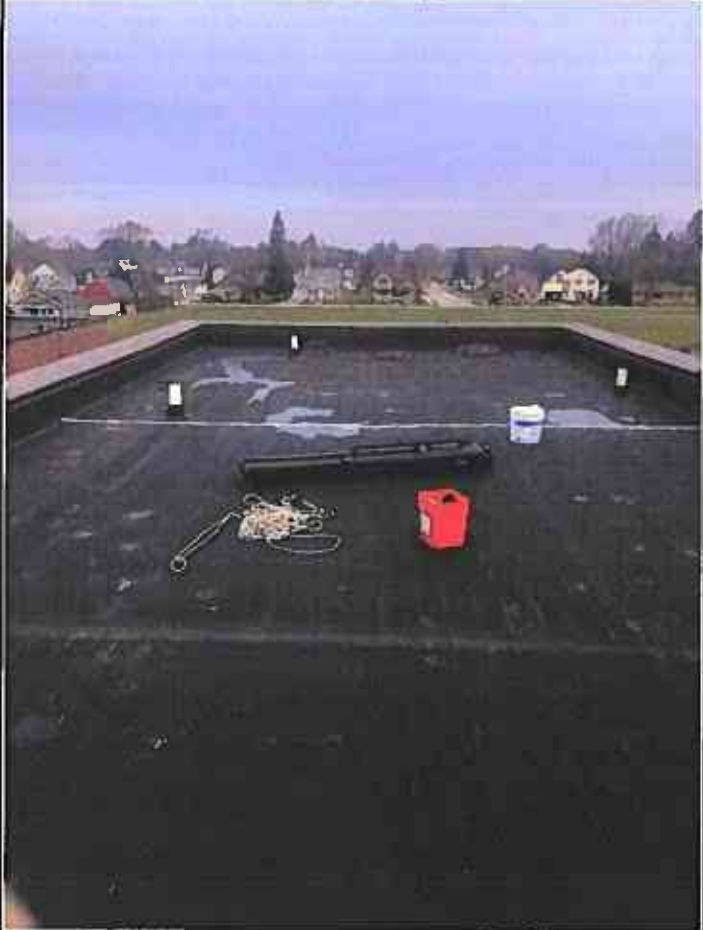
A wide-angle photograph of a flat roof system. The roof is dark and appears to be made of asphalt or a similar material. There are several white markers or stakes placed on the roof surface. A red bucket and some equipment are visible in the foreground. In the background, there are residential houses and trees under a clear sky.	<p>3. This is the roof system above room 302. It should be noted that three outside walls are present. Two of these walls do not have windows.</p>

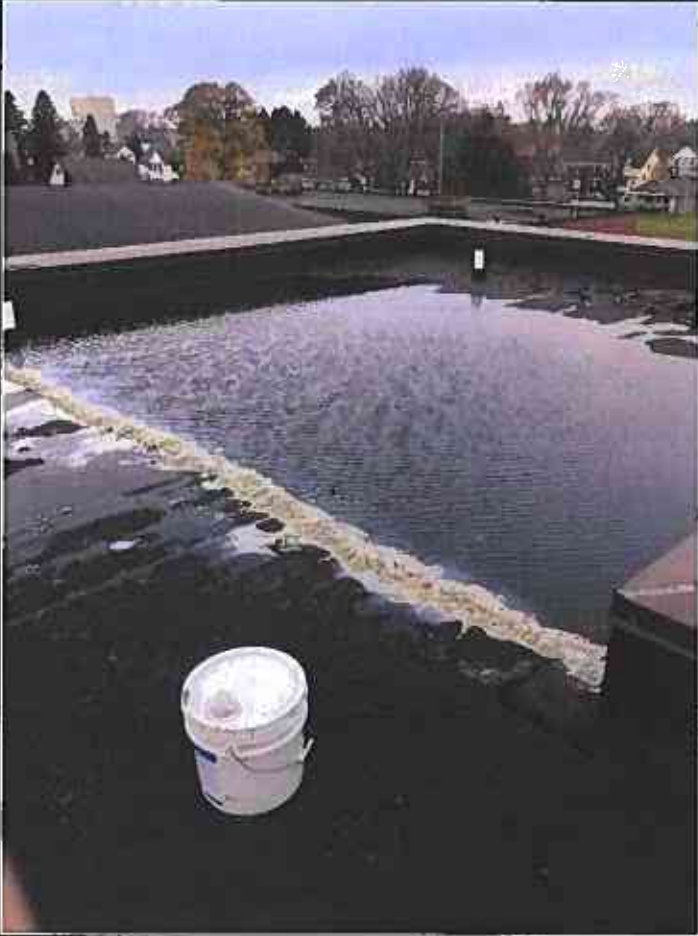
<p>4. The first simulated test was to flood the roof area above room 302. Using leak stop we were able to build a dam to keep the water over room 302. The hose was moved five feet every twenty minutes for water to be passed on the entire system.</p>

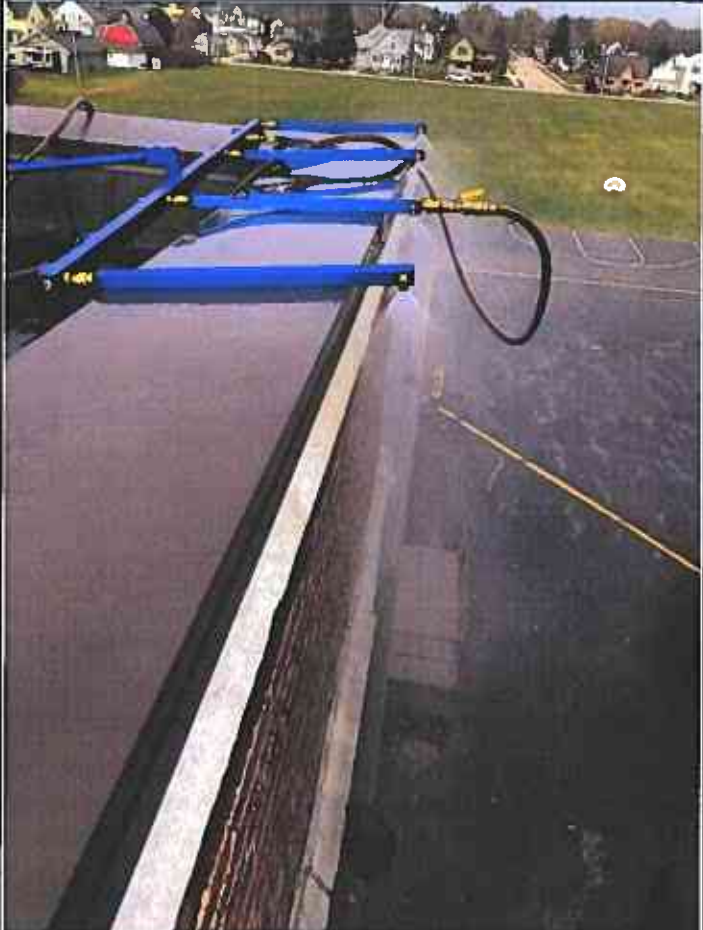
A photograph taken from a high angle looking down at a roof edge. A blue metal rain simulator rig is mounted along the edge of the roof. The rig consists of several horizontal bars and a hose. In the background, a residential neighborhood with houses and trees is visible under a clear sky.	<p>5. The next step was to water test the walls and metal coping cap. The rain simulator was targeted on the two walls with no windows. The interior ceiling damage/peeling paint was worse there. Every 40 minutes we would move the simulator five feet down.</p>

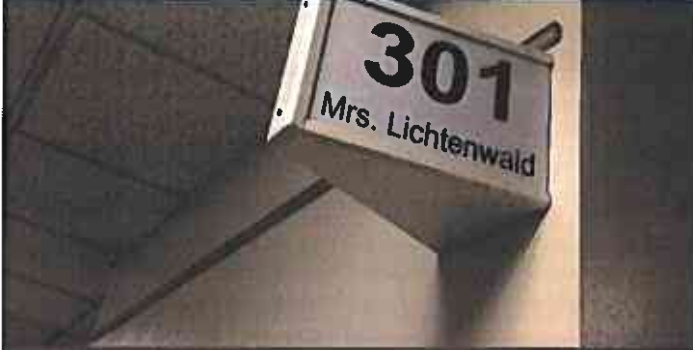
A photograph of a white rectangular sign mounted on a wall. The sign has the number '301' in large black digits and the name 'Mrs. Lichtenwald' in smaller black text below it. The background is a light-colored wall.	<p>7. Room 301 was looked into to see if it too experienced the same situation as room 302. The bottom picture shows paint peeling.</p>

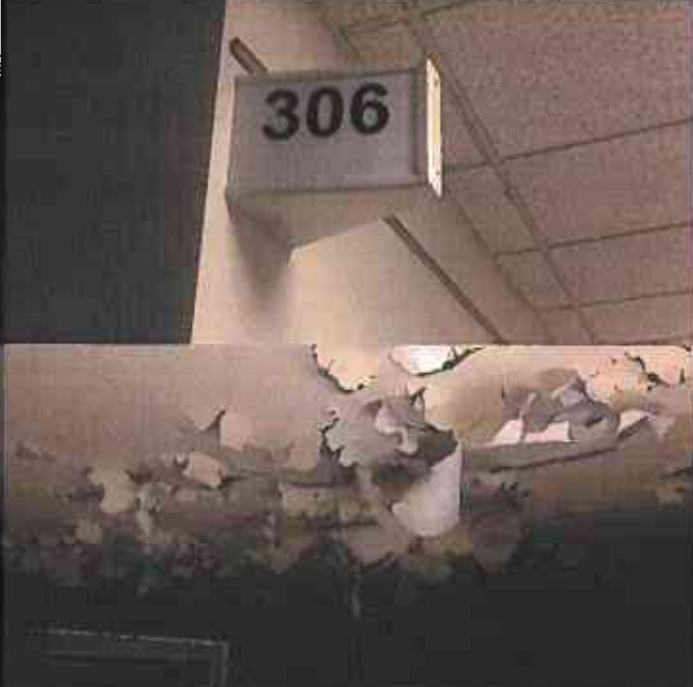
A photograph showing a white rectangular sign with the number '306' in black. Below the sign, there is a close-up view of a wall where the paint is severely peeling and chipping away, revealing a lighter surface underneath. A white cup is visible in the foreground, partially filled with the peeling paint.	<p>8. This is room 306. Almost as severe peeling as room 302. It's on the east side of the building while 302 is on the west. It also appears that room 306 had walls exposed to the outside at one time. An addition to the school building is suspected to be built on from room 306 at sometime.</p>

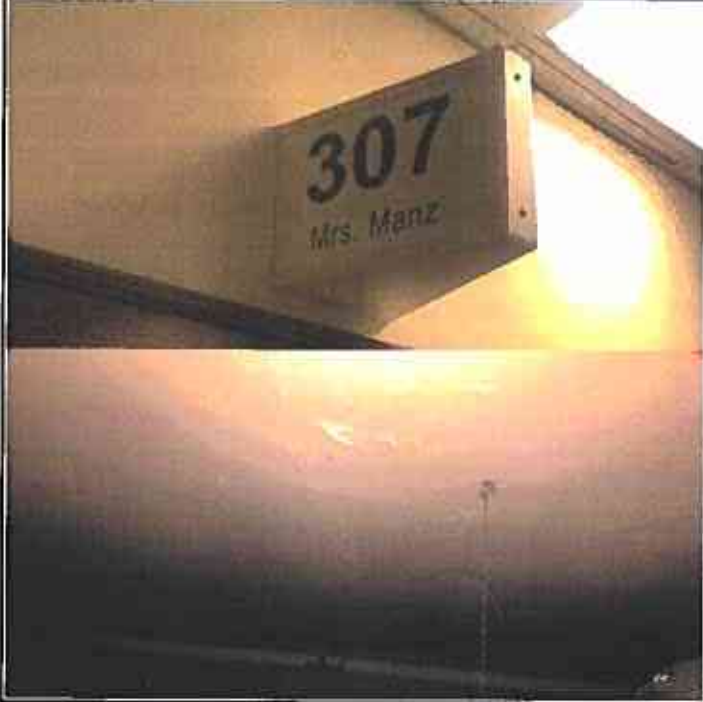
A photograph showing a white rectangular sign with the number '307' and the name 'Mrs. Manz' in black text. The sign is mounted on a wall. Below the sign, the ceiling is visible, showing some discoloration and peeling paint.	<p>9. Room 307 is located on the south side. Limited peeling paint was observed at this location.</p>

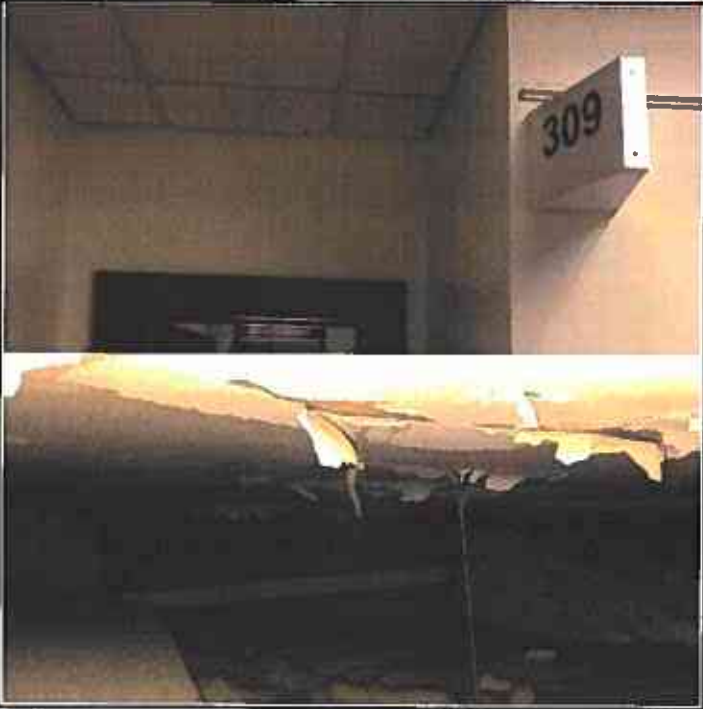
A photograph showing a white rectangular sign with the number '309' in black text. The sign is mounted on a wall. Below the sign, the ceiling is severely damaged, with large sections of white paint peeling away, revealing a dark, textured surface underneath.	<p>10. Room 309 is located in the middle south side of the building. The ceiling shows signs of peeling paint.</p>

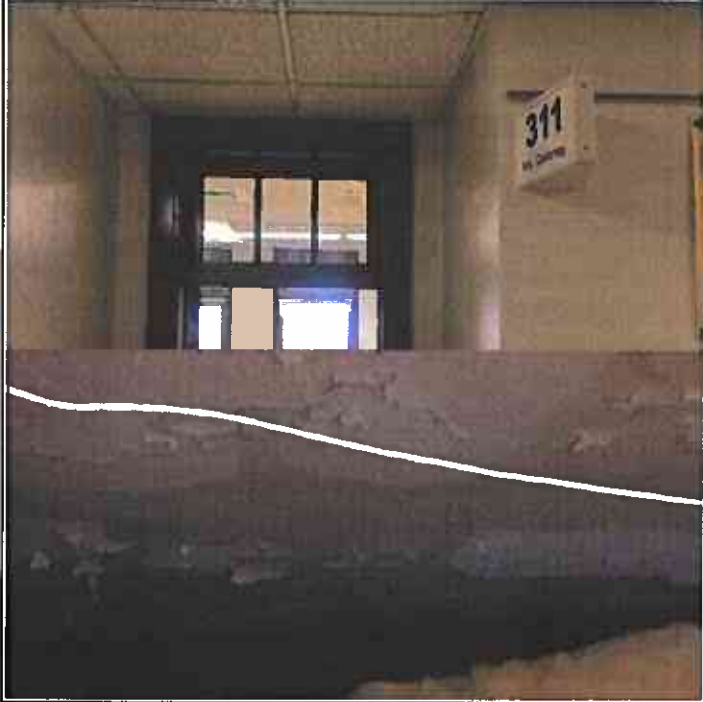
<p>11. Room 311 is located on the south side of the building. It shows peeling throughout the ceiling.</p>

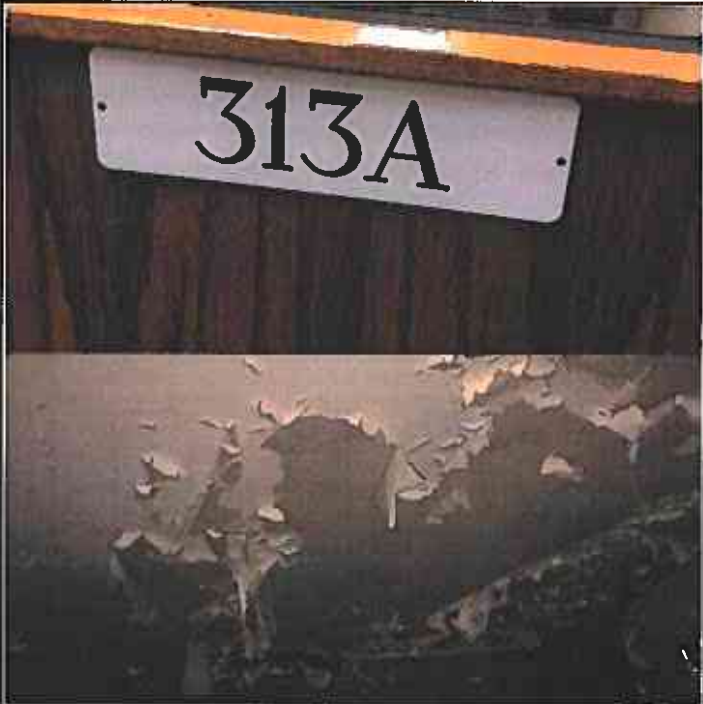
<p>12. Room 313A is located across from room 306. It is suspected that the school was added on to at room 306 and 313A. That room 306 and 313A had exposed outside walls at one point. The deck of the building changes to metal right after these rooms.</p>
